2024 ODAV Pavement Evaluation Program Pinehurst State Airport

Pinehurst, Oregon

February 12, 2025

Prepared for
State of Oregon Department of Aviation
3040 25th Street SE
Salem, OR 97302-2595

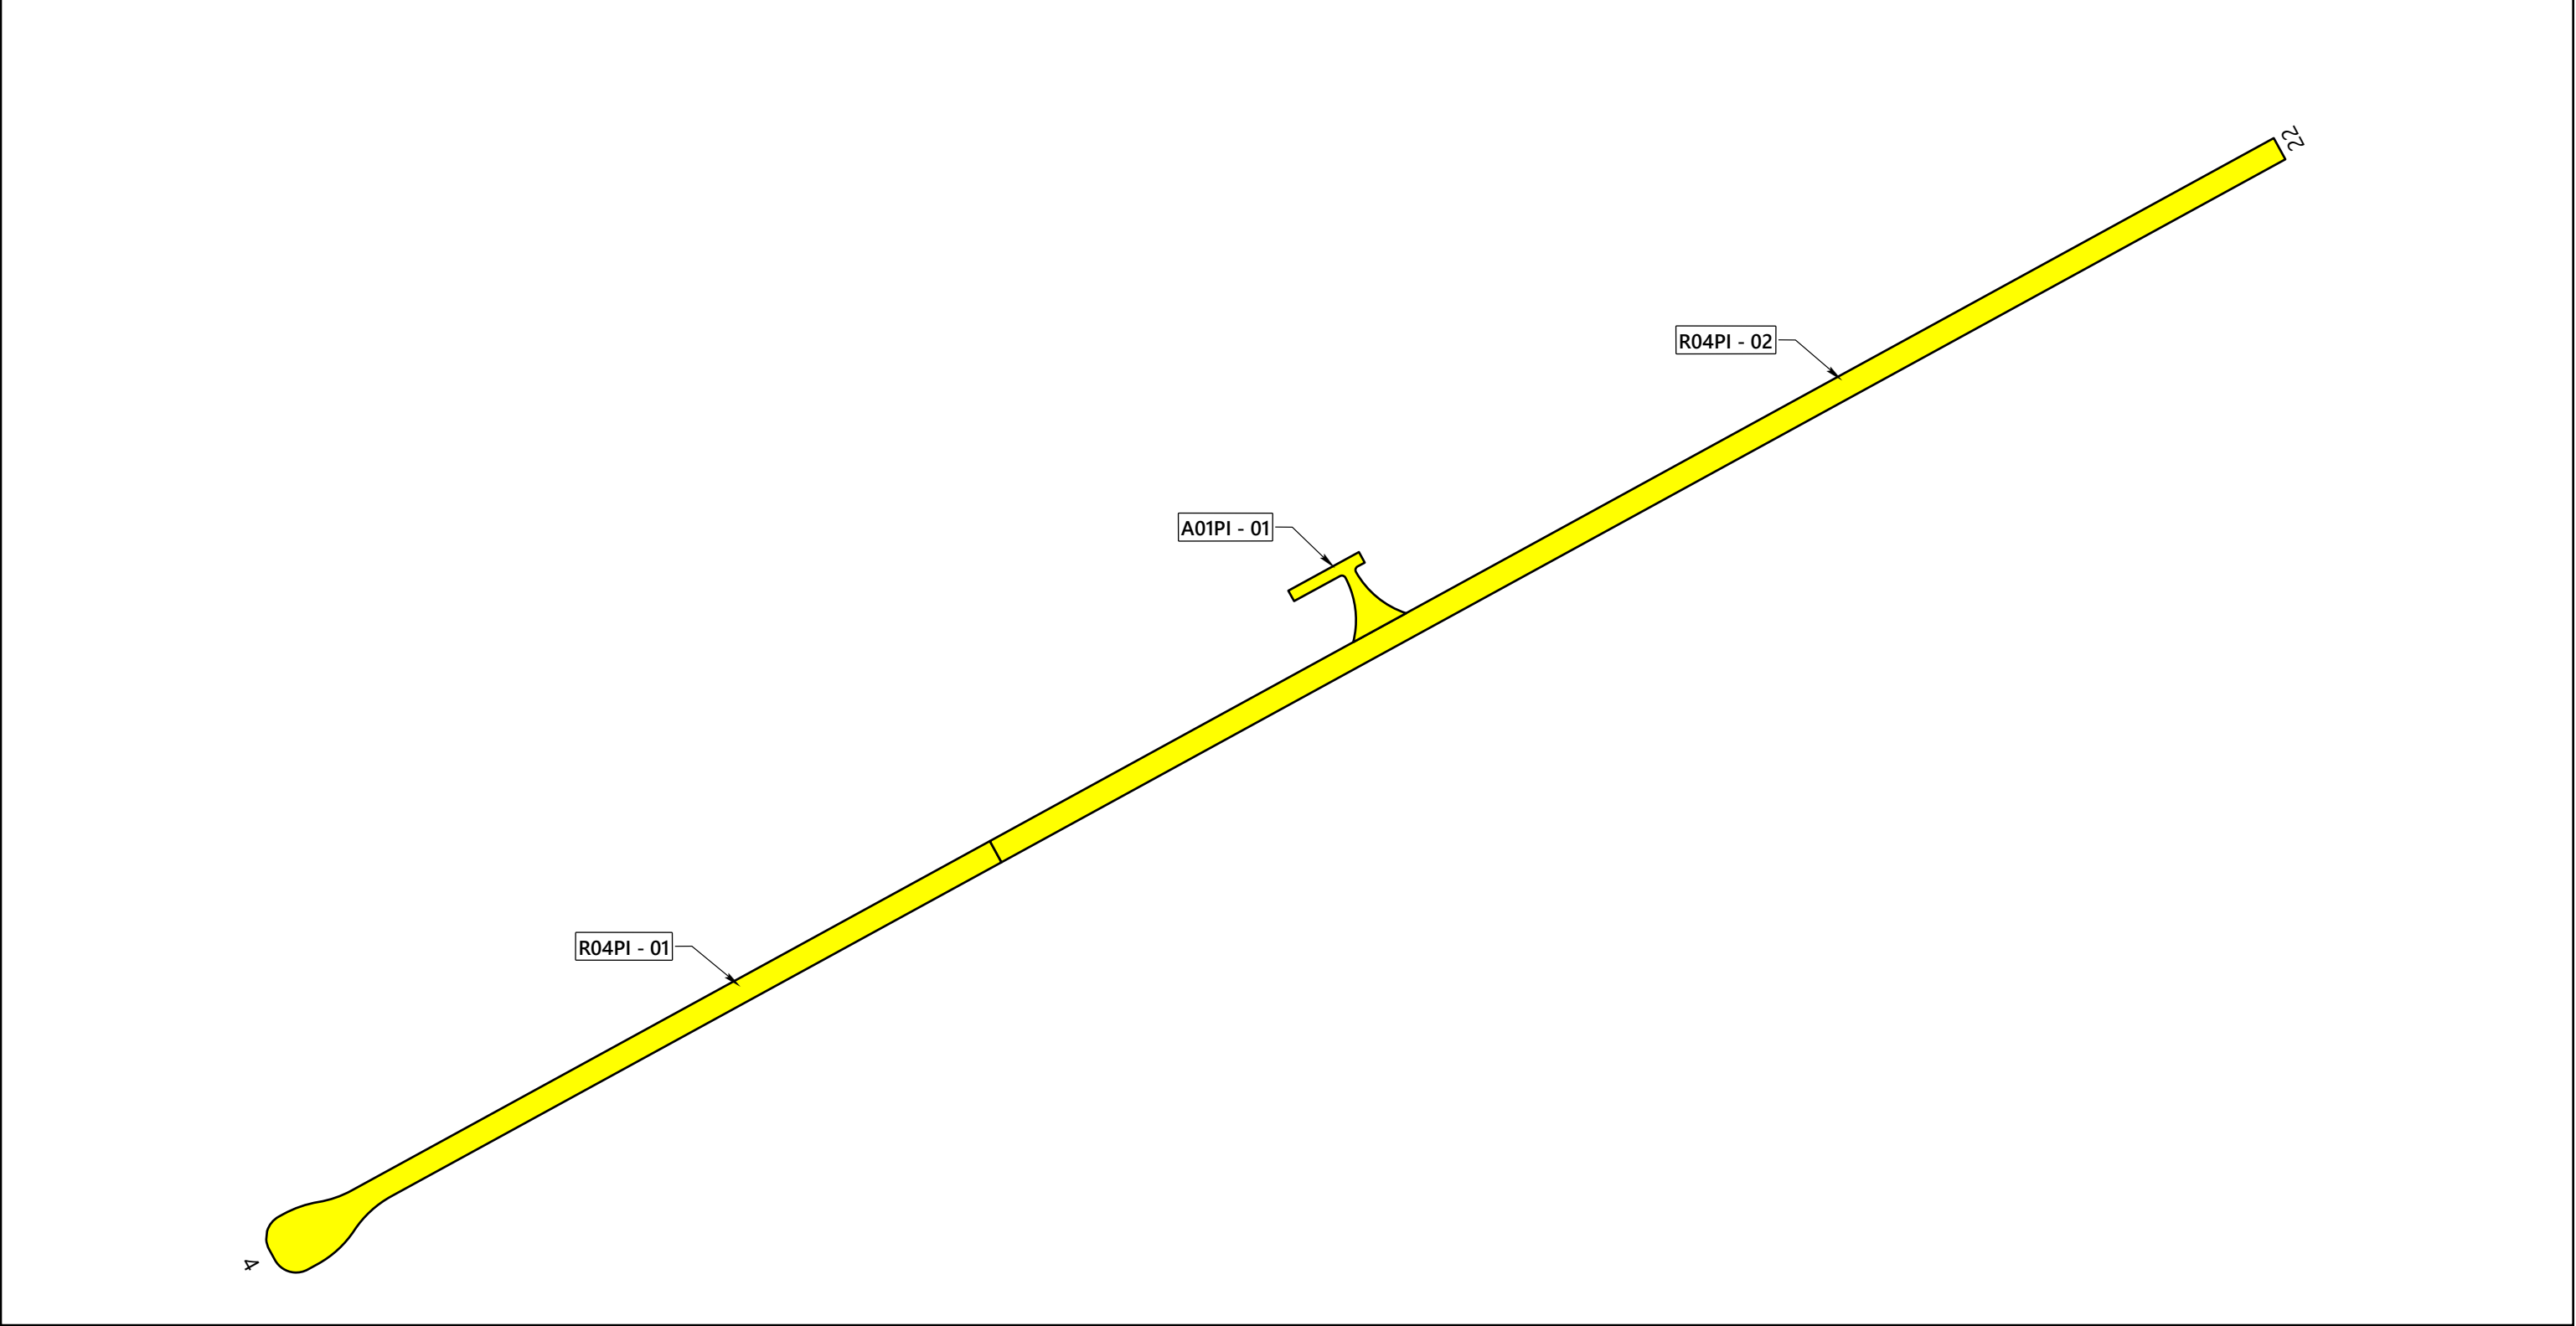
**PINEHURST STATE AIRPORT
2024 PCI SURVEY RESULTS**

The area-weighted average PCI for all airport pavements at Pinehurst State Airport is approximately 65. The section PCIs ranged from a low of 59 to a high of 68. The primary distresses observed during the inspection were weathering, longitudinal and transverse cracking, fatigue (alligator) cracking, and raveling on AC-surfaced pavements. Section PCIs following our pavement survey are displayed spatially on the Pinehurst State Airport 2024 PCI Survey Results, Figure 3.1, below.

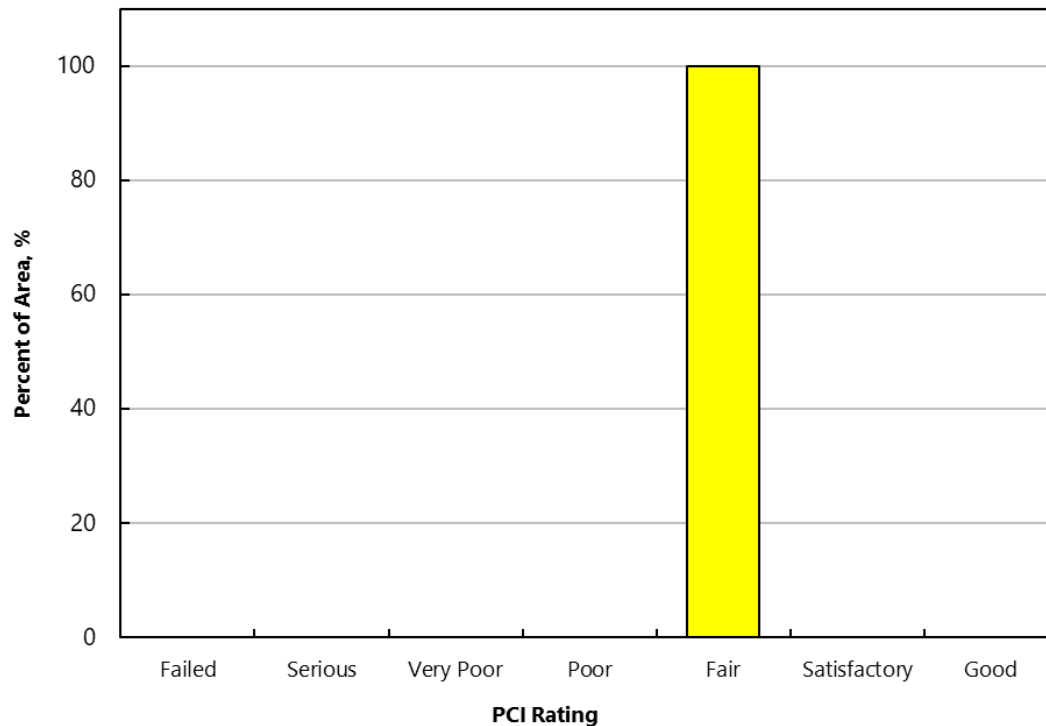
Figure 3.2: PINEHURST STATE AIRPORT PAVEMENT CONDITION RATING BY PERCENT OF AREA

The condition distribution of the network by percent of total pavement area is provided on the Pinehurst State Airport Pavement Condition Rating by Percent of Area, Figure 3.2. Summaries of the pavement condition results by branch and section are included in Tables 2B and 3B of Appendix B, respectively. A comparison between the previous inspection and the 2024 inspection is provided in Table 4B in Appendix B. The re-inspection report that includes inspection details for individual sample units is presented in Appendix E.

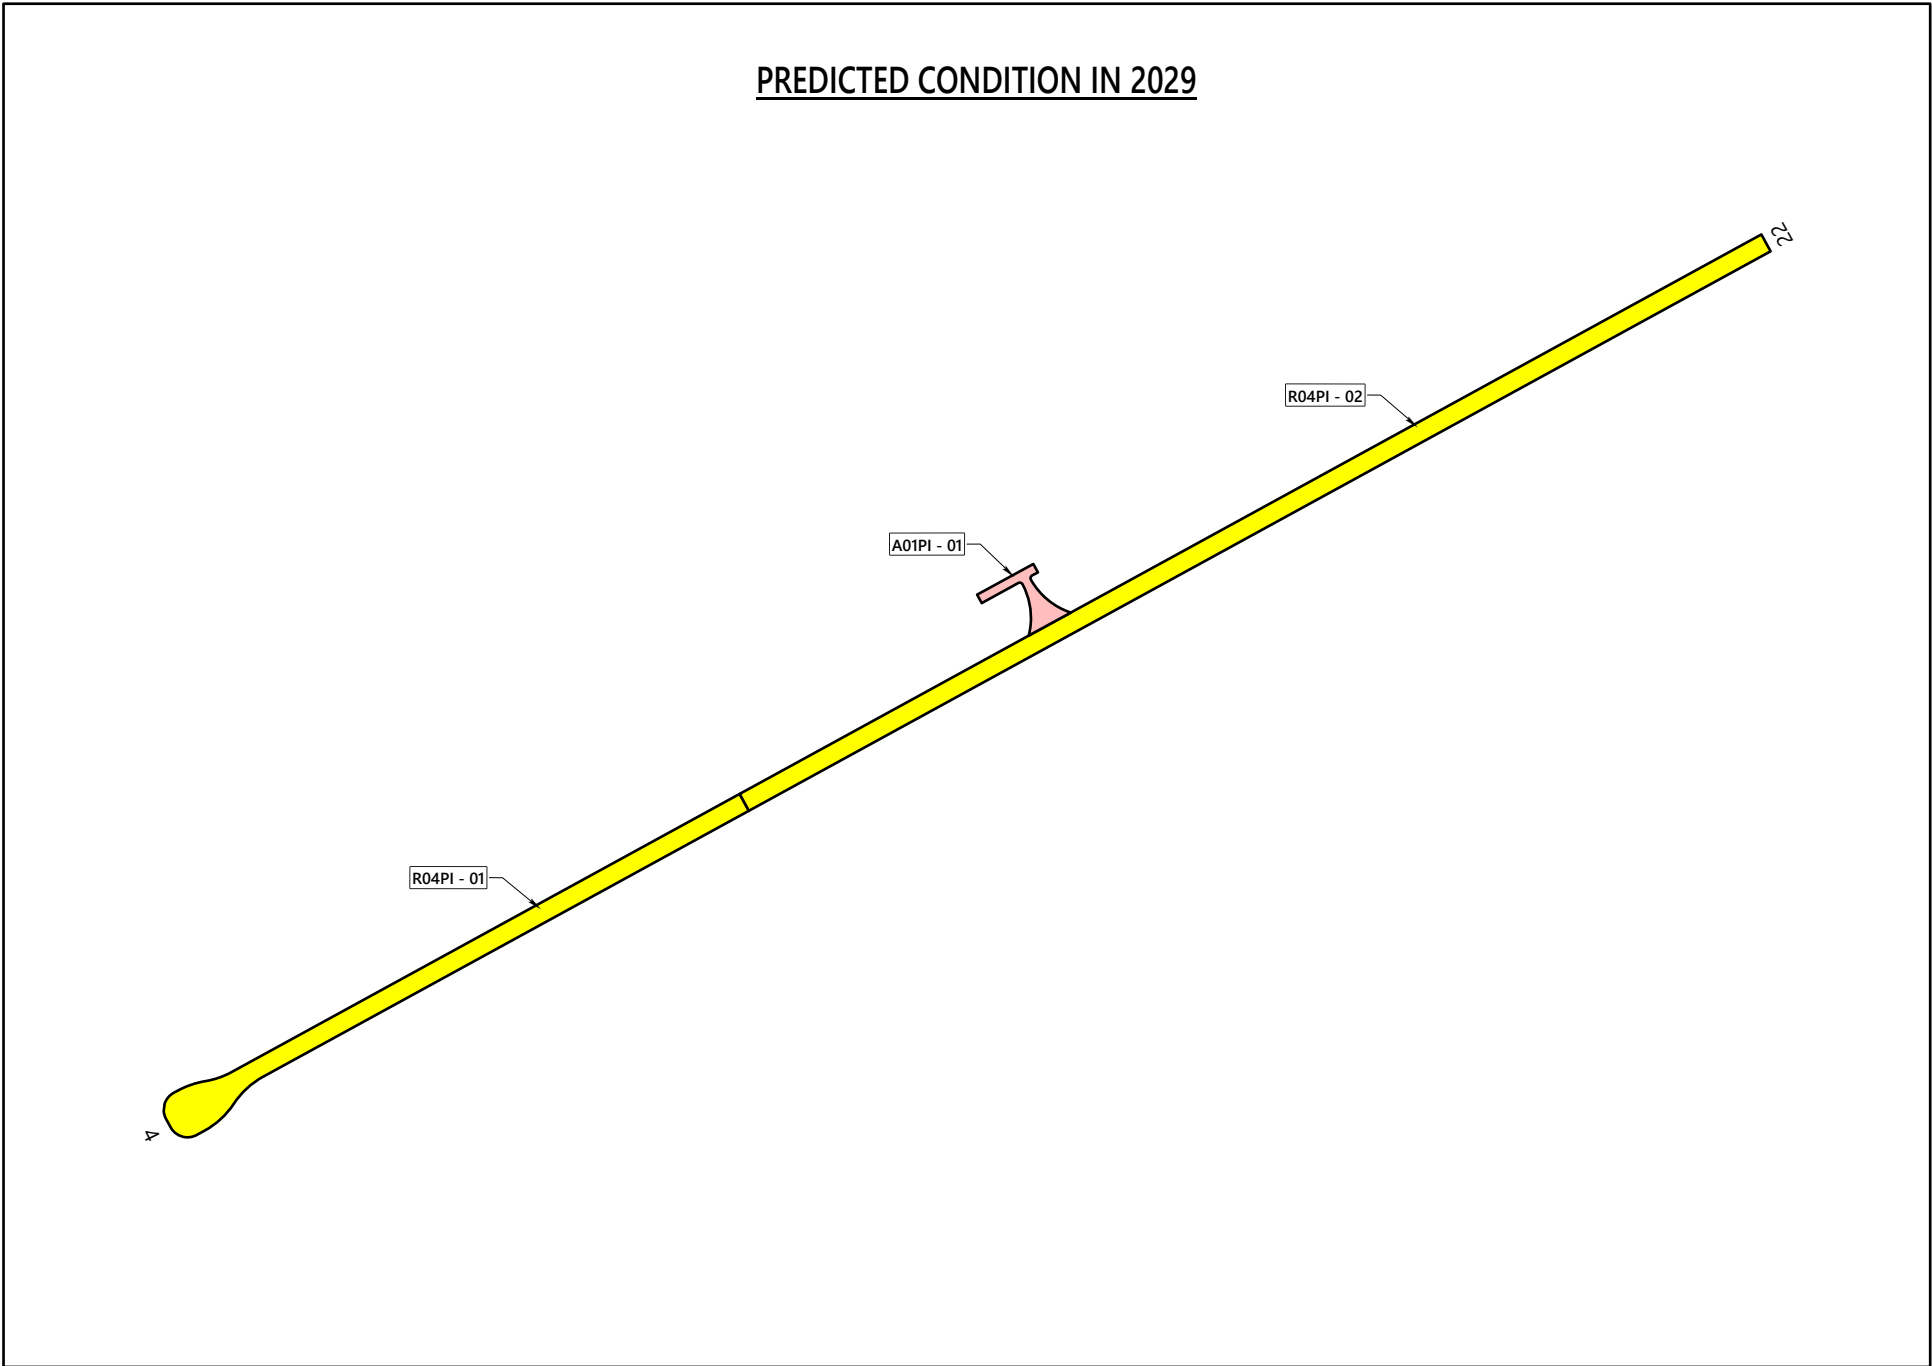
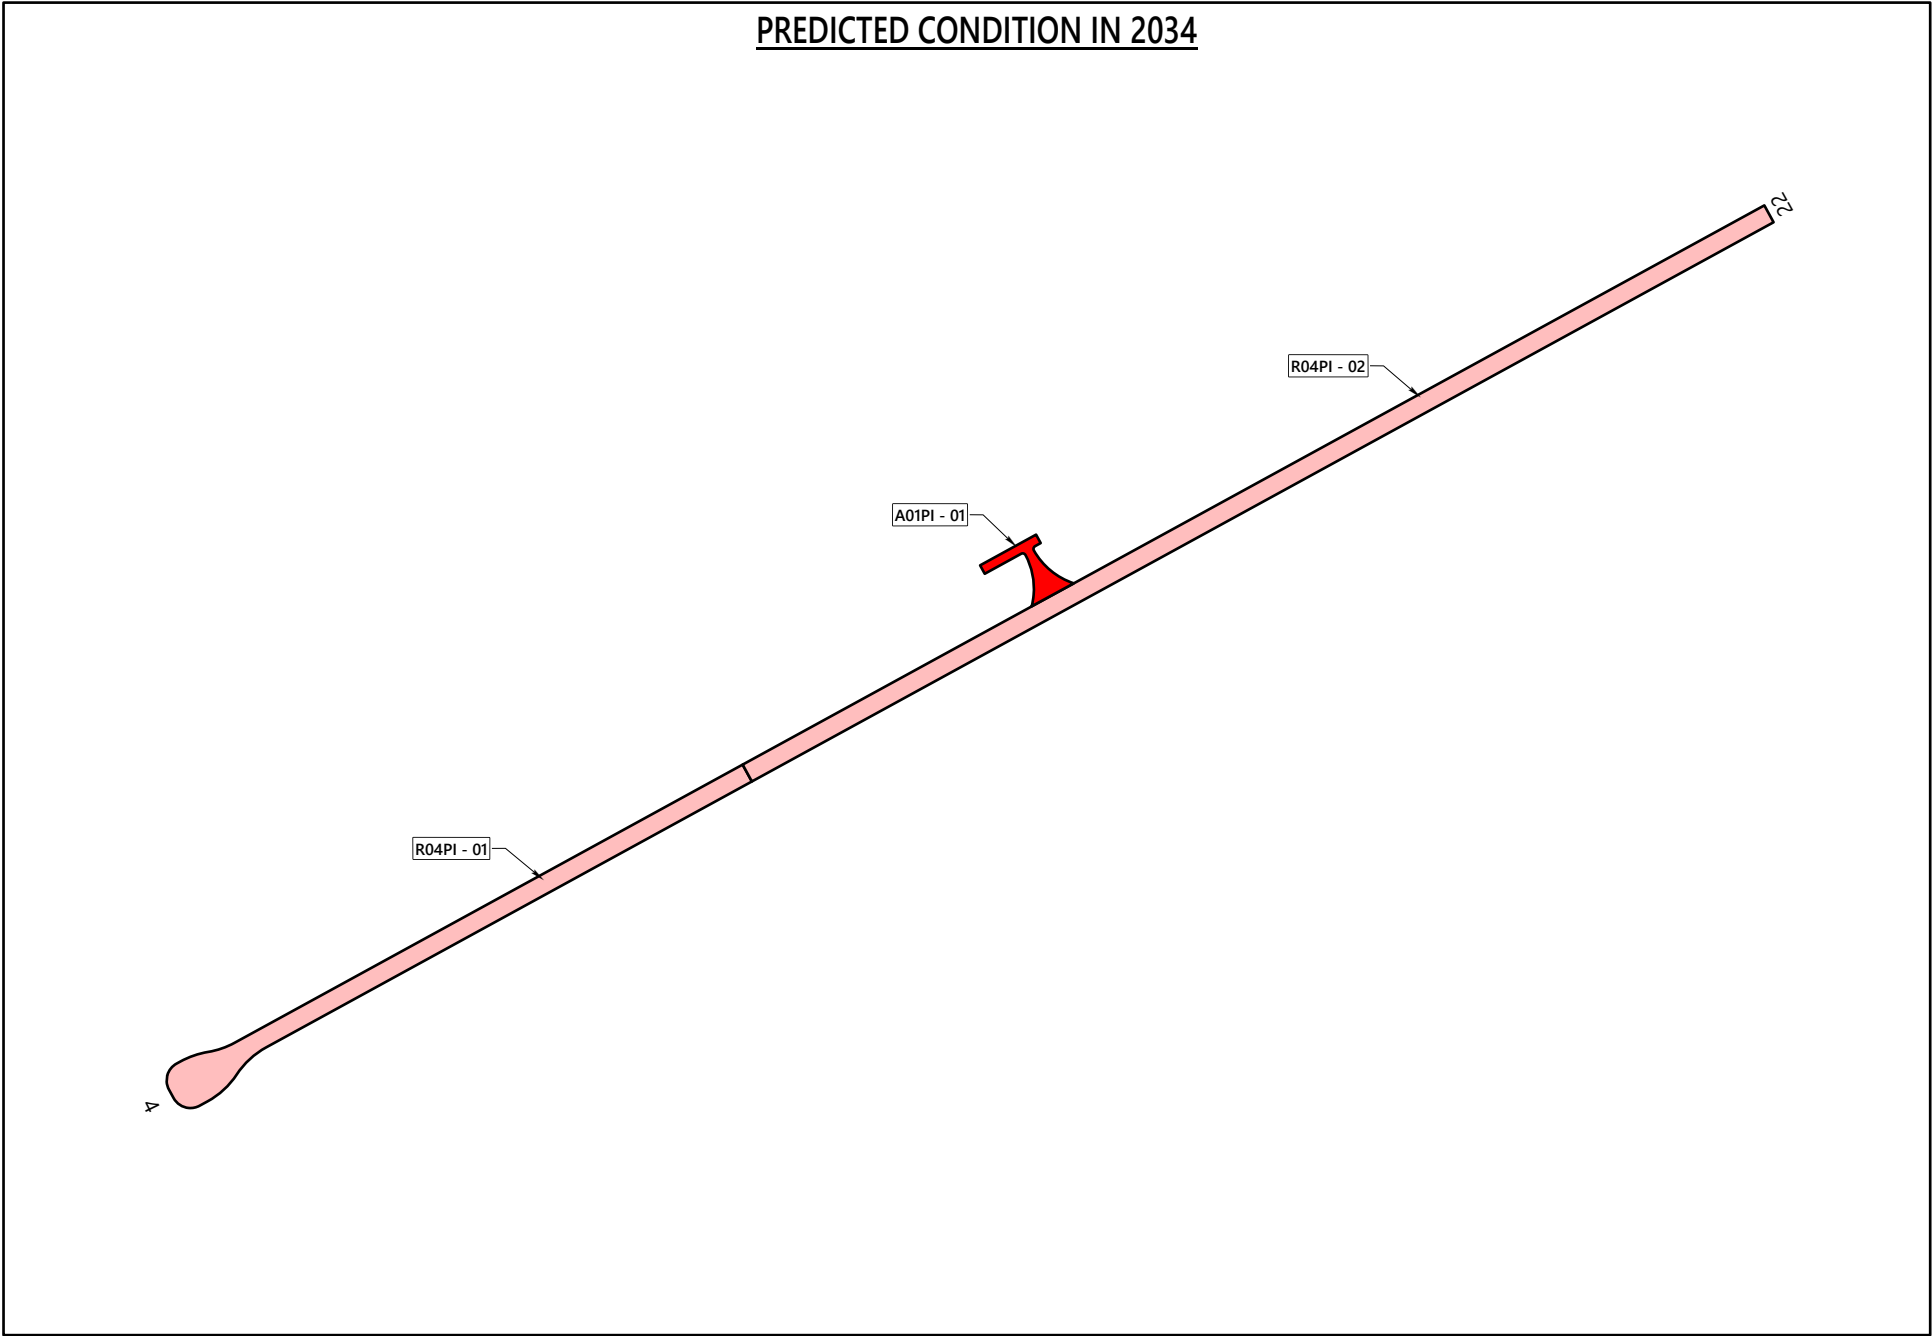
PINEHURST STATE AIRPORT
FUTURE PAVEMENT CONDITION

project the PCI will decrease from its current value of 65 to a value of 58 in 2029 and 50 in 2034 if no maintenance or rehabilitation work is performed. The projected pavement condition in five years and 10 years for each pavement section at Pinehurst State Airport is displayed spatially on the Pinehurst State Airport Future Pavement Condition, Figure 4.1, and listed in Table 1C in Appendix C, along with the past and present PCI values for the pavement network.
