2024 ODAV Pavement Evaluation Program Prospect State Airport

Prospect, Oregon

February 12, 2025

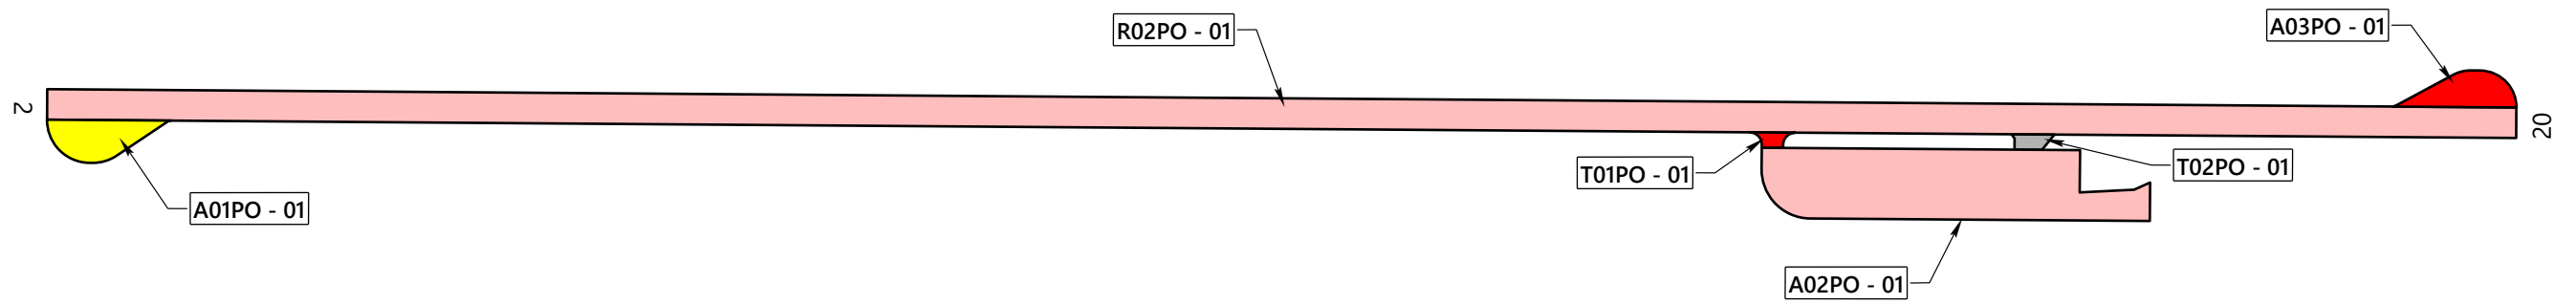
**PROSPECT STATE AIRPORT
2024 PCI SURVEY RESULTS**

The area-weighted average PCI for all airport pavements at Prospect State Airport is approximately 54. The section PCIs ranged from a low of 0 to a high of 61. The primary distresses observed during the inspection were weathering, longitudinal and transverse cracking, fatigue (alligator) cracking, block cracking, patching, and raveling on AC-surfaced pavements. Section PCIs following our pavement survey are displayed spatially on the Prospect State Airport 2024 PCI Survey Results, Figure 3.1, below.

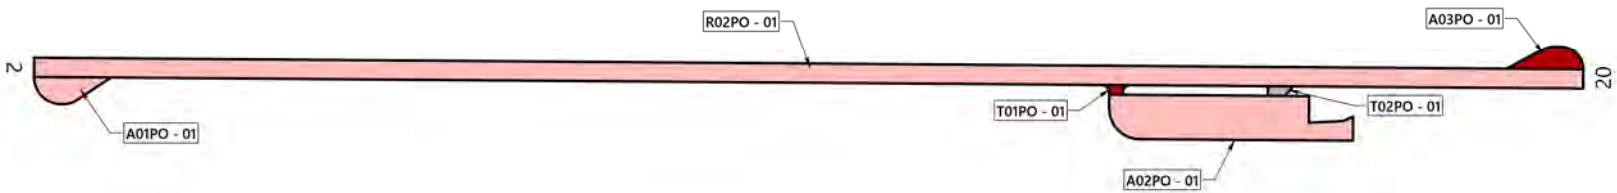
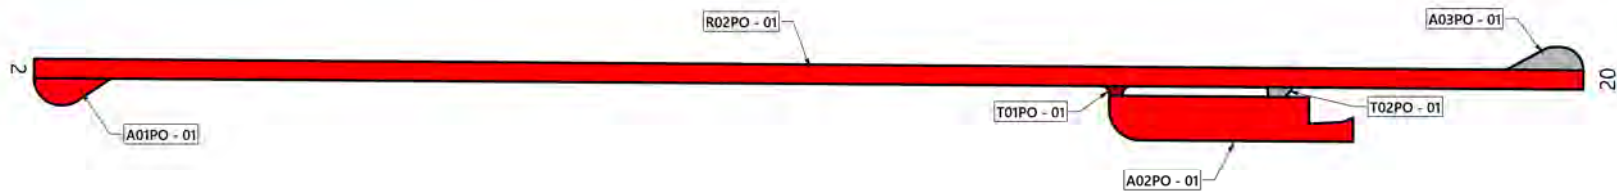
PROSPECT STATE AIRPORT
FUTURE PAVEMENT CONDITION

Using the condition prediction models discussed above, the projected condition of each pavement section was determined for five- and 10-year periods. Based on this analysis, we project the PCI to decrease from its current value of 54 to values of 45 in 2029 and 37 in

2034 if no maintenance or rehabilitation work is performed. The projected pavement condition in five years and 10 years for each pavement section at Prospect State Airport is displayed spatially on the Prospect State Airport Future Pavement Condition, Figure 4.1, and listed in Table 1C in Appendix C, along with the past and present PCI values for the pavement network.
