2022 ODA Pavement Evaluation Program Chiloquin State Airport

Chiloquin, Oregon

**December 30, 2022
(REVISED: 01/24/2023)**

Prepared for
State of Oregon Department of Aviation
3040 25th Street SE
Salem, OR 97303-1125

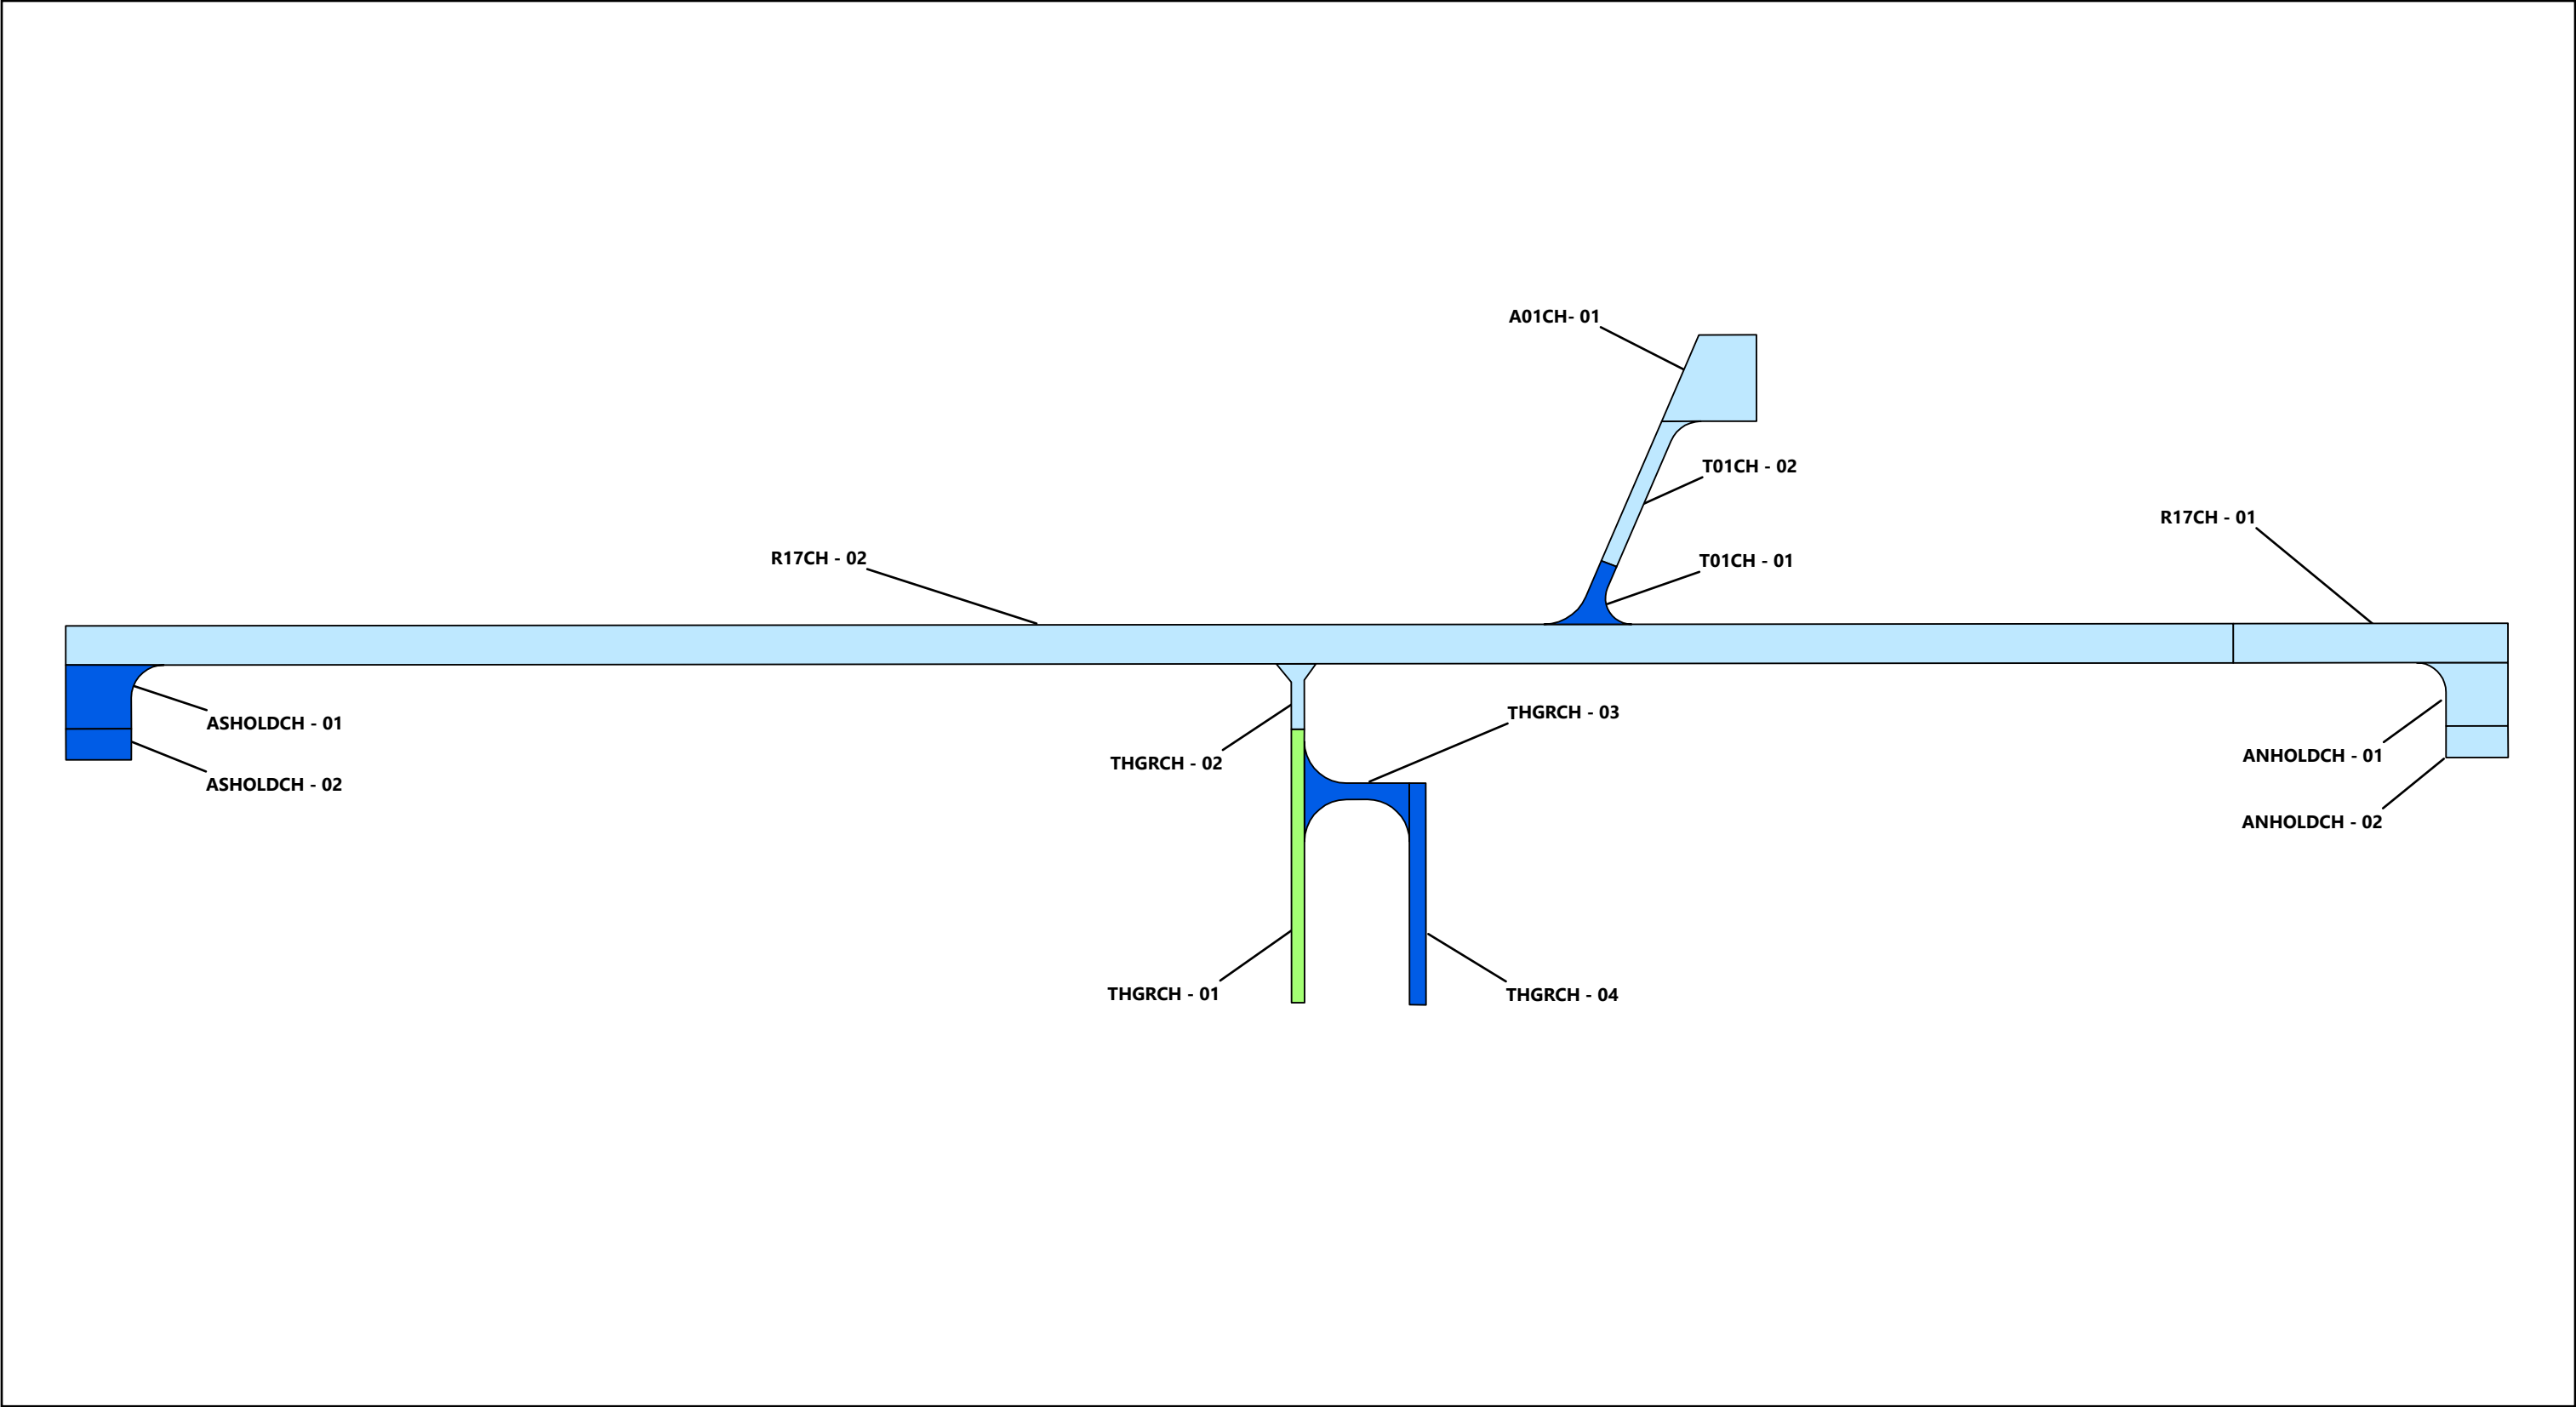
The area-weighted average PCI for all airport pavements at Chiloquin Airport is approximately 71. The section PCIs ranged from a low of 52 to a high of 75. The primary distresses observed during the inspection were weathering and longitudinal and transverse cracking. Section PCIs following our pavement survey are displayed below spatially on the 2022 PCI Survey Results, Figure 3.1.

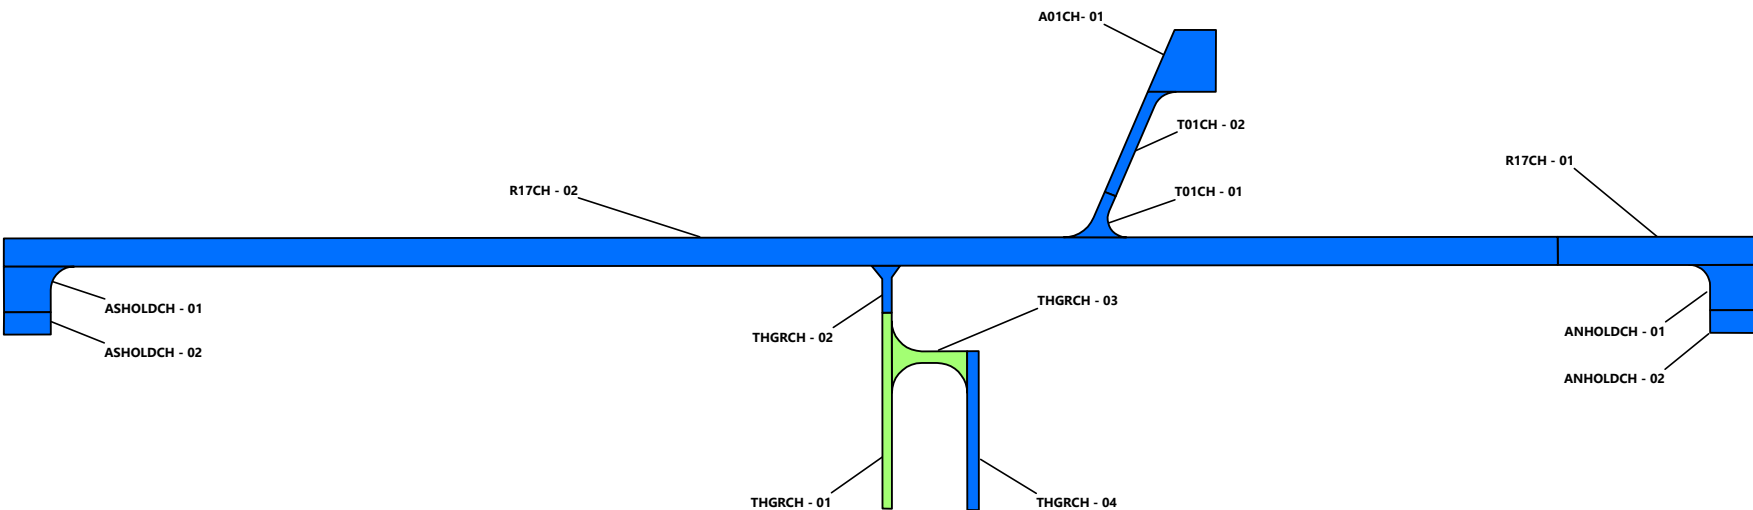
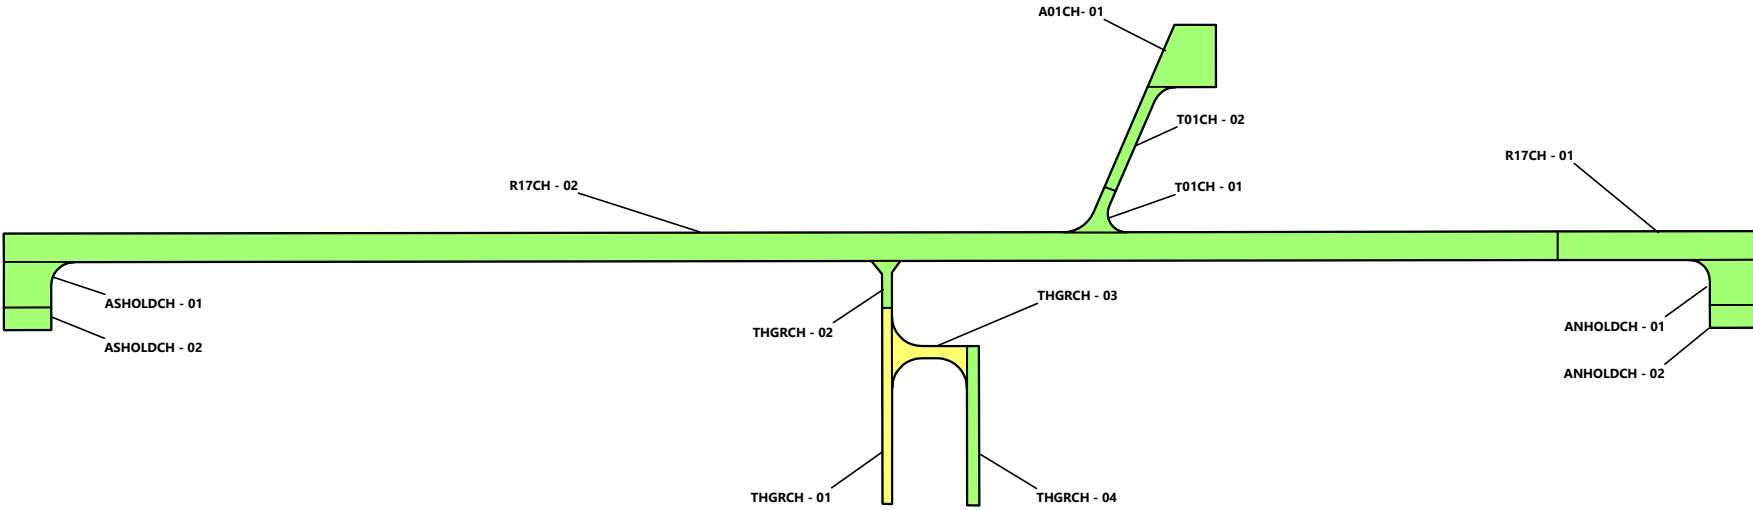
Using the condition prediction models discussed above, the projected condition of each pavement section was determined for 5- and 10-year periods. Based on this analysis, we project the PCI to decrease from a current value of 71 to a value of 59 in the year 2027

and 48 in the year 2032, if no maintenance or rehabilitation work is performed. The projected pavement condition in 5 years and 10 years for each pavement section at Chiloquin Airport is displayed spatially on the Future Pavement Condition, Figure 4.1 and listed in Table 1C in Appendix C, along with the past and present PCI values for the pavement network.
