# **2022 ODA Pavement Evaluation Program Christmas Valley Airport**

Christmas Valley, Oregon

**December 30, 2022  
(REVISED: 01/24/2023)**

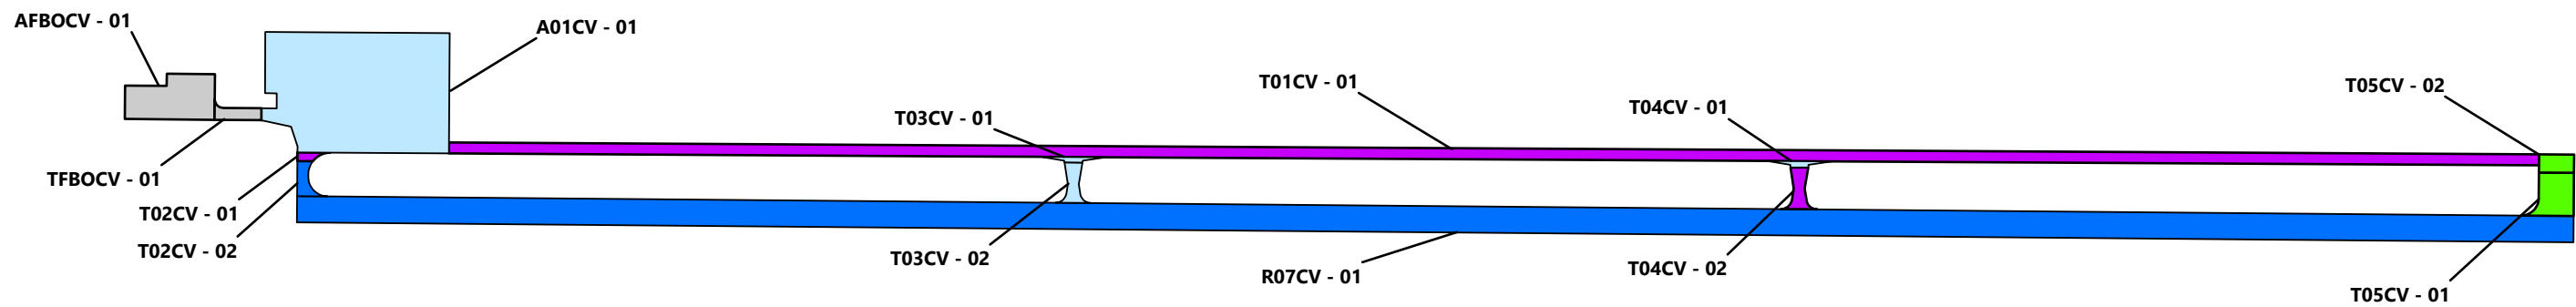
## 2022 PCI SURVEY RESULTS

The area-weighted average PCI for all airport pavements at Christmas Valley Airport is approximately 68. The section PCIs ranged from a low of 14 to a high of 94. The primary distresses observed during the inspection were weathering, longitudinal and transverse cracking, fatigue (alligator) cracking, and block cracking. Section PCIs following our pavement survey are displayed below spatially on the 2022 PCI Survey Results, Figure 3.1.

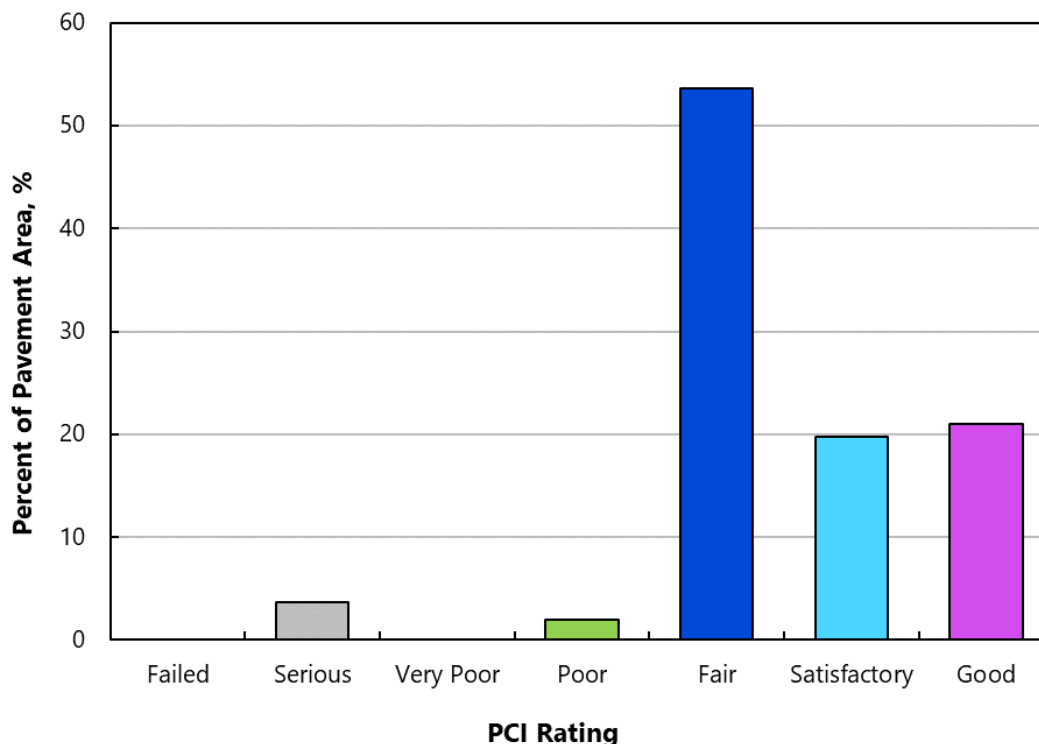
**Figure 3.2 – CHRISTMAS VALLEY AIRPORT PAVEMENT CONDITION RATING BY PERCENT OF AREA**

The condition distribution of the network by the percent of total pavement area is provided on the Christmas Valley Airport Pavement Condition Rating by Percent of Area, Figure 3.2. A summary of the pavement condition results by branch and section are included in Tables 2B and 3B of Appendix B, respectively. A comparison between the previous inspection and the 2022 inspection is provided in Table 4B in Appendix B. The re-inspection report that includes inspection details for individual sample units is provided in Table 1E in Appendix E.

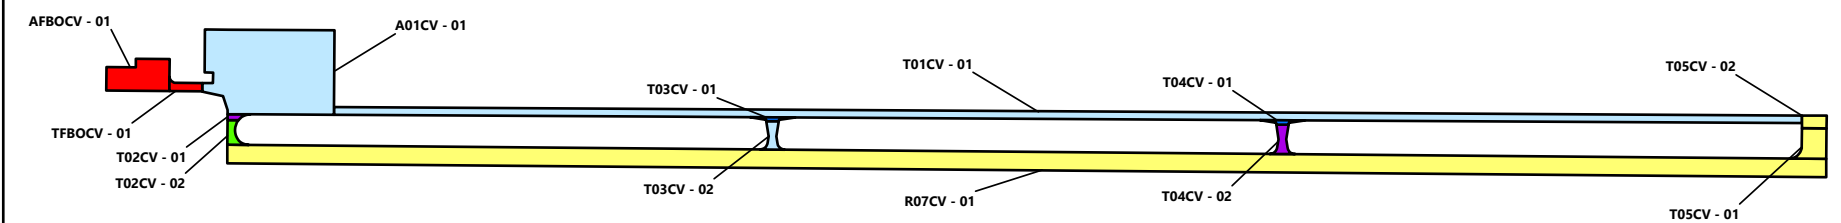
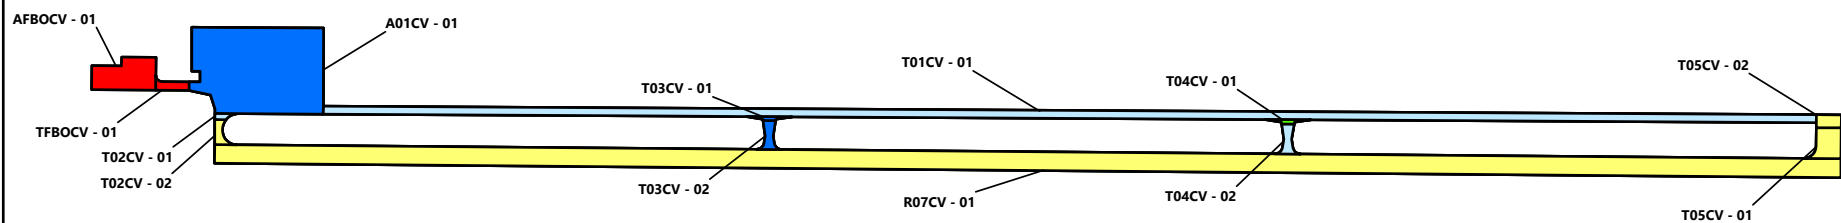
PREDICTED CONDITION IN 2027

project the PCI to decrease from a current value of 68 to a value of 56 in the year 2027 and 43 in year the 2032 if no maintenance or rehabilitation work is performed. The projected pavement condition in five years and ten years for each pavement section at Christmas Valley Airport is displayed spatially on the Future Pavement Condition, Figure 4.1 and listed in Table 1C in Appendix C, along with the past and present PCI values for the pavement network.

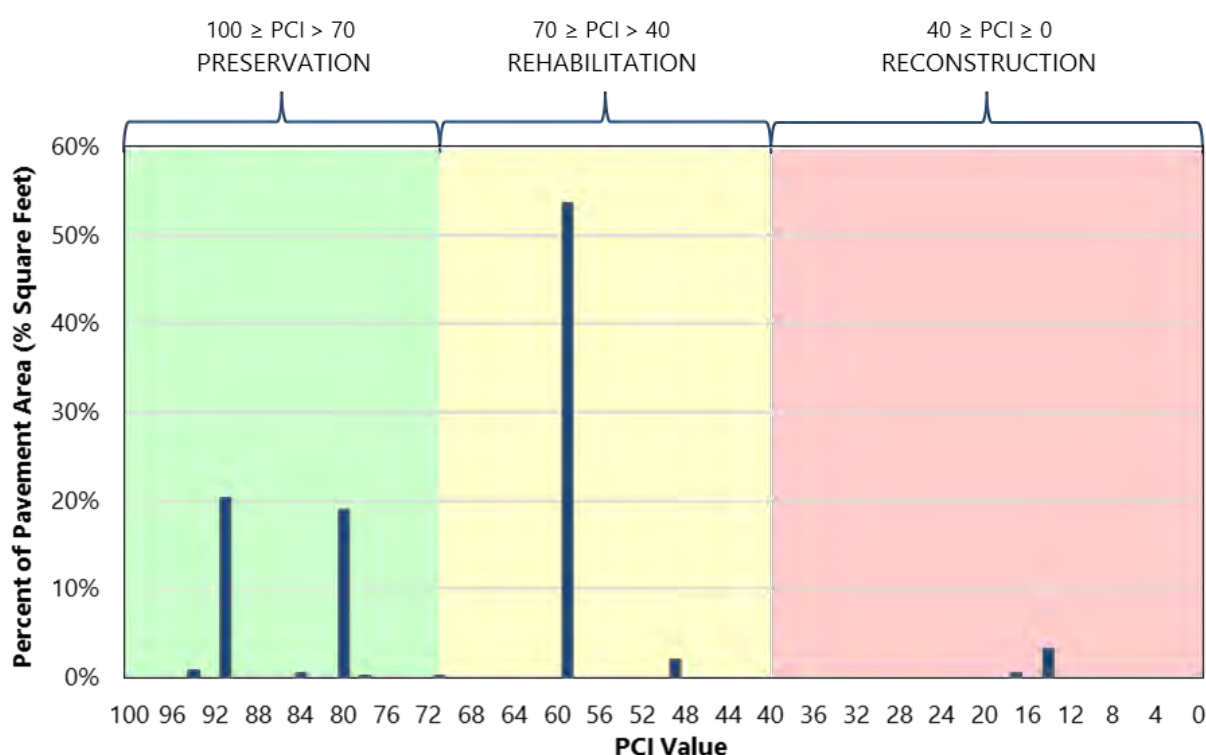
Figure 5.1 – CHRISTMAS VALLEY AIRPORT PAVEMENT NETWORK GENERAL TREATMENT TYPE DISTRIBUTION BASED ON PCI

Based on the 2022 PCI-survey results, the Christmas Valley Airport Pavement Network General Treatment Type Distribution Based on PCI, Figure 5.1 displays a breakdown of the Christmas Valley Airport network pavement condition by percent of area and general M&R treatment categories. Approximately 41%, 55%, and 4% of the area require preservation treatments, rehabilitation, and reconstruction, respectively.
