2022 ODA Pavement Evaluation Program Lake Billy Chinook State Airport

Culver, Oregon

December 30, 2022 (REVISED: 01/24/2023)

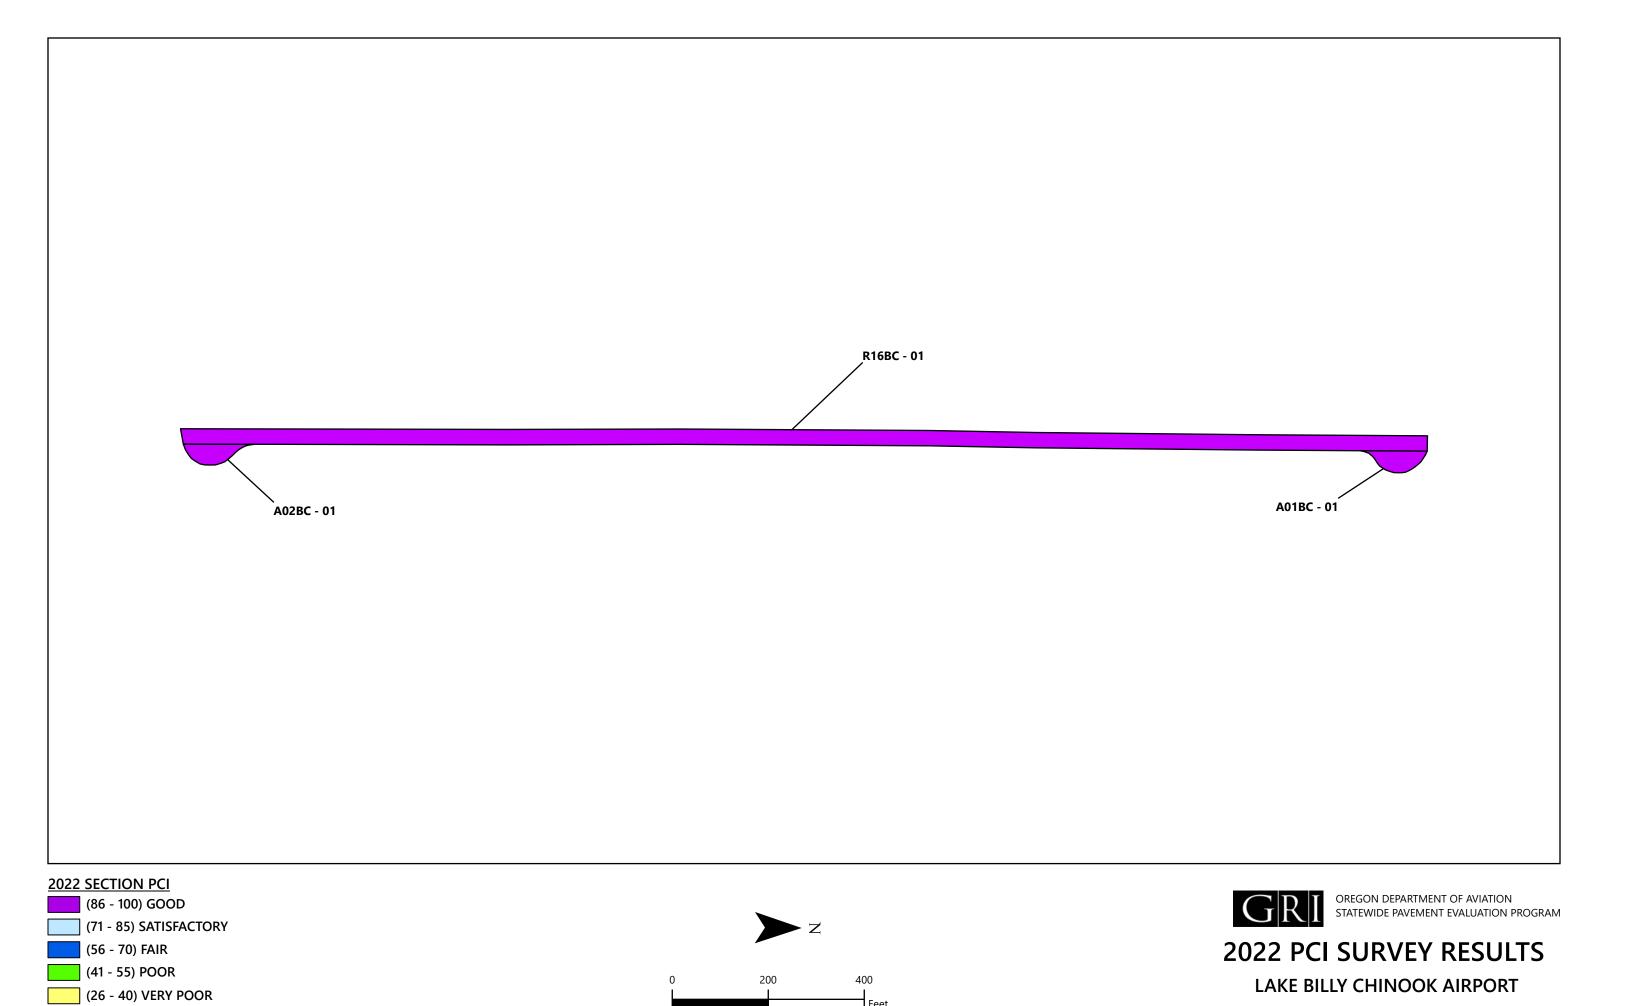
FIG. 3.1

The area-weighted average PCI for all airport pavements at Lake Billy Chinook Airport is approximately 96. The section PCIs ranged from a low of 86 to a high of 97. The primary distresses observed during the inspection were longitudinal and transverse cracking. Section PCIs following our pavement survey are displayed below spatially on the 2022 PCI Survey Results, Figure 3.1.
