2022 ODA Pavement Evaluation Program Lake County Airport

Lakeview, Oregon

**December 30, 2022
(REVISED: 01/24/2023)**

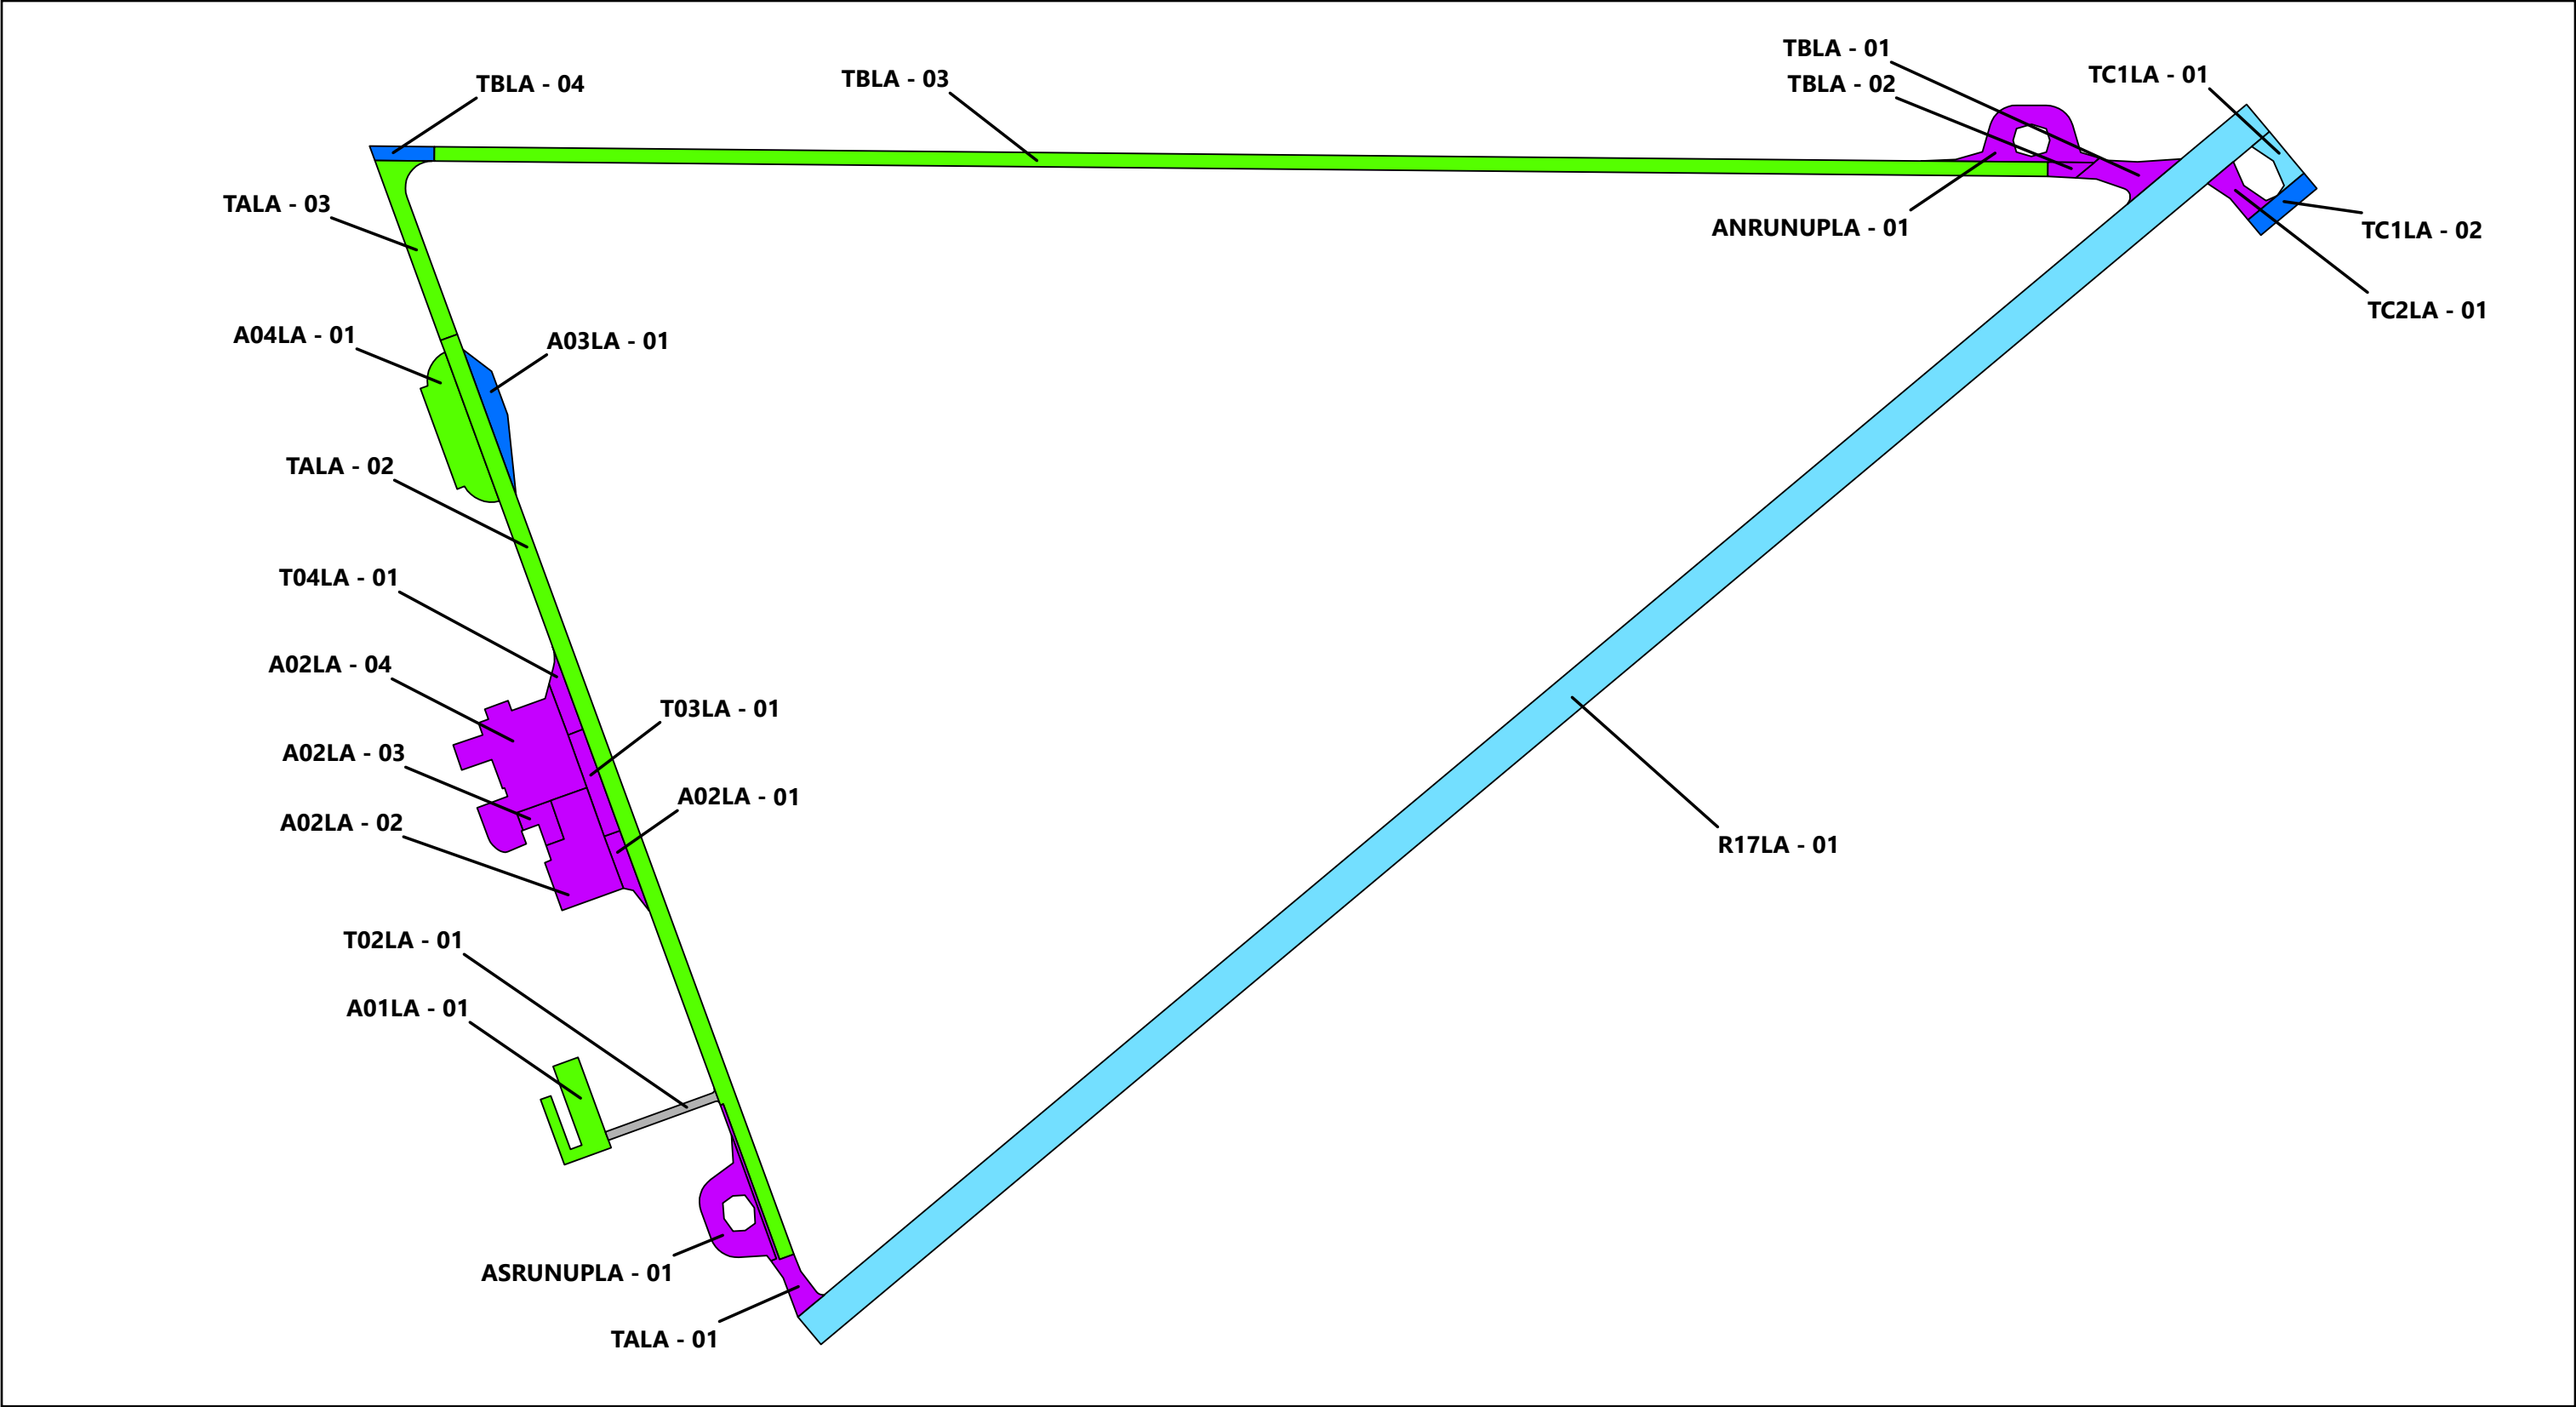
**2022 PCI SURVEY RESULTS
LAKE COUNTY AIRPORT**

The area-weighted average PCI for all airport pavements at Lake County Airport is approximately 74. The section PCIs ranged from a low of 18 to a high of 100. The primary distresses observed during the inspection were weathering, raveling, longitudinal and transverse cracking, fatigue (alligator) cracking, and block cracking. Section PCIs following our pavement survey are displayed below spatially on the 2022 PCI Survey Results, Figure 3.1.
