2022 ODA Pavement Evaluation Program Paisley Airport

Paisley, Oregon

**December 30, 2022
(REVISED: 01/24/2023)**

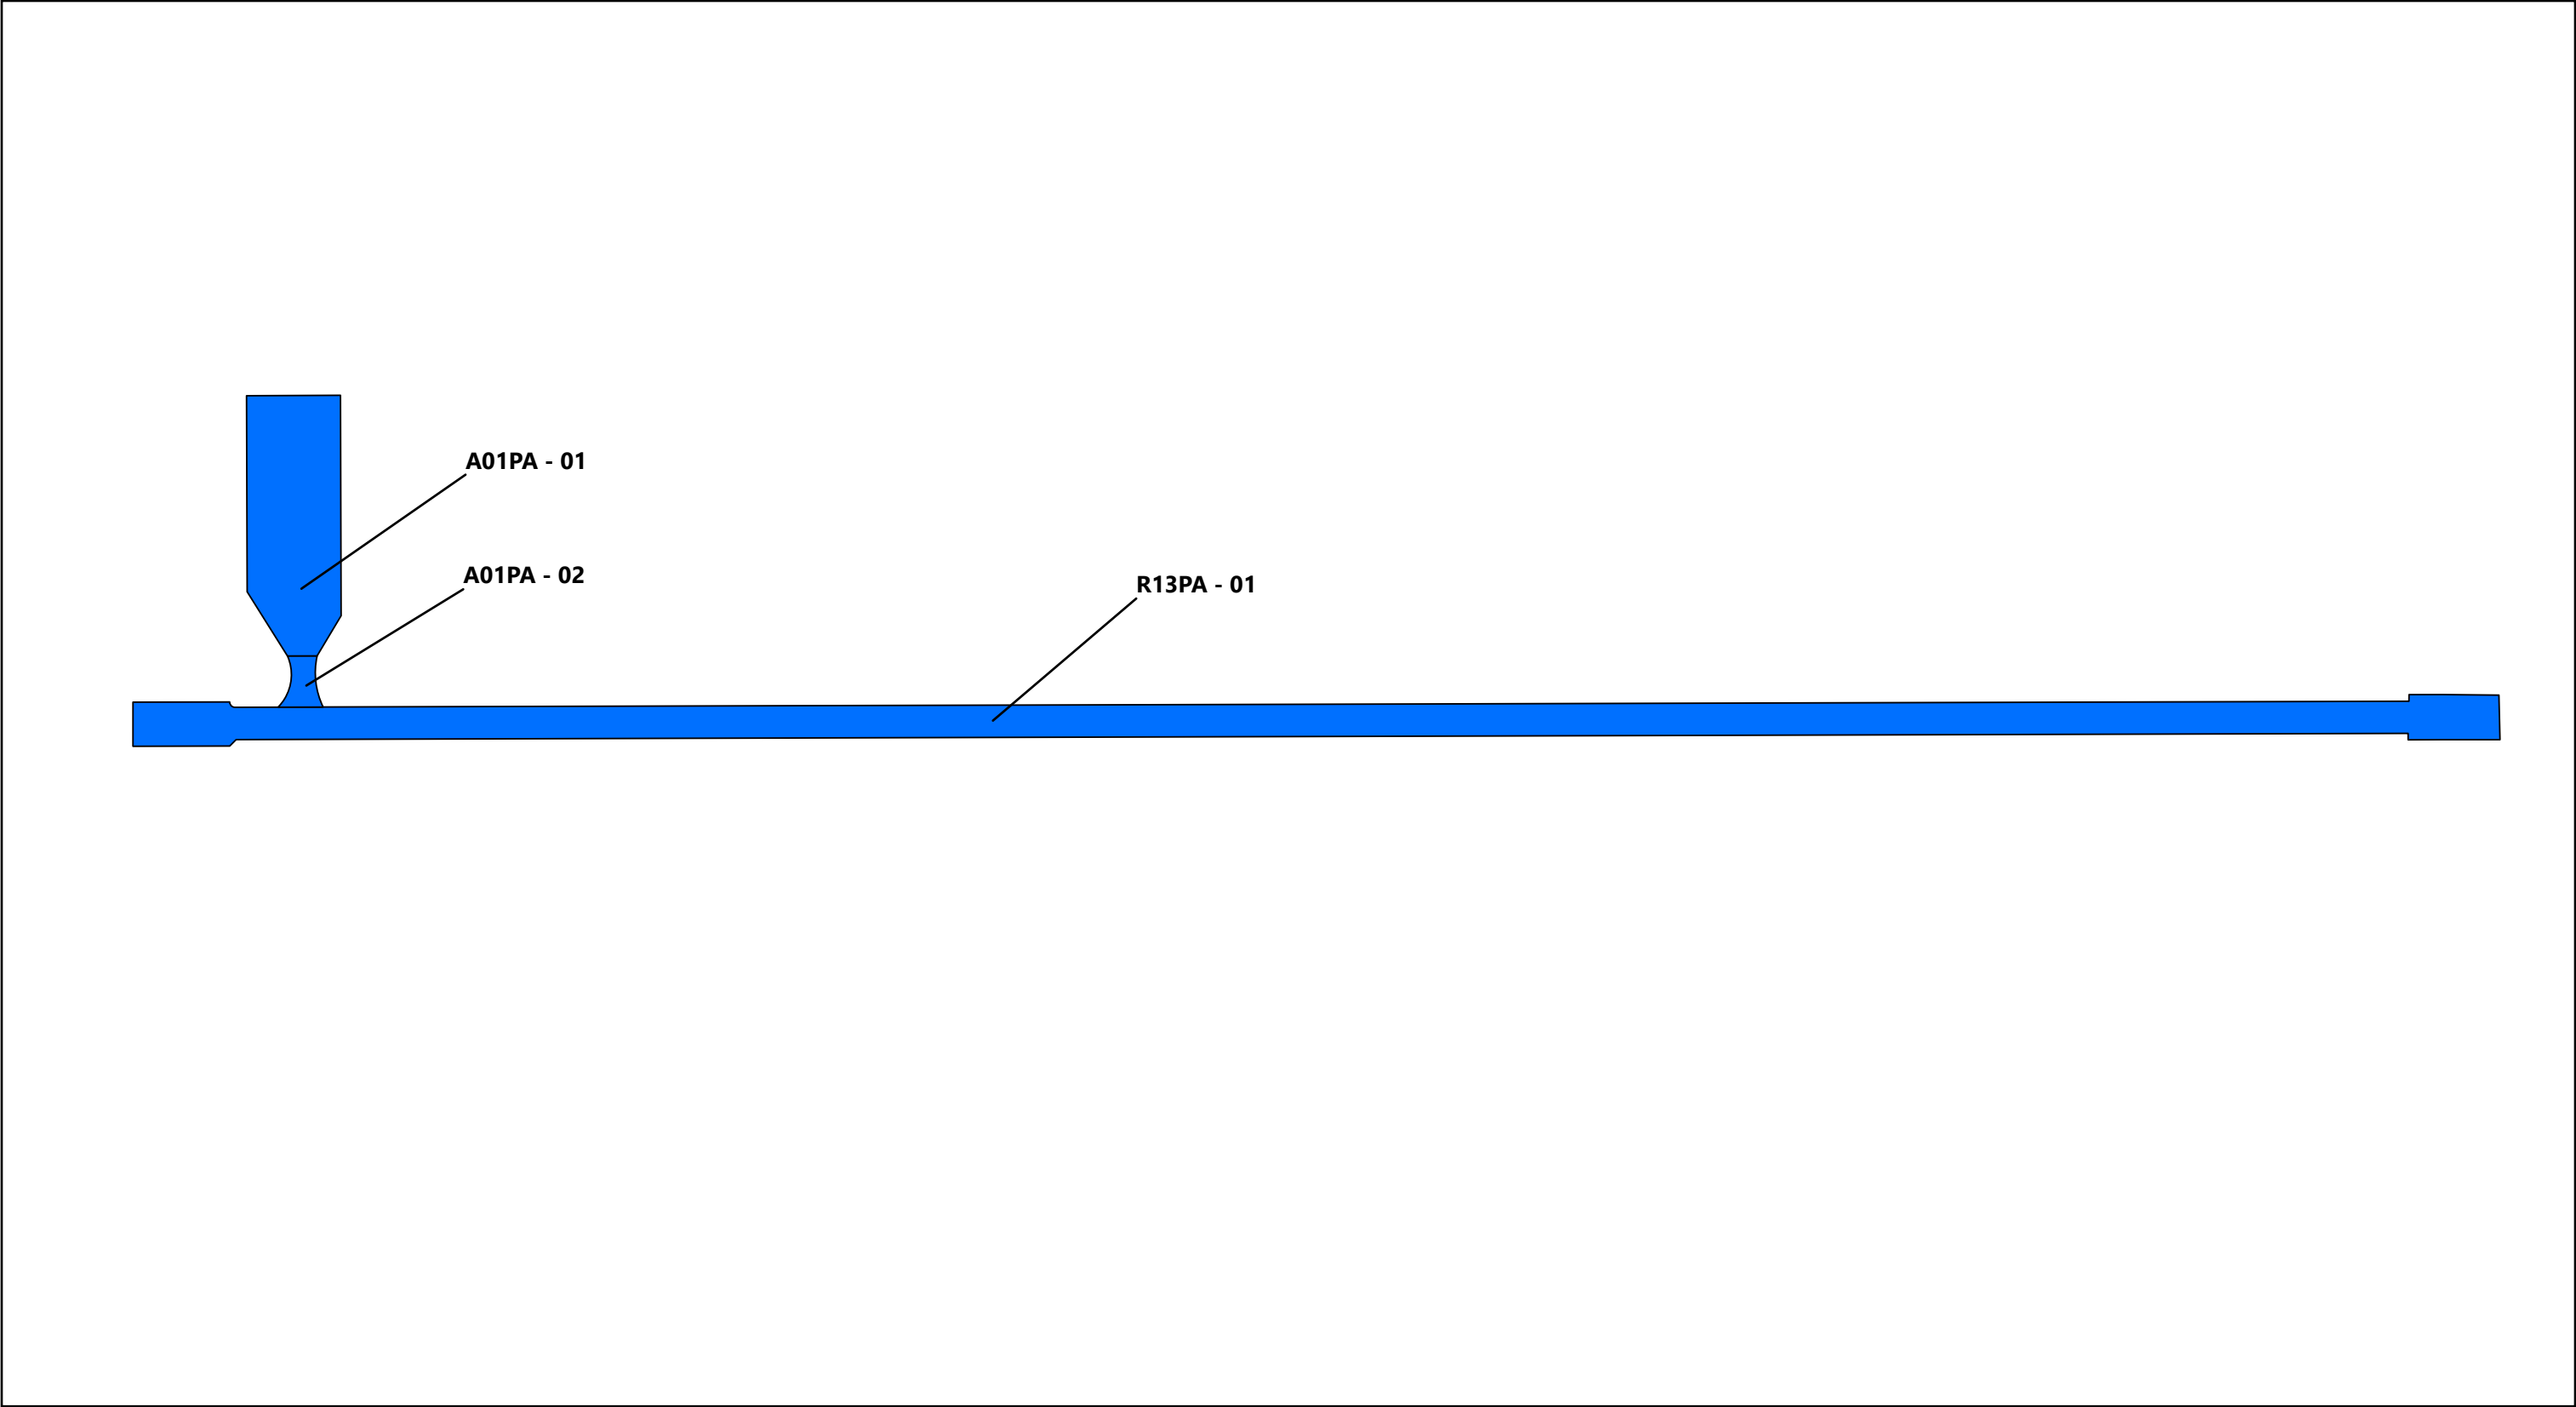
2022 PCI SURVEY RESULTS
PAISLEY AIRPORT

The area-weighted average PCI for all airport pavements at Paisley Airport is approximately 59. The section PCIs ranged from a low of 59 to a high of 61. The primary distresses observed during the inspection were weathering, raveling, and block cracking. Section PCIs following our pavement survey are displayed below spatially on the 2022 PCI Survey Results, Figure 3.1.

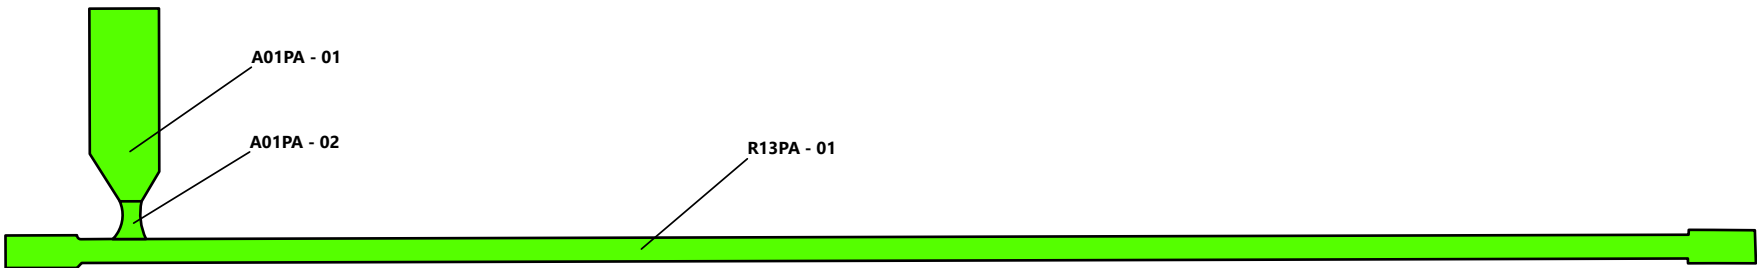
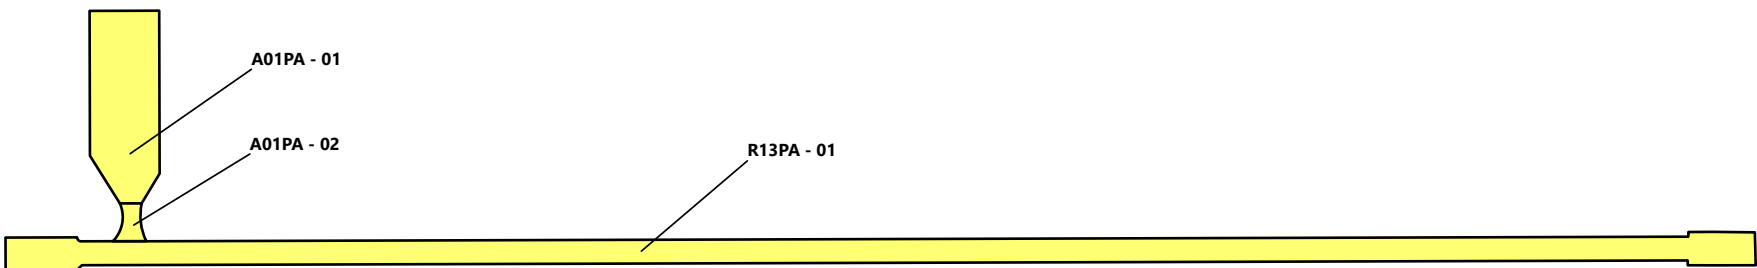
PREDICTED CONDITION IN 2027

Using the condition prediction models discussed above, the projected condition of each pavement section was determined for 5- and 10-year periods. Based on this analysis, we project the PCI to decrease from a current value of 59 to a value of 47 in the year 2027

and 35 in the year 2032, if no maintenance or rehabilitation work is performed. The projected pavement condition in 5 years and 10 years for each pavement section at Paisley Airport is displayed spatially on the Future Pavement Condition, Figure 4.1 and listed in Table 1C in Appendix C, along with the past and present PCI values for the pavement network.
