2022 ODA Pavement Evaluation Program

Sisters Eagle Air Airport

Sisters, Oregon

**December 30, 2022
(REVISED: 01/24/2023)**

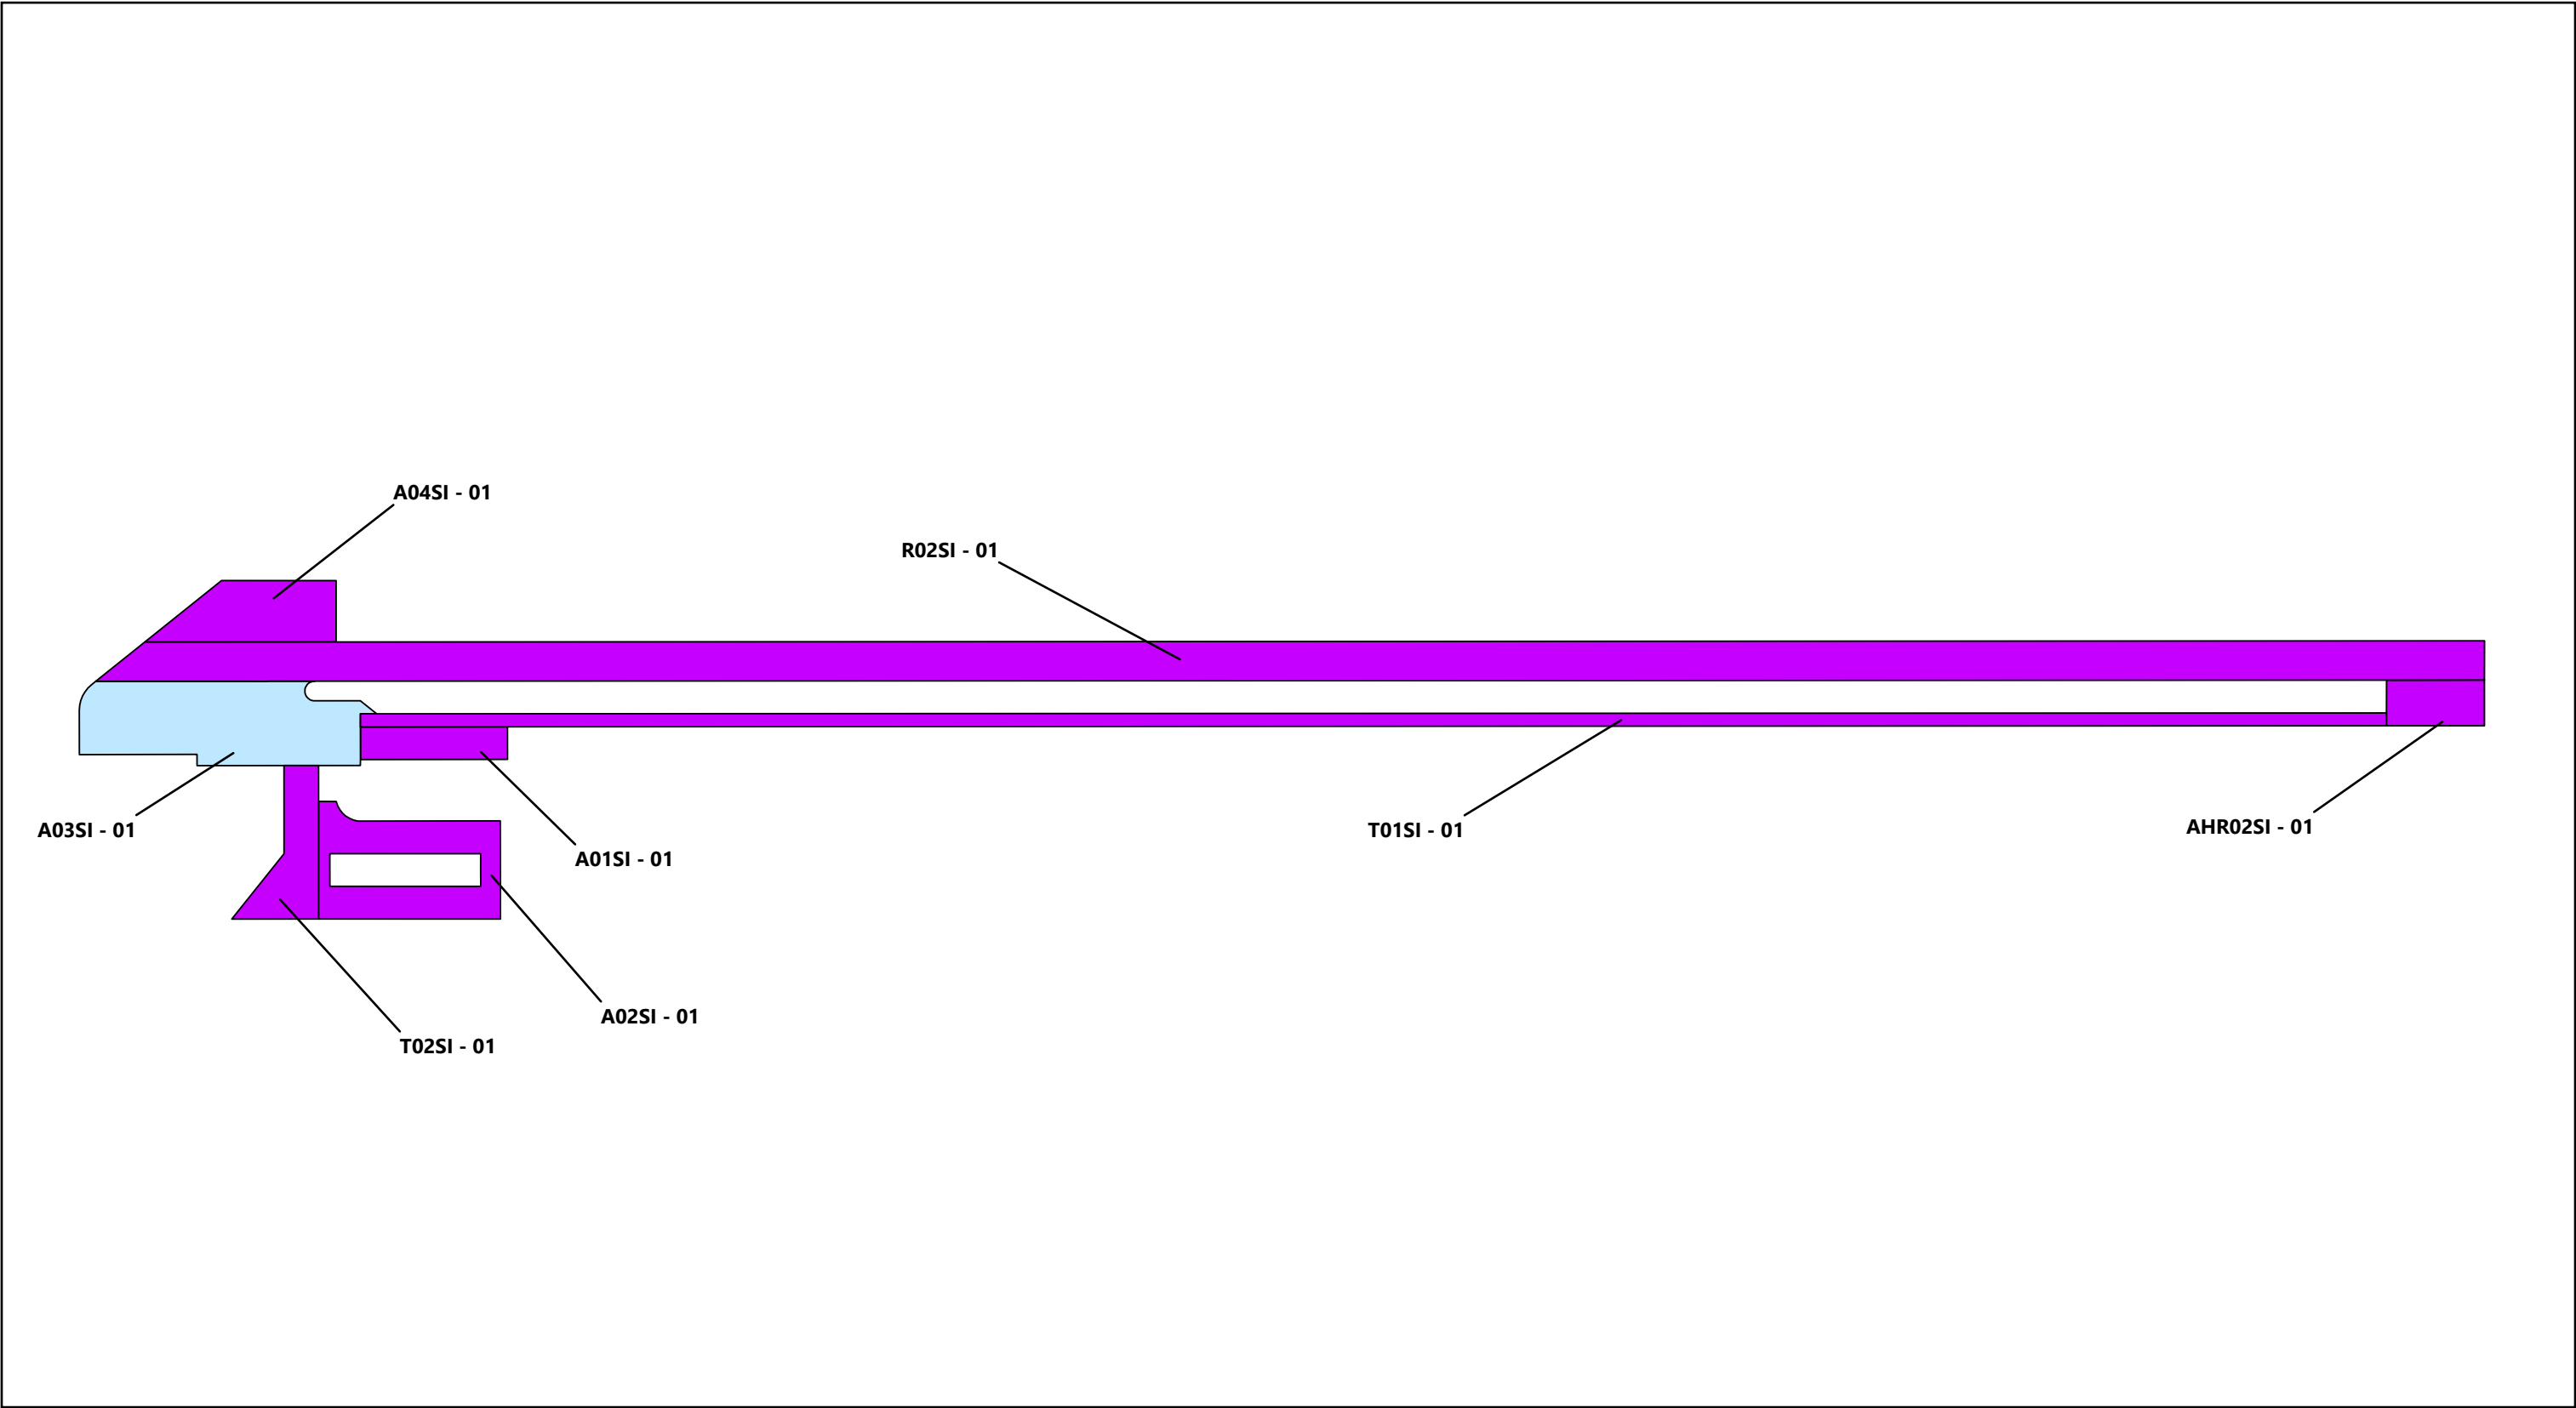
2022 PCI SURVEY RESULTS

The area-weighted average PCI for all airport pavements at Sisters Airport is approximately 90. The section PCIs ranged from a low of 84 to a high of 94. The primary distresses observed during the inspection were weathering and longitudinal and transverse cracking. Section PCIs following our pavement survey are displayed below spatially on the 2022 PCI Survey Results, Figure 3.1.

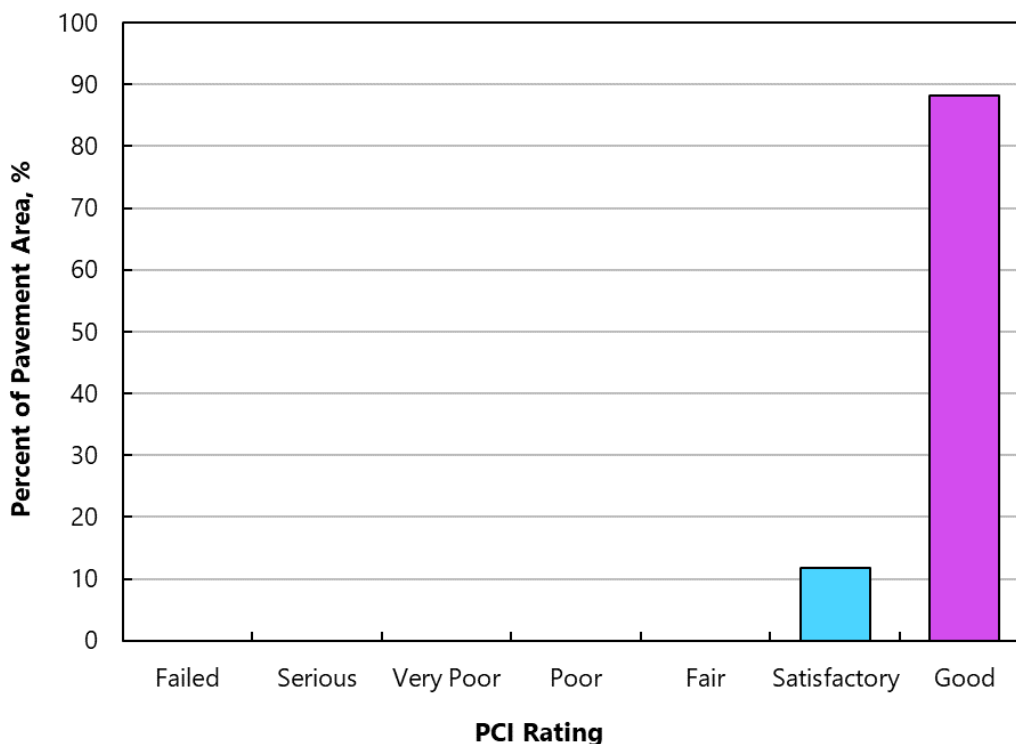
Figure 3.2 – SISTERS AIRPORT PAVEMENT CONDITION RATING BY PERCENT OF PAVEMENT AREA

The condition distribution of the network by the percent of total pavement area is provided on the Sisters Airport Pavement Condition Rating by Percent of Pavement Area, Figure 3.2. A summary of the pavement condition results by branch and section are included in Tables 2B and 3B of Appendix B, respectively. A comparison between the previous inspection and the 2022 inspection is provided in Table 4B in Appendix B. The Re-Inspection report that includes inspection details for individual sample units is provided in Appendix E.

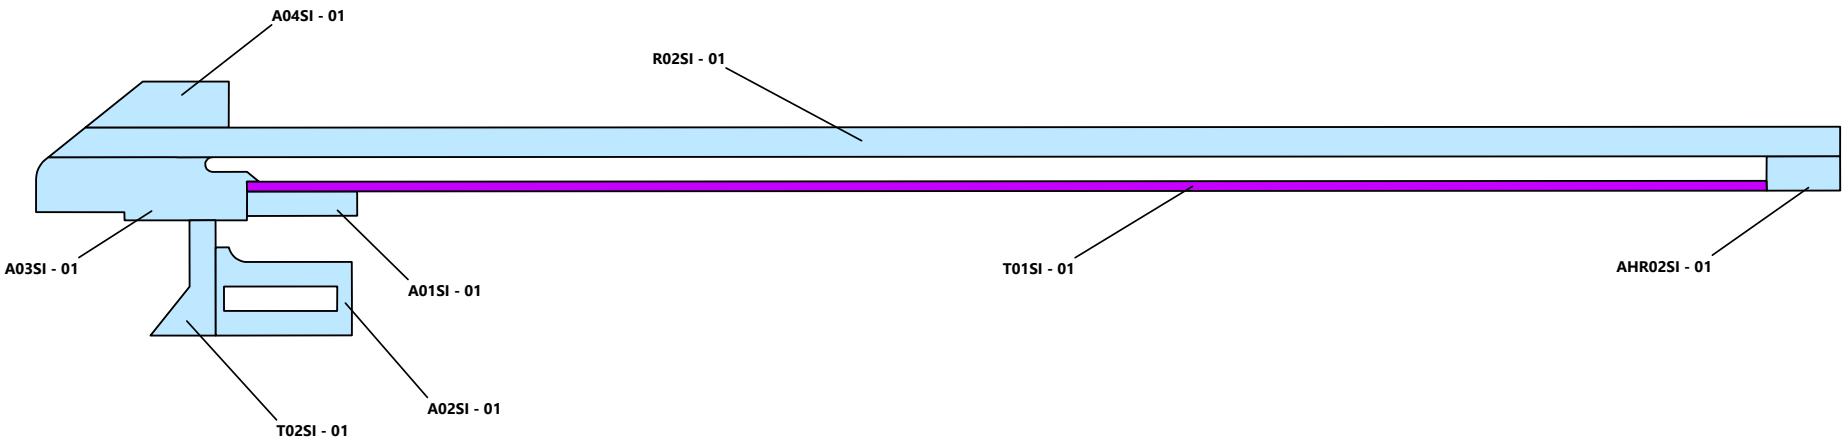
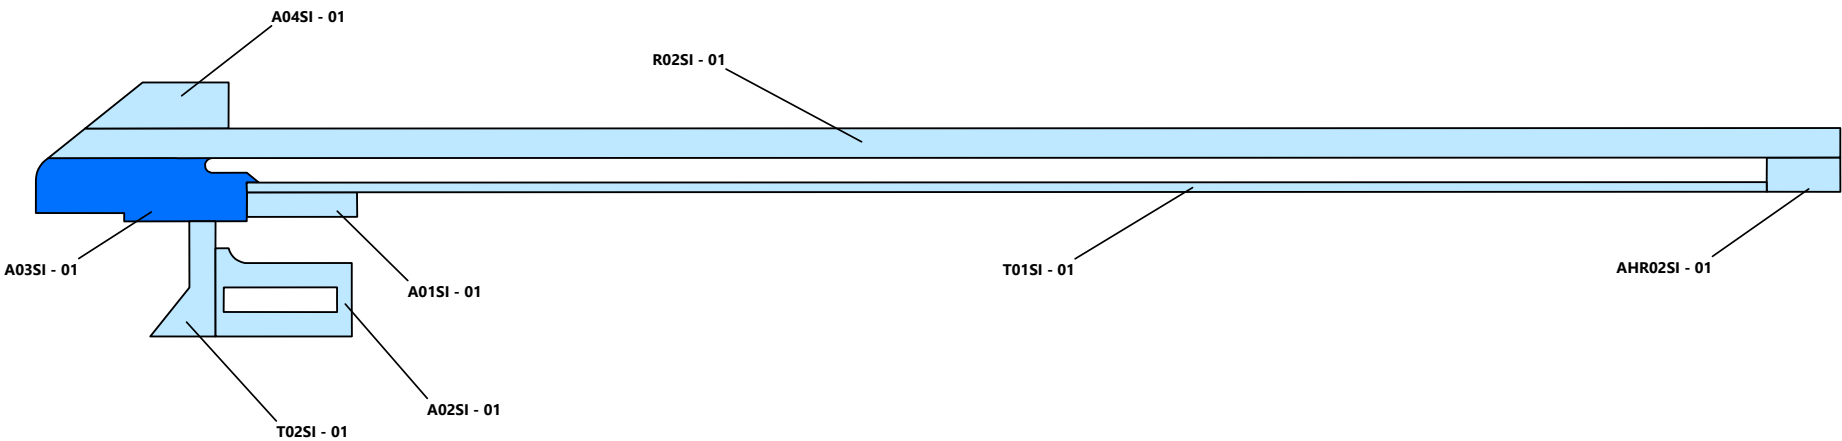
PREDICTED CONDITION IN 2027

Using the condition prediction models discussed above, the projected condition of each pavement section was determined for 5- and 10-year periods. Based on this analysis, we project the PCI to decrease from a current value of 90 to a value of 79 in the year 2027

and 69 in the year 2032, if no maintenance or rehabilitation work is performed. The projected pavement condition in 5 years and 10 years for each pavement section at Sisters Airport is displayed spatially on the Future Pavement Condition, Figure 4.1 and listed in Table 1C in Appendix C, along with the past and present PCI values for the pavement network.

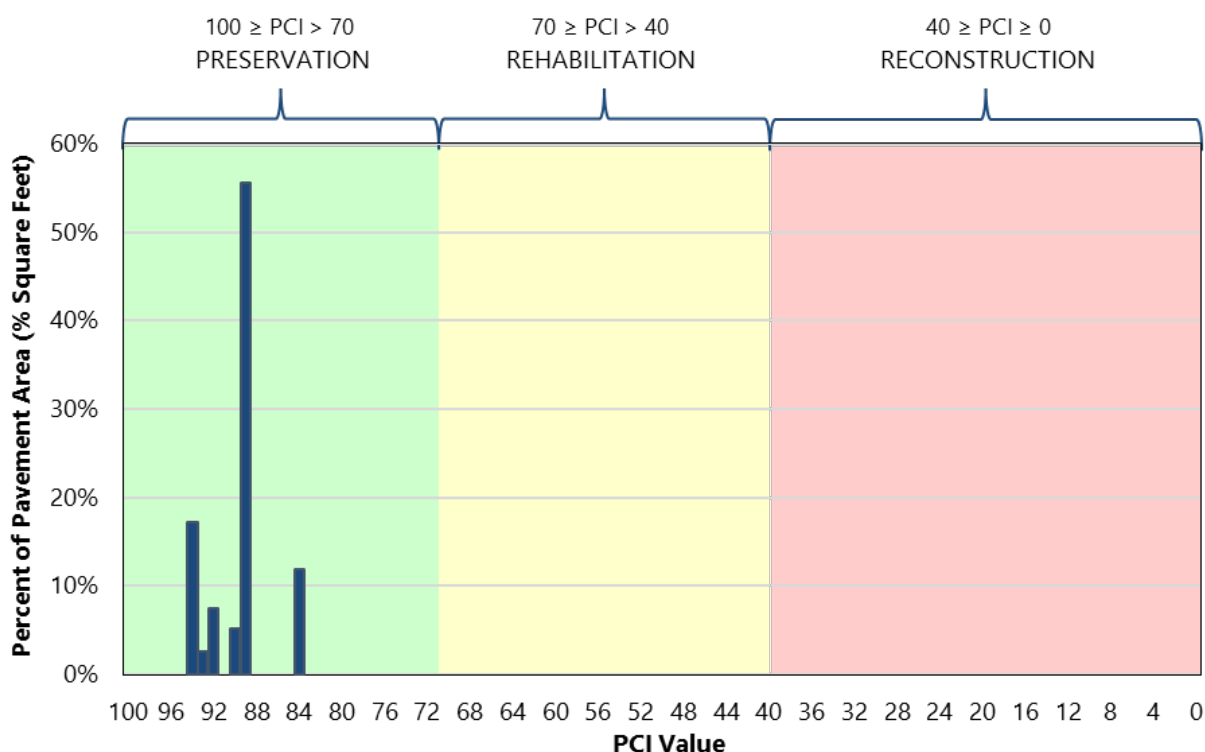
Figure 5.1 – SISTERS AIRPORT PAVEMENT NETWORK GENERAL TREATMENT TYPE DISTRIBUTION BASED ON PCI

Based on the 2022 PCI-survey results, the Sisters Airport Pavement Network General Treatment Type Distribution Based on PCI, Figure 5.1 displays a breakdown of the Sisters Airport network pavement condition by percent of pavement area and general M&R treatment categories. Approximately 100% of the area requires preservation treatments, and none of the area requires rehabilitation or reconstruction treatments.
