2022 ODA Pavement Evaluation Program Sunriver Airport

Sunriver, Oregon

December 30, 2022 (REVISED: 01/24/2023)

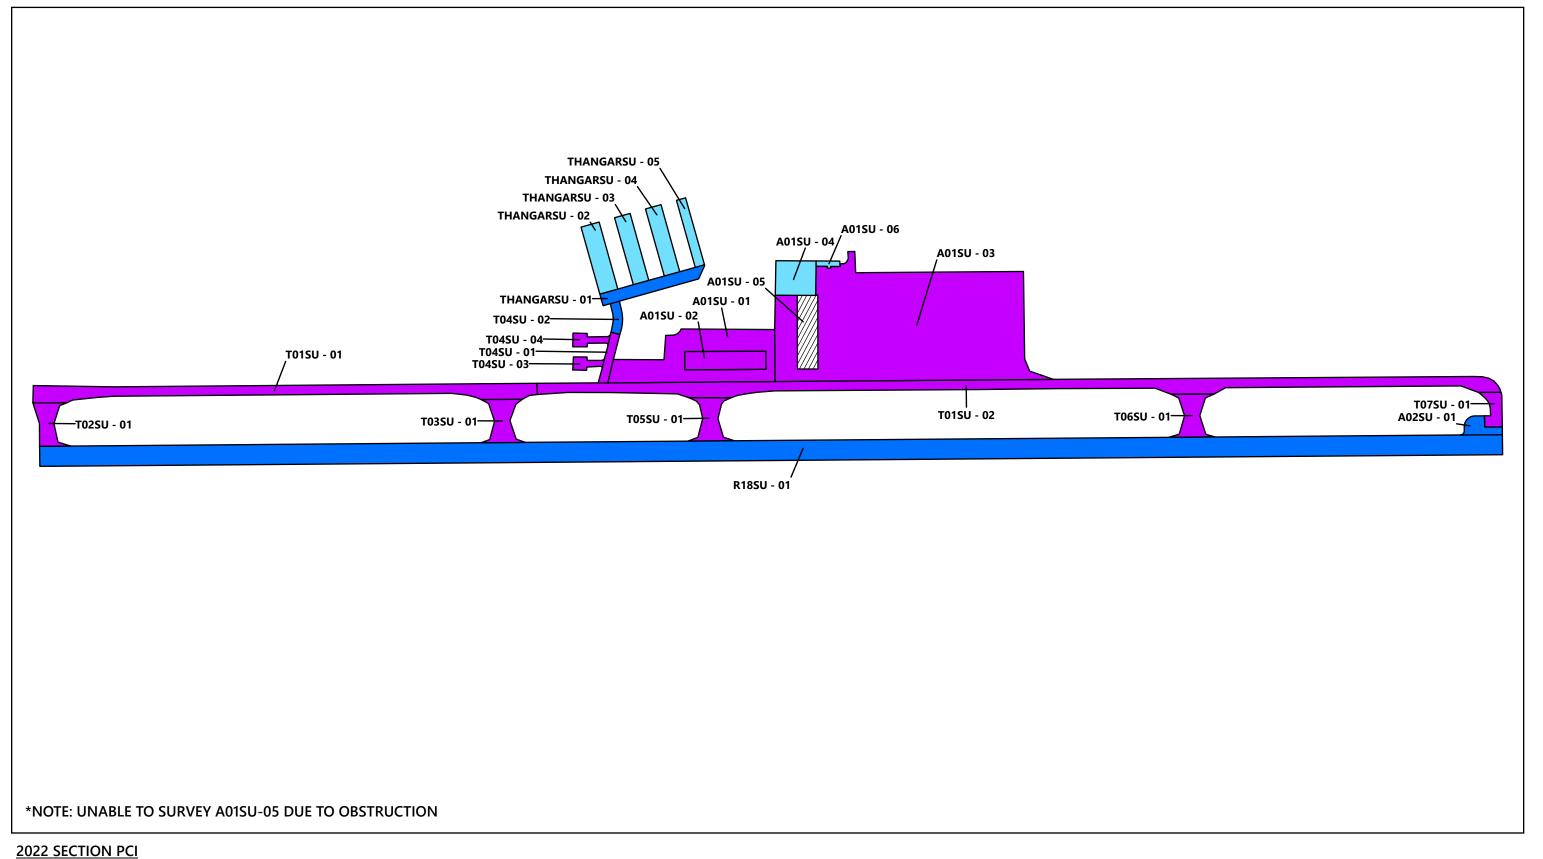
JOB NO. 6593-B FIG. 3.1

The area-weighted average PCI for all airport pavements at Sunriver Airport is approximately 84. The section PCIs ranged from a low of 57 to a high of 100. The primary distresses observed during the inspection were weathering, longitudinal and transverse cracking, fatigue (alligator) cracking, and patching for AC-surfaced pavements, and spalling, linear cracking, shrinkage cracking, and faulting for PCC-surfaced pavements. Section PCIs following our pavement survey are displayed below spatially on the 2022 PCI Survey Results, Figure 3.1. Section A01SU-05 was not surveyed due to obstructions.

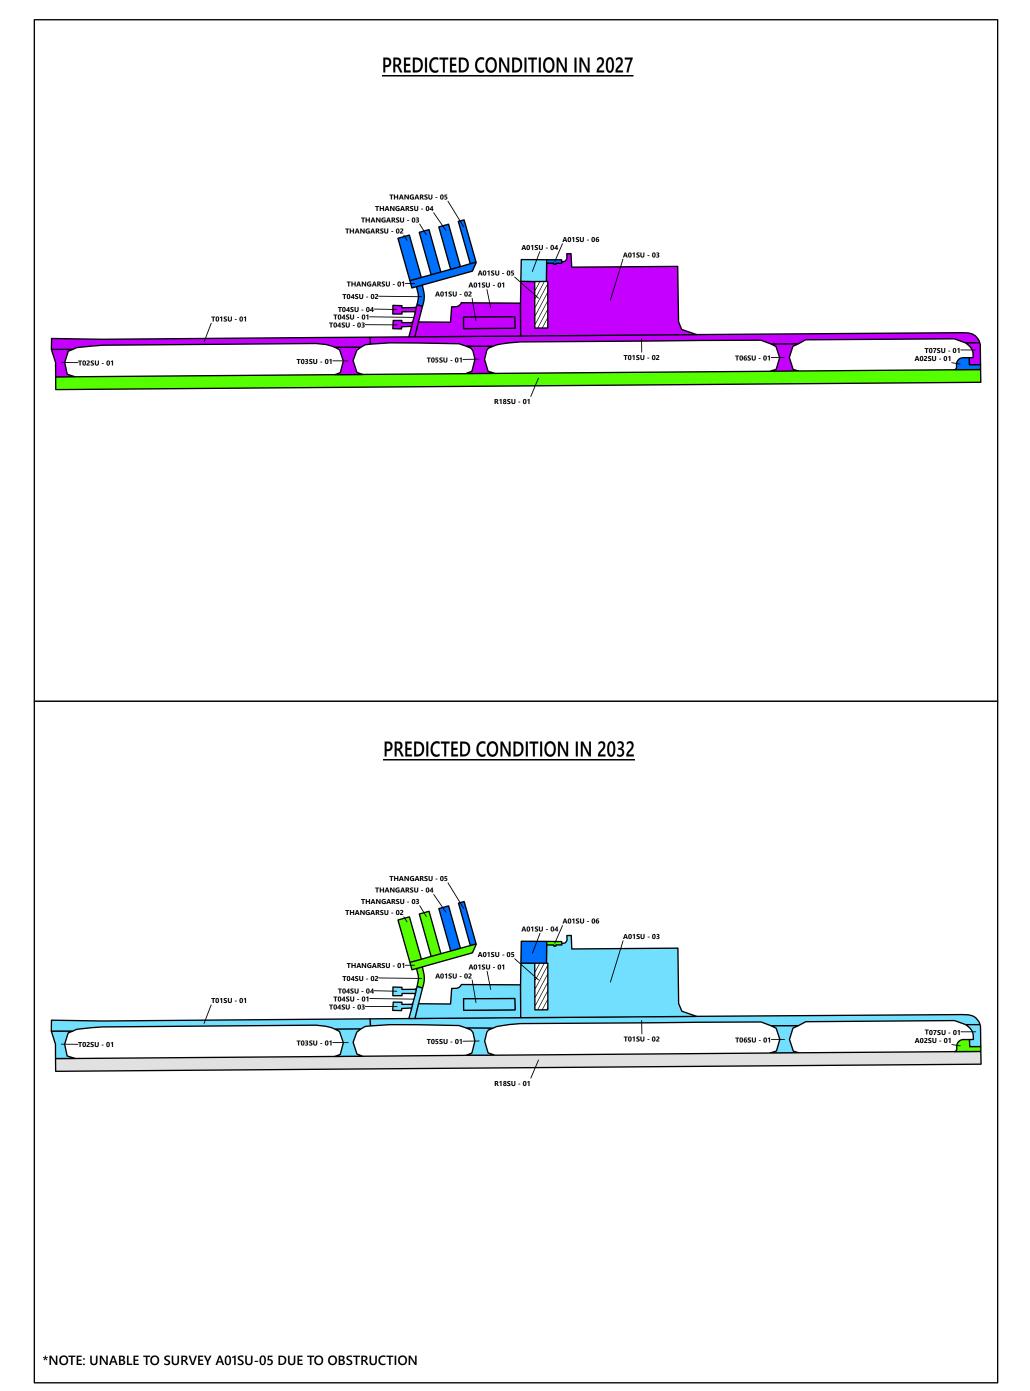
FUTURE PAVEMENT CONDITION SUNRIVER AIRPORT

Using the condition prediction models discussed above, the projected condition of each pavement section was determined for 5- and 10-year periods. Based on this analysis, we project the PCI to decrease from a current value of 84 to a value of 72 in the year 2027

and 61 in the year 2032, if no maintenance or rehabilitation work is performed. The projected pavement condition in 5 years and 10 years for each pavement section at Sunriver Airport is displayed spatially on the Future Pavement Condition, Figure 4.1 and listed in Table 1C in Appendix C, along with the past and present PCI values for the pavement network.
