# **2022 ODA Pavement Evaluation Program Boardman Airport**

Boardman, Oregon

**May 8, 2023**

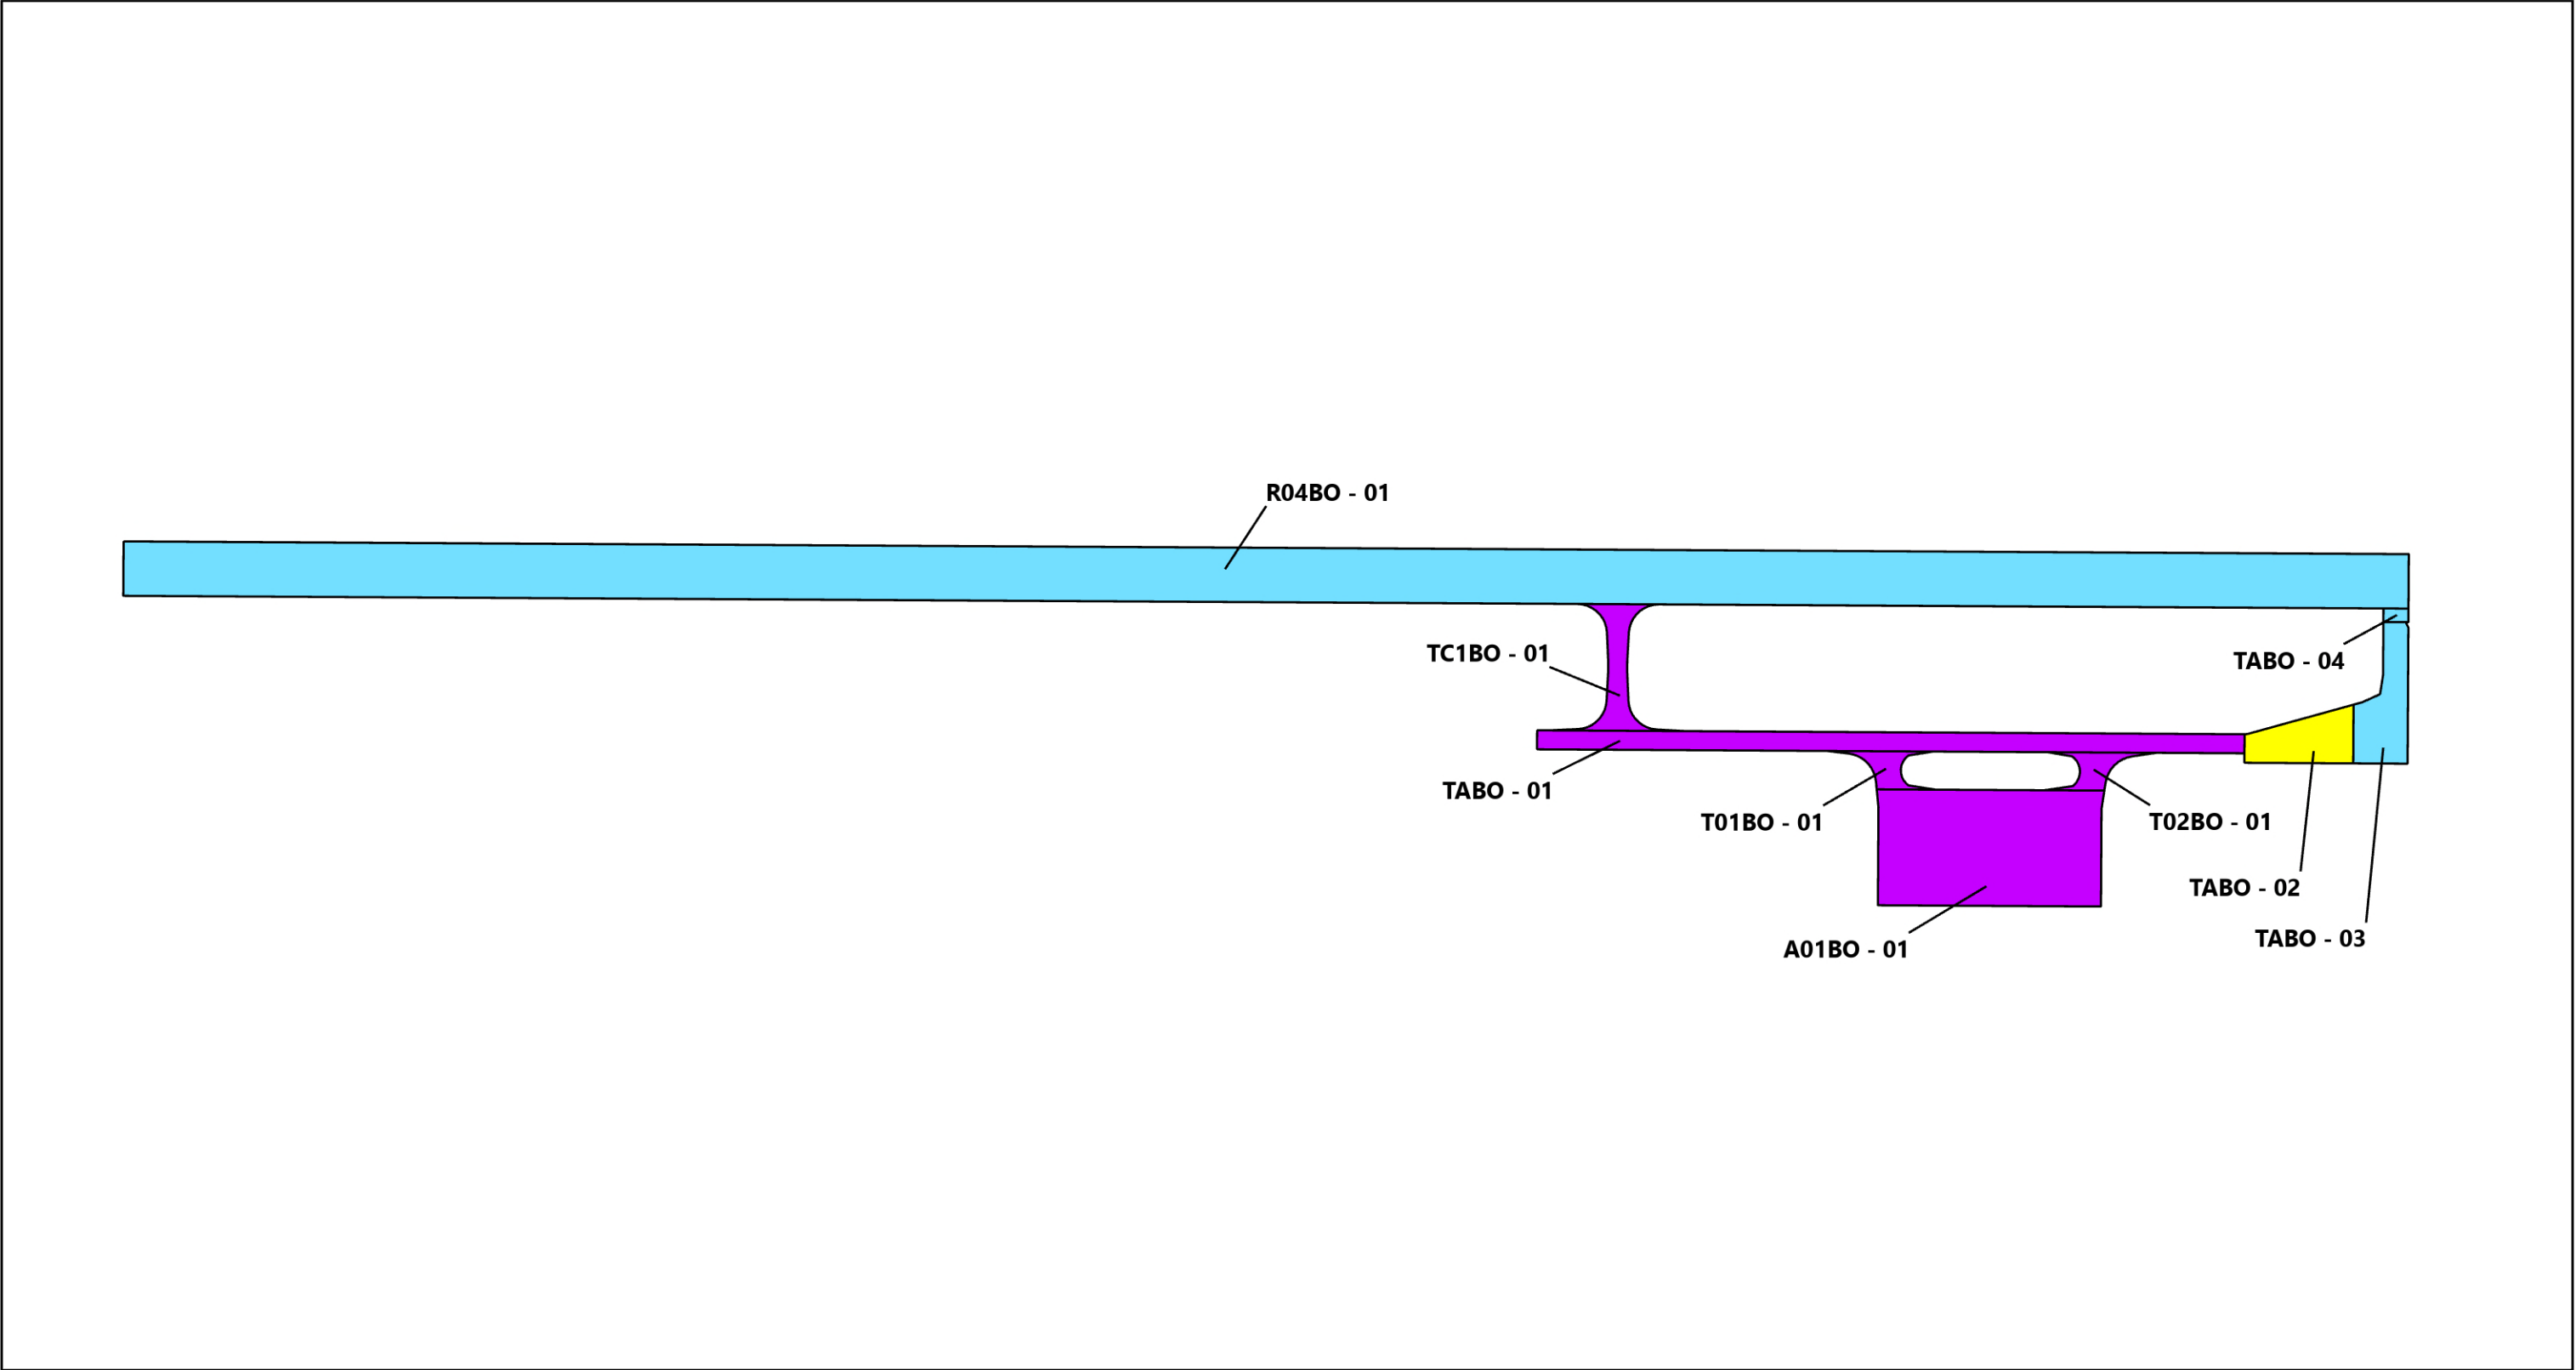
2022 SECTION PCI

The area-weighted average PCI for all airport pavements at Boardman Airport is approximately 81. The section PCIs ranged from a low of 36 to a high of 100. The primary distresses observed on AC-surfaced pavements during the inspection were weathering, longitudinal and transverse cracking, fatigue (alligator) cracking, and patching. Section PCIs following our pavement survey are displayed below spatially on the 2022 PCI Survey Results Boardman Airport, Figure 3.1.

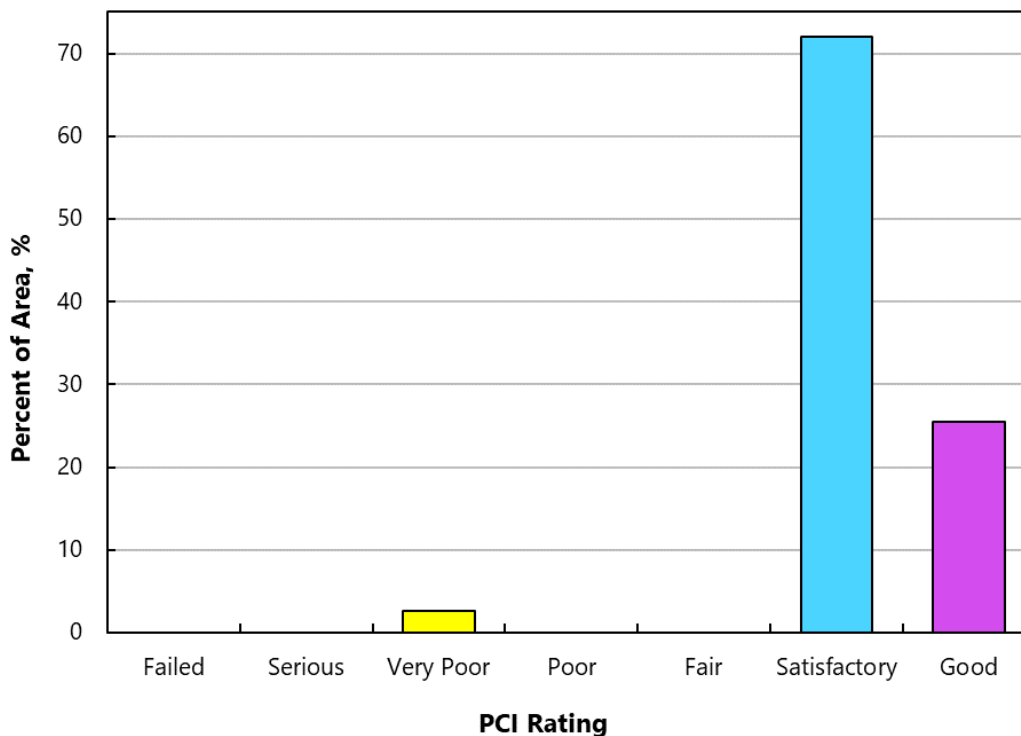
**Figure 3.2 - BOARDMAN AIRPORT PAVEMENT CONDITION RATING BY PERCENT OF AREA**

The condition distribution of the network by percent of total pavement area is provided below on the Boardman Airport Pavement Condition Rating by Percent of Area, Figure 3.2. A summary of the pavement condition results by branch and section are included in Tables 2B and 3B of Appendix B, respectively. A comparison between the previous inspection and the 2022 inspection is provided in Table 4B in Appendix B. The re-inspection report that includes inspection details for individual sample units is provided in Table 1E in Appendix E.

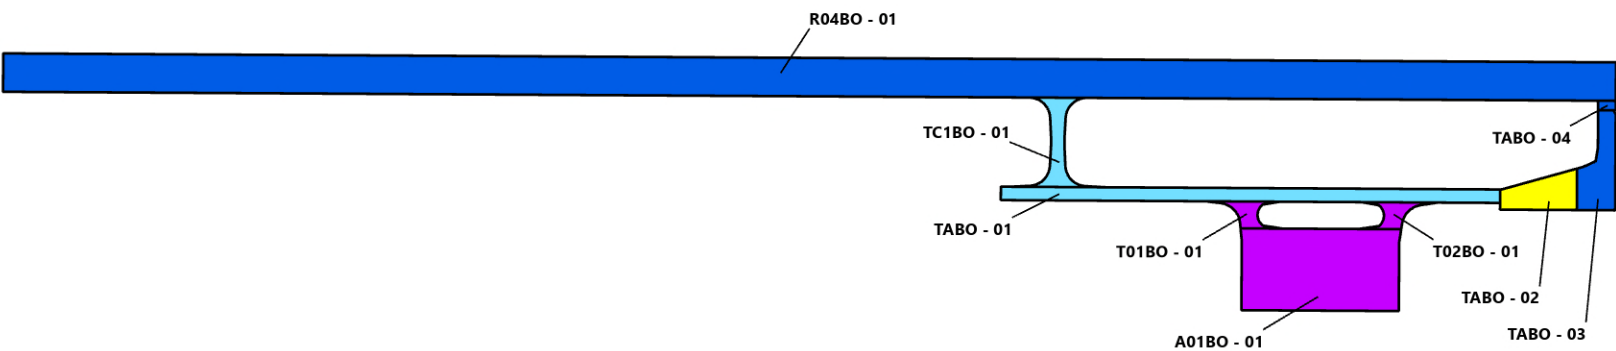
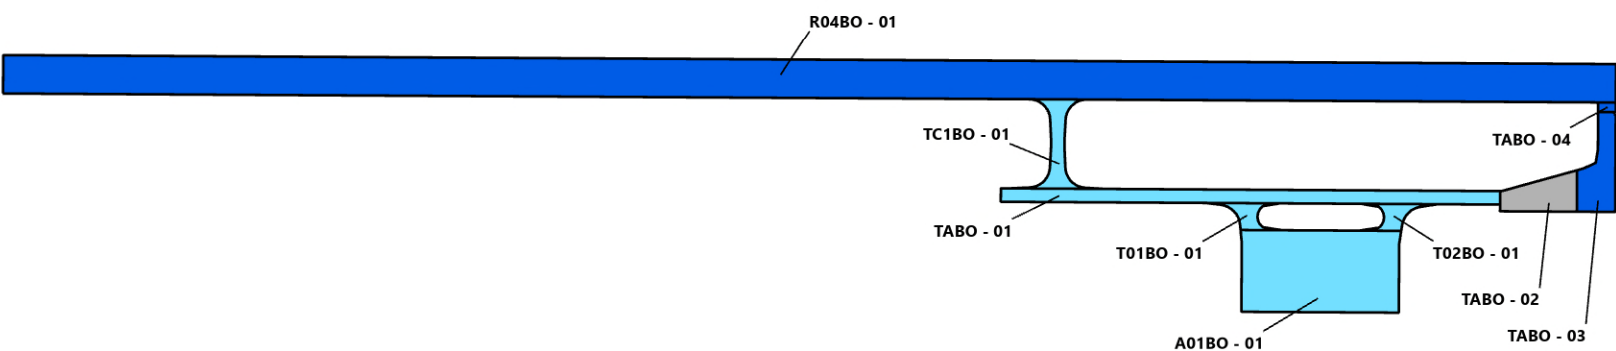
FUTURE PAVEMENT CONDITION  
BOARDMAN AIRPORT

project the PCI to decrease from a current value of 81 to a value of 73 in the year 2027 and 66 in year the 2032 if no maintenance or rehabilitation work is performed. The projected pavement condition in five years and ten years for each pavement section at Boardman Airport is displayed spatially on the Future Pavement Condition Boardman Airport, Figure 4.1 and listed in Table 1C in Appendix C, along with the past and present PCI values for the pavement network.

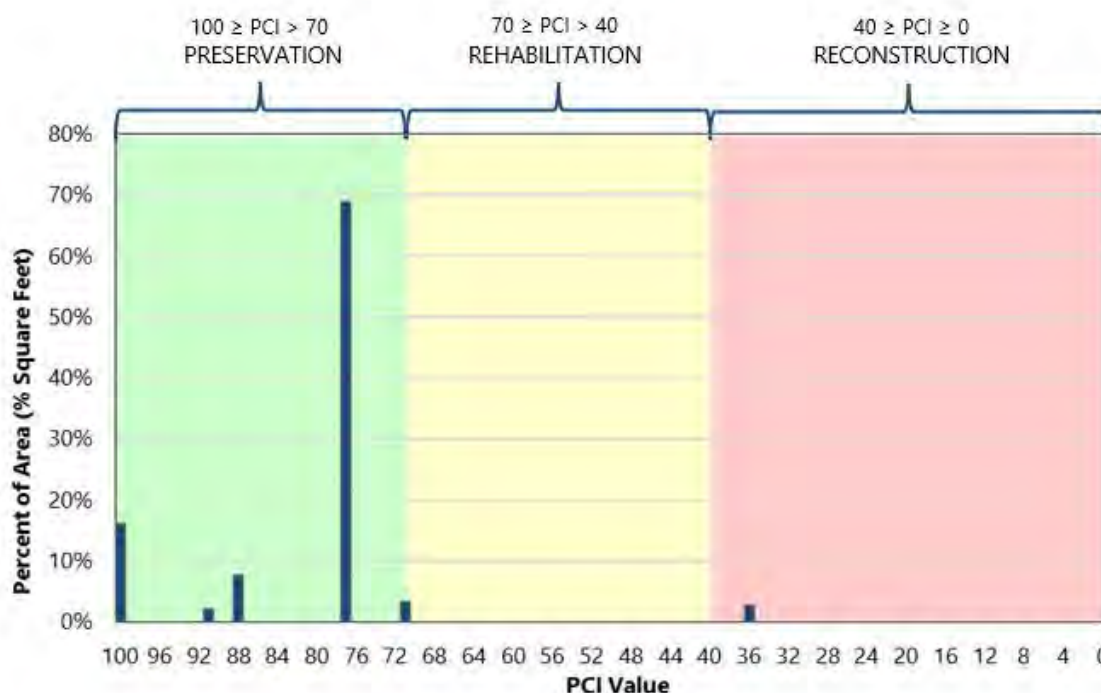
Figure 5.1 - BOARDMAN AIRPORT PAVEMENT NETWORK GENERAL TREATMENT TYPE DISTRIBUTION BASED ON PCI

Based on the 2022 PCI survey results, shown on Boardman Airport Pavement Network General Treatment Type Distribution Based on PCI, Figure 5.1 displays a breakdown of the Boardman Airport network pavement condition by percent of area and general M&R treatment categories. Approximately 97% and 3% of the area require preservation treatments and reconstruction, respectively.
