2022 ODA Pavement Evaluation Program Enterprise Municipal Airport

Enterprise, Oregon

May 8, 2023

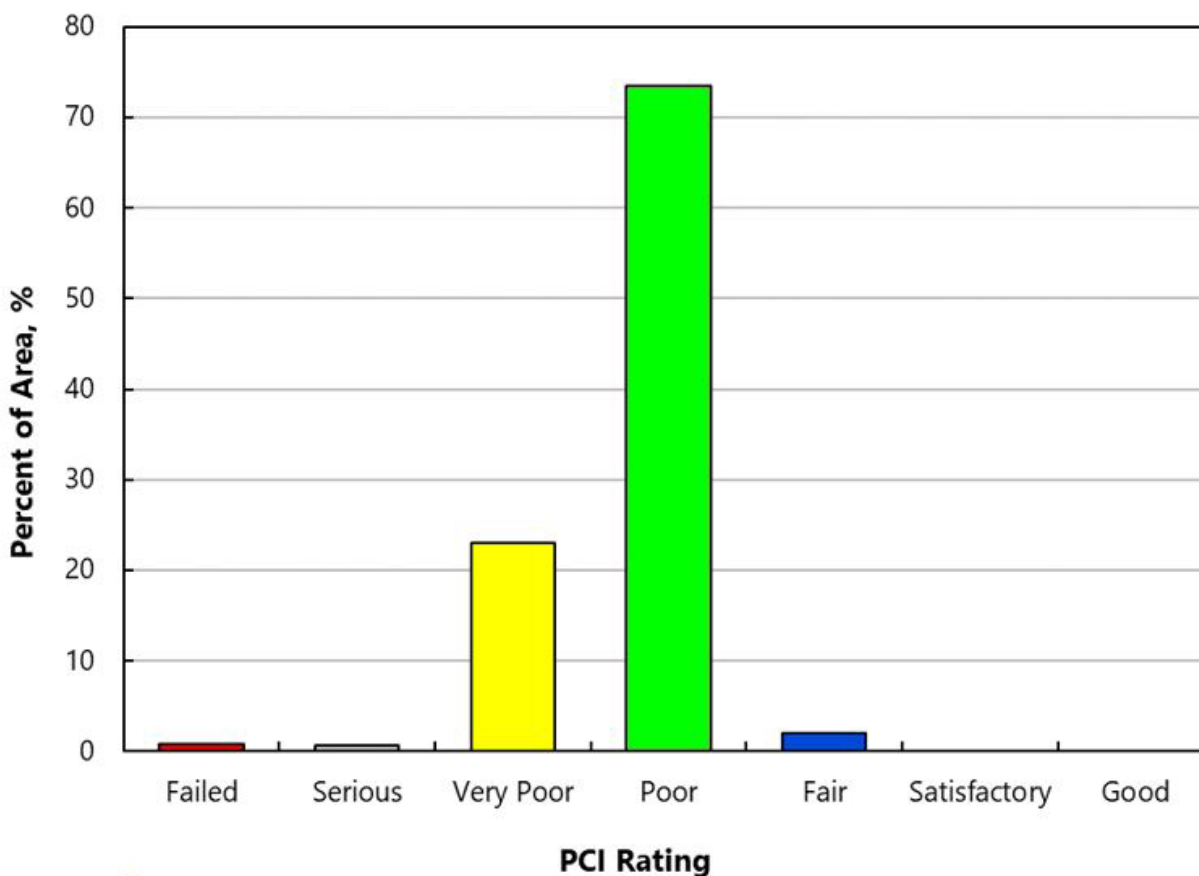
Figure 3.2 - ENTERPRISE MUNICIPAL AIRPORT PAVEMENT CONDITION RATING BY PERCENT OF AREA

The condition distribution of the network by percent of total pavement area is provided on the Enterprise Municipal Airport Pavement Condition Rating by Percent of Area, Figure 3.2. A summary of the pavement condition results by branch and section is included in Tables 2B and 3B of Appendix B, respectively. A comparison between the previous inspection and the 2022 inspection is provided in Table 4B in Appendix B. The re-inspection report that includes inspection details for individual sample units is provided in Table 1E in Appendix E.

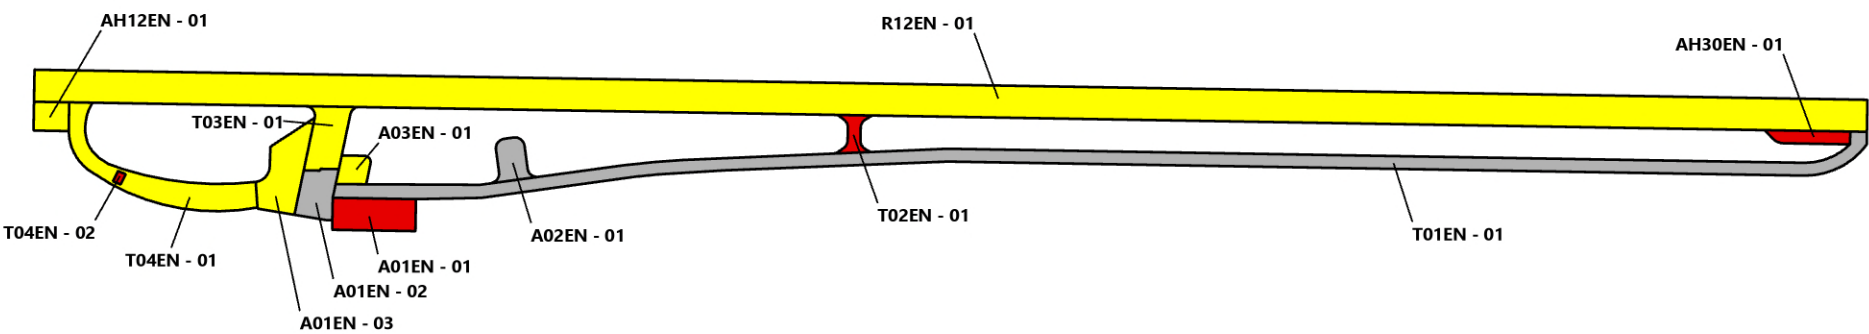
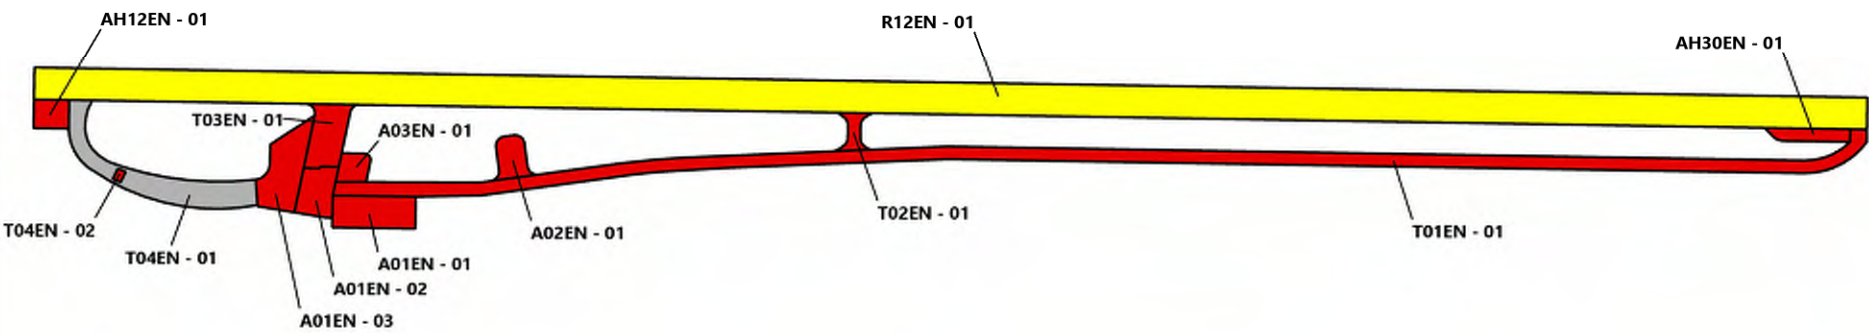
FUTURE PAVEMENT CONDITION
ENTERPRISE MUNICIPAL AIRPORT

Using the condition prediction models discussed above, the projected condition of each pavement section was determined for 5- and 10-year periods. Based on this analysis, we project the PCI to decrease from a current value of 46 to a value of 32 in the year 2027 and 19 in year the 2032 if no maintenance or rehabilitation work is performed. The projected pavement condition in five years and ten years for each pavement section at Enterprise Municipal Airport is displayed spatially on the Future Pavement Condition Enterprise Municipal Airport, Figure 4.1 and listed in Table 1C in Appendix C, along with the past and present PCI values for the pavement network.

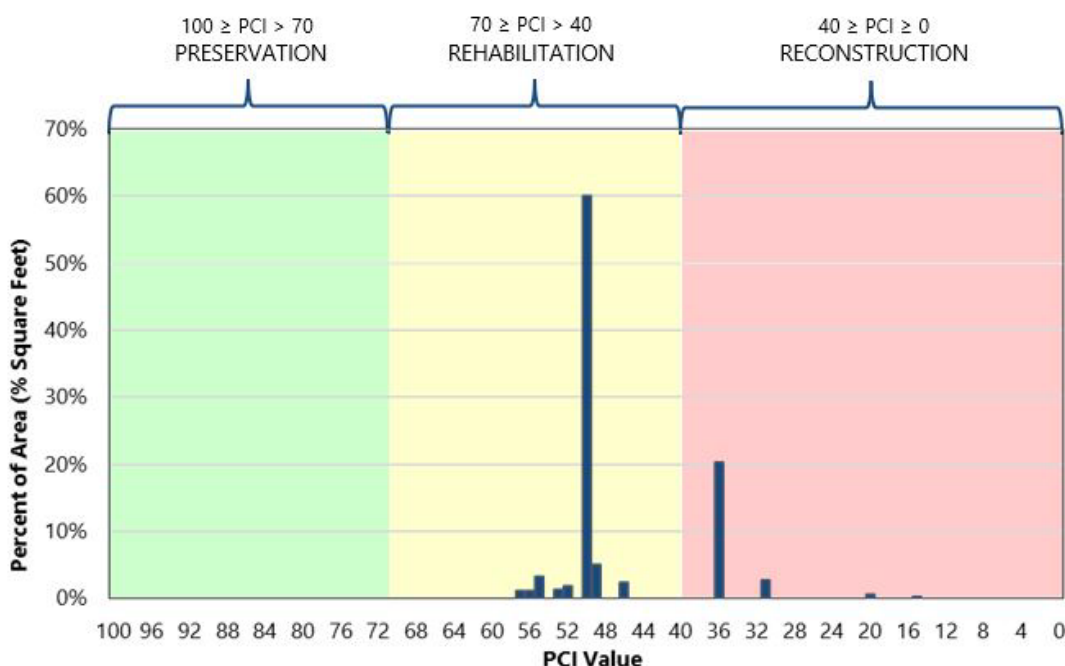
Figure 5.1 - ENTERPRISE MUNICIPAL AIRPORT PAVEMENT NETWORK GENERAL TREATMENT TYPE DISTRIBUTION BASED ON PCI

Based on the 2022 PCI survey results shown on the Enterprise Municipal Airport Pavement Network General Treatment Type Distribution Based on PCI, Figure 5.1 displays a breakdown of the Enterprise Municipal Airport network pavement condition by percent of area and general M&R treatment categories. Approximately 76% and 24% of the area require rehabilitation and reconstruction.
