2022 ODA Pavement Evaluation Program Miller Memorial Airpark

Vale, Oregon

May 8, 2023

State of Oregon Department of Aviation
3040 25th Street SE
Salem, OR 97303-1125

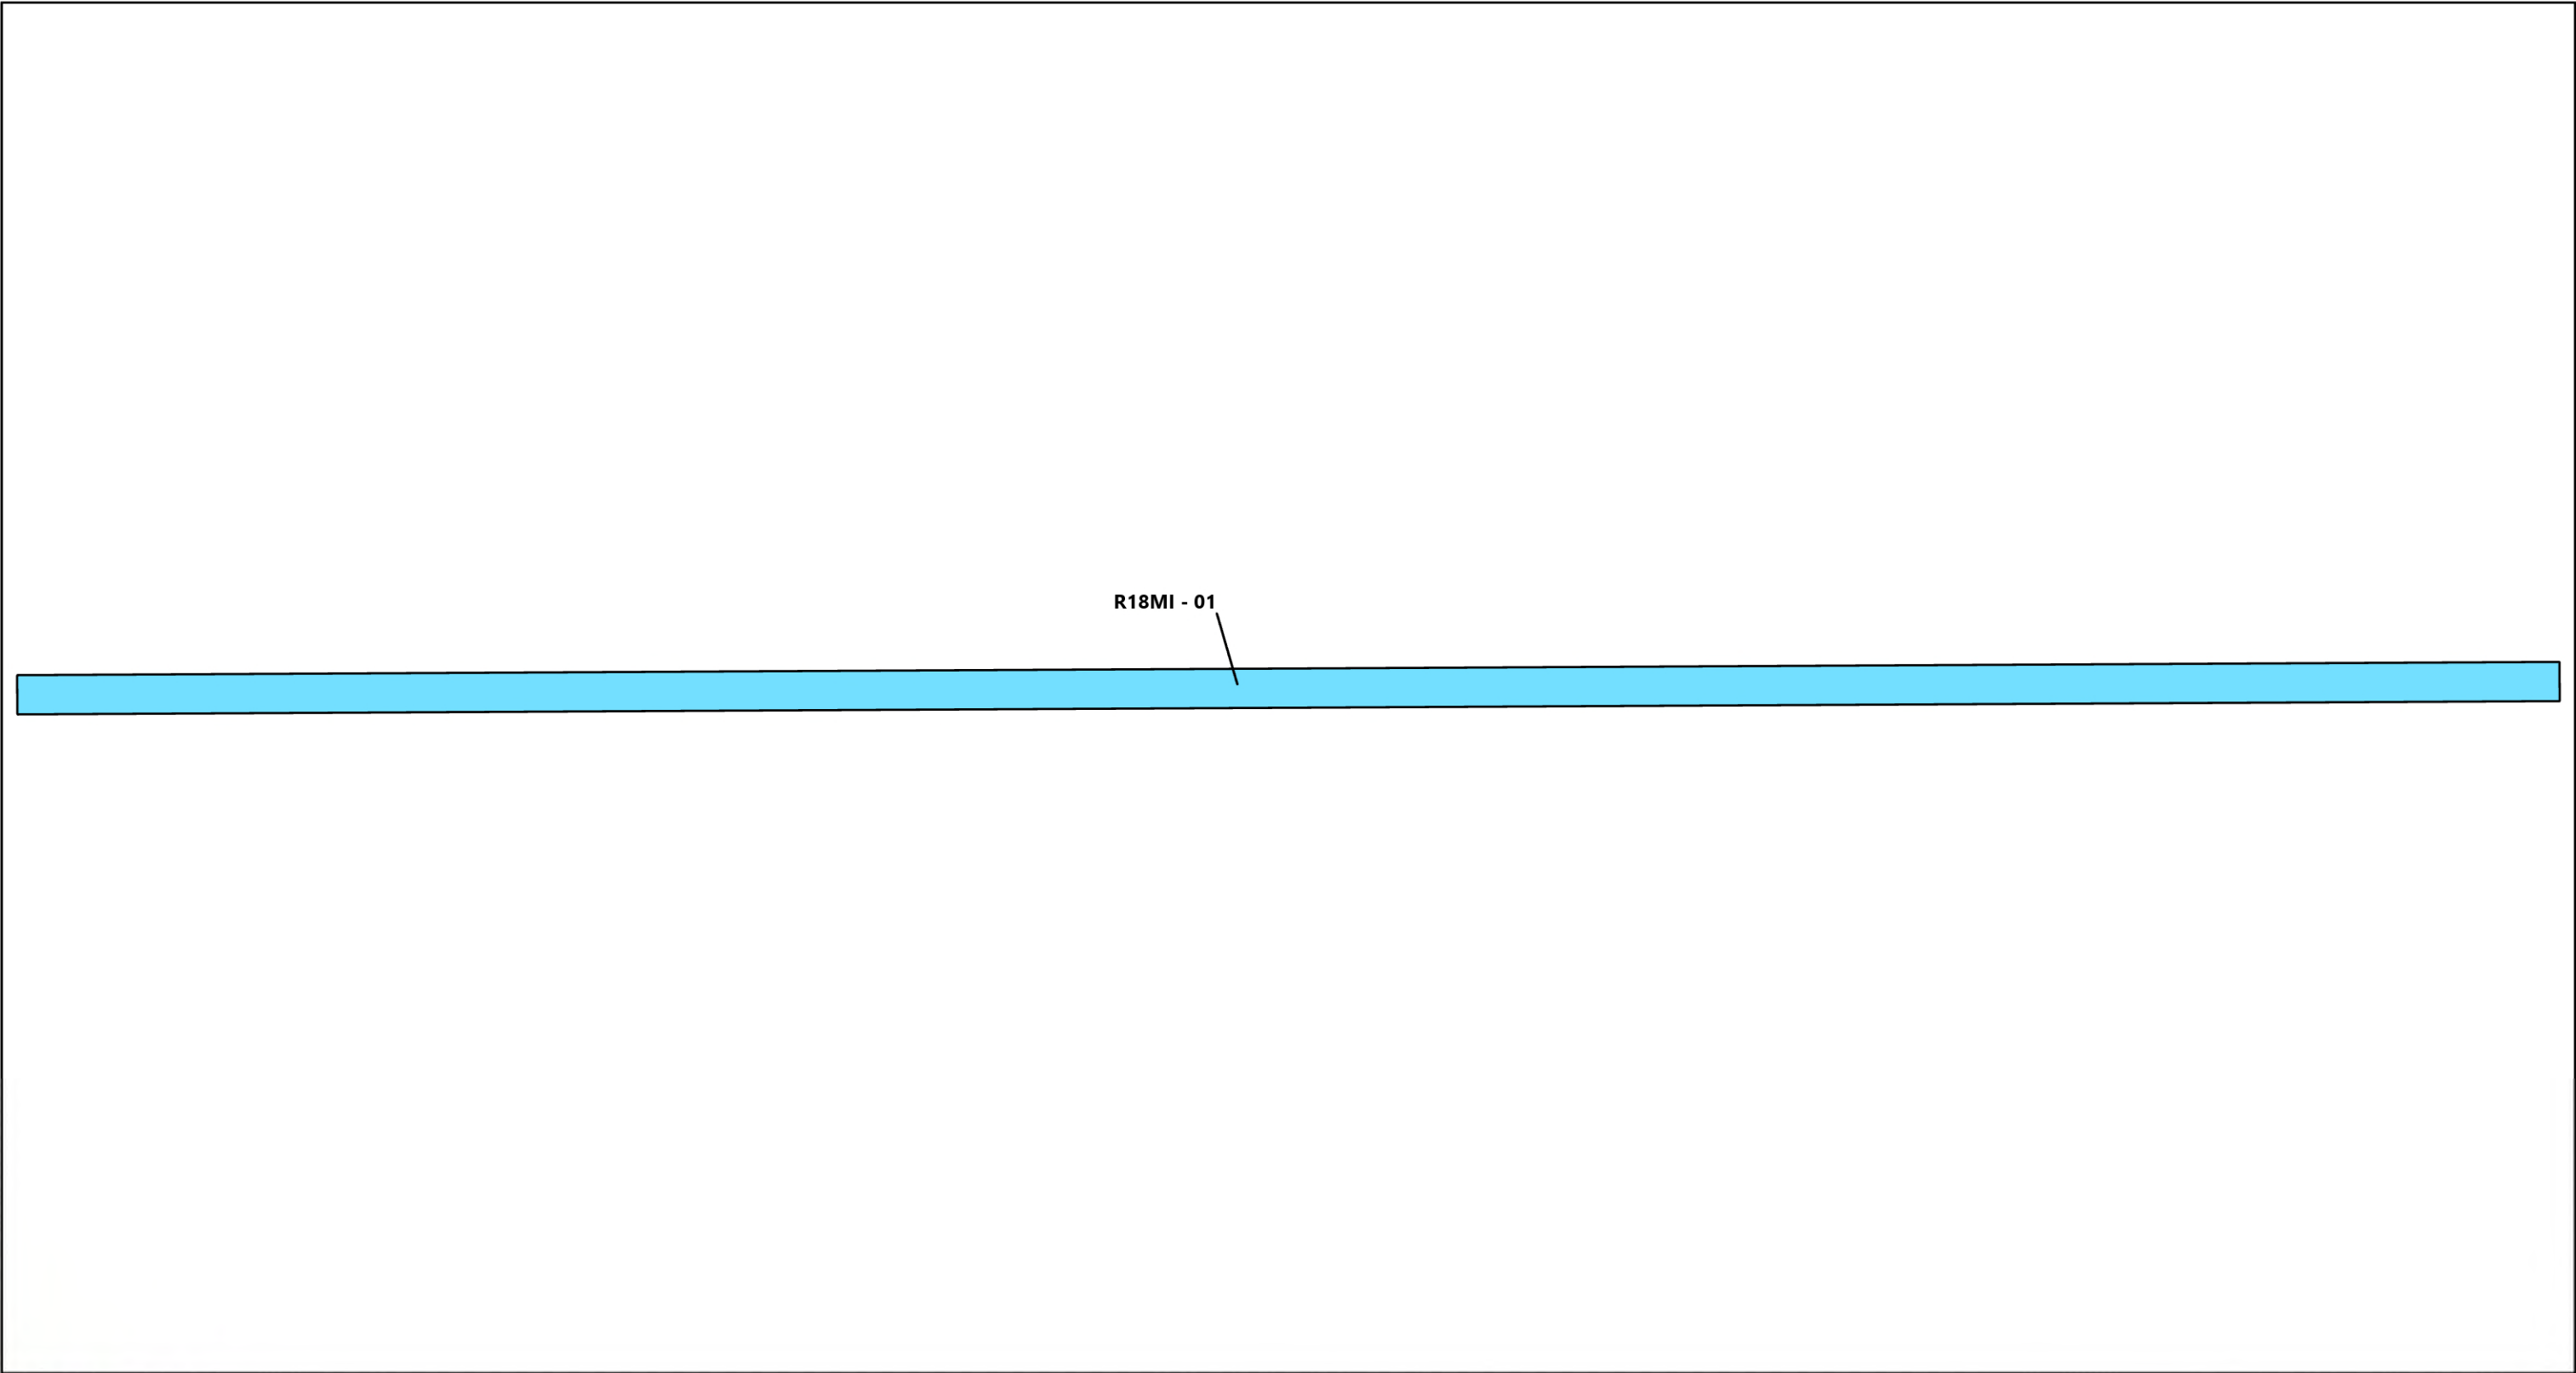
2022 PCI SURVEY RESULTS
MILLER MEMORIAL AIRPARK

The area-weighted average PCI for all airport pavements at Miller Memorial Airpark is approximately 74. The primary distresses observed during the inspection were weathering and longitudinal and transverse cracking on AC-surfaced pavements. Section PCIs following our pavement survey are displayed below spatially on the 2022 PCI Survey Results Miller Memorial Airpark, Figure 3.1.
