# **2022 ODA Pavement Evaluation Program Monument Municipal Airport**

Monument, Oregon

**May 8, 2023**

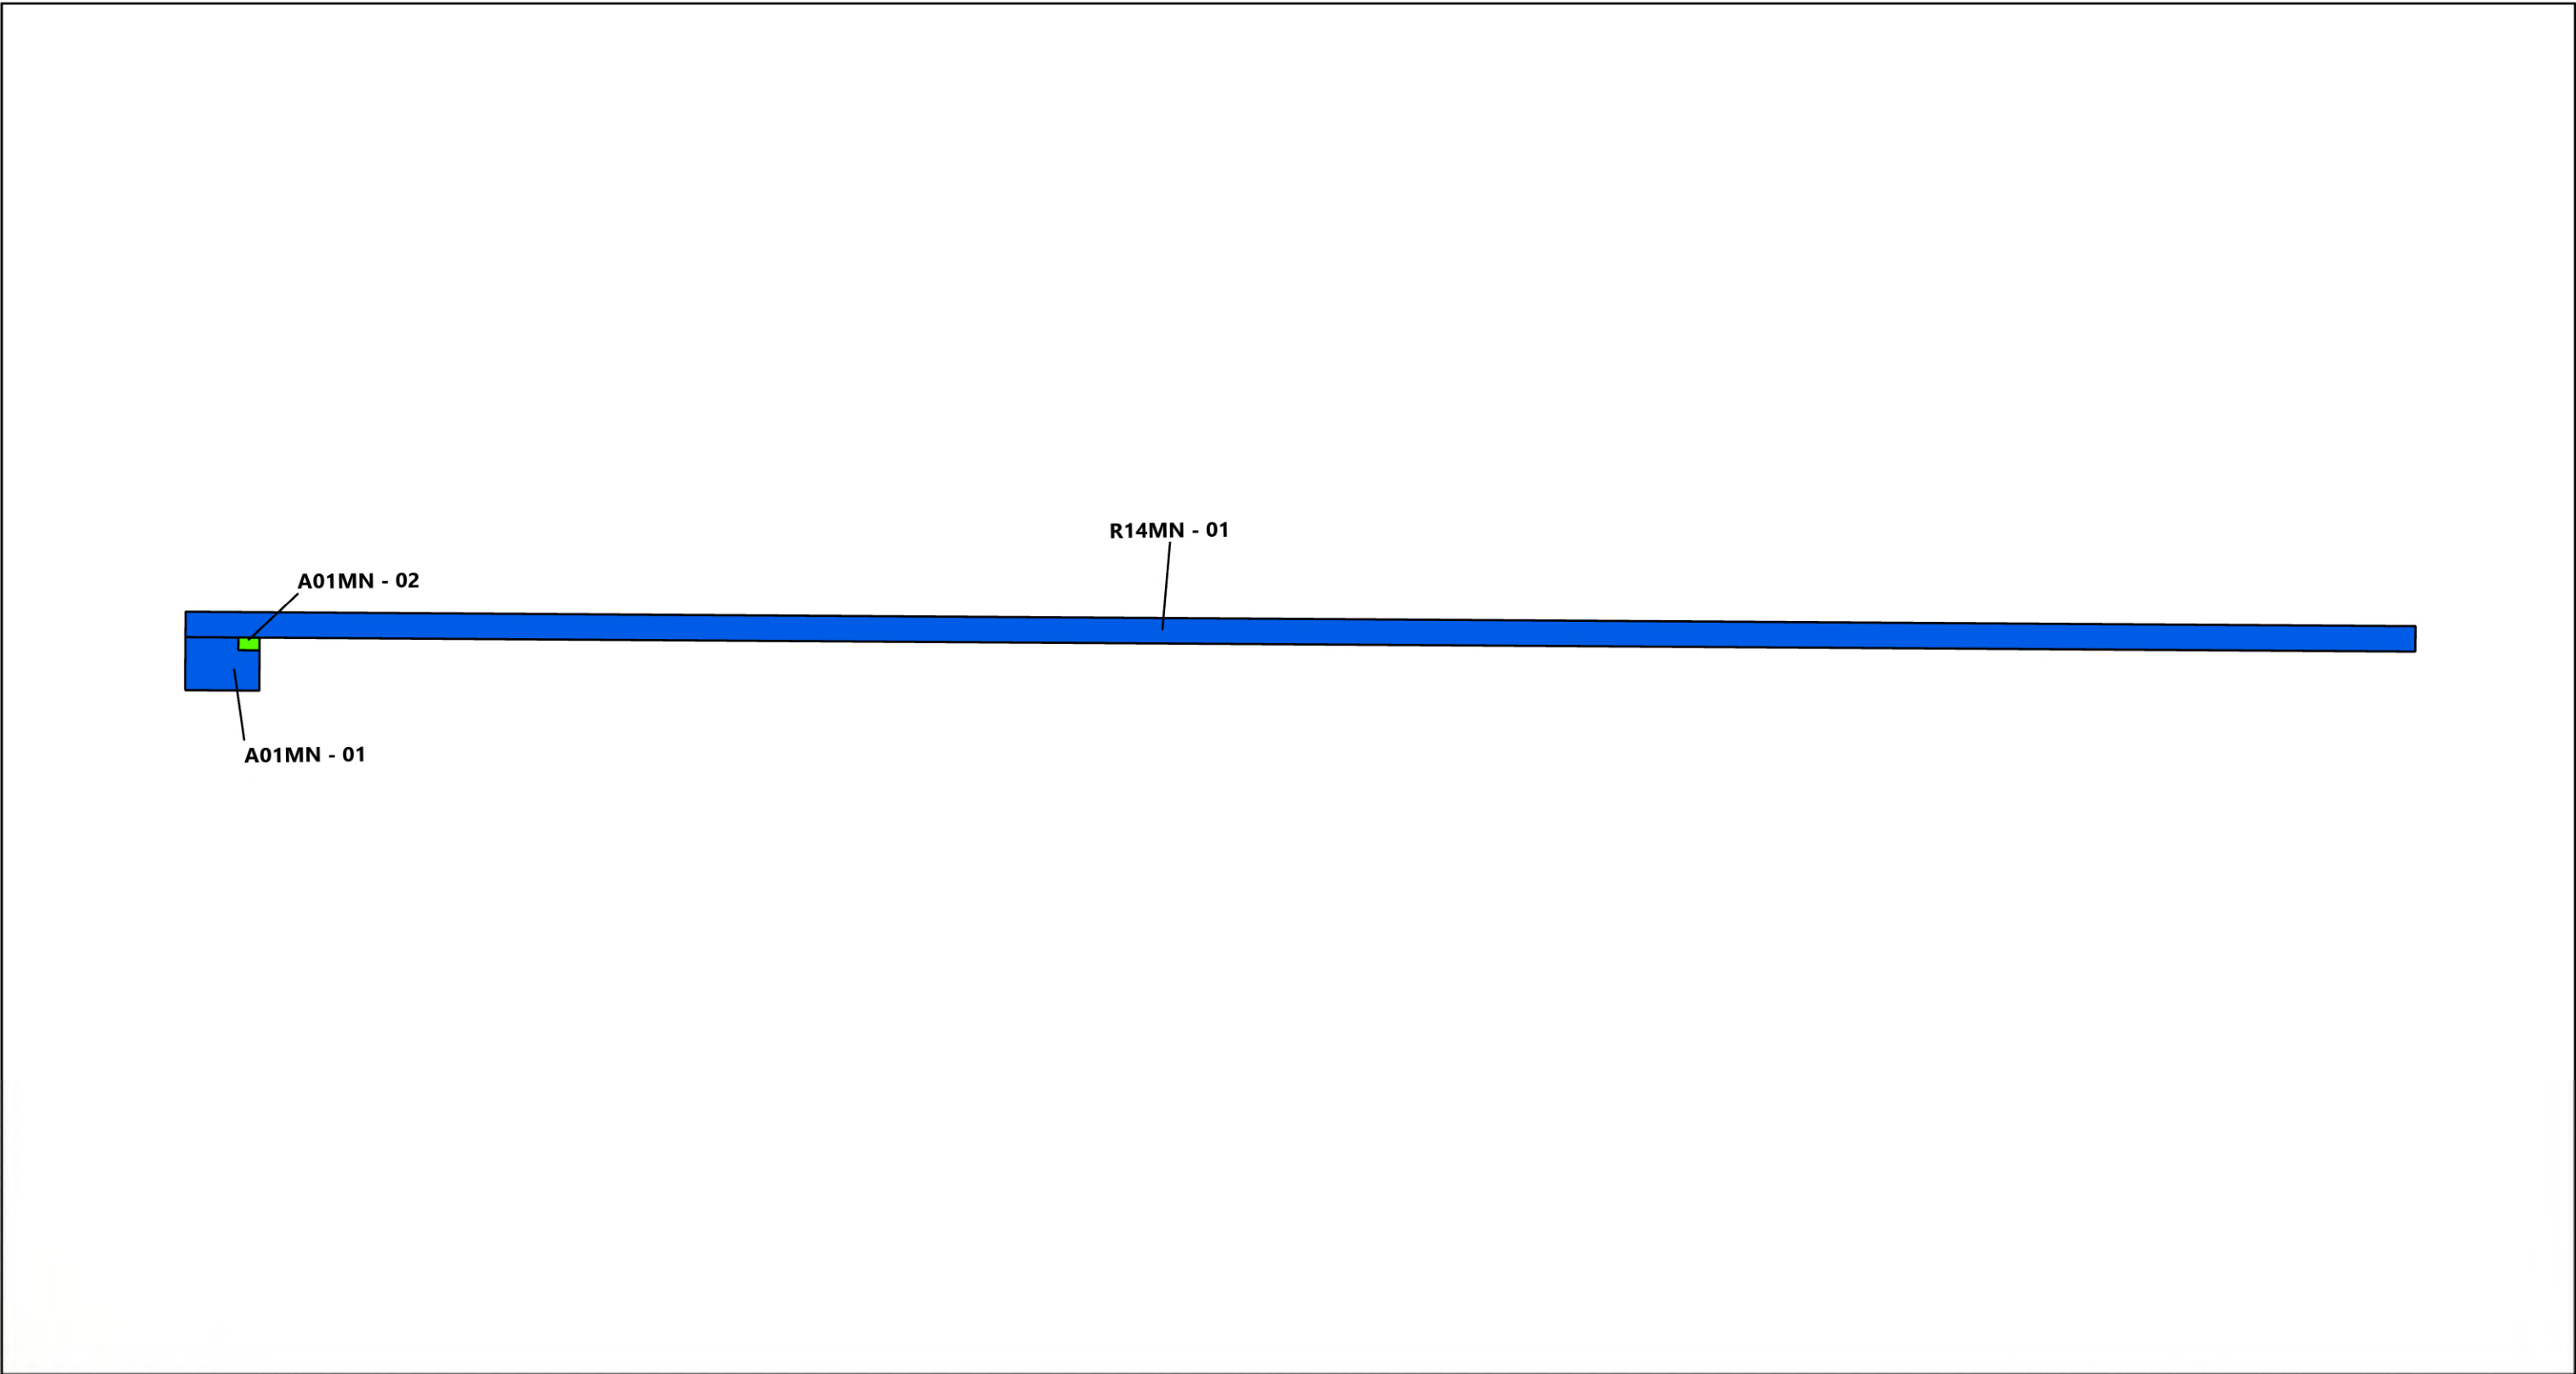
2022 PCI SURVEY RESULTS  
MONUMENT MUNICIPAL AIRPORT

The area-weighted average PCI for all airport pavements at Monument Municipal Airport is approximately 65. The section PCIs ranged from a low of 42 to a high of 65. The primary distresses observed during the inspection were weathering and longitudinal and transverse cracking on AC-surfaced pavements, and linear cracking and shrinkage cracking on PCC pavements. Section PCIs following our pavement survey are displayed below spatially on the 2022 PCI Survey Results Monument Municipal Airport, Figure 3.1.

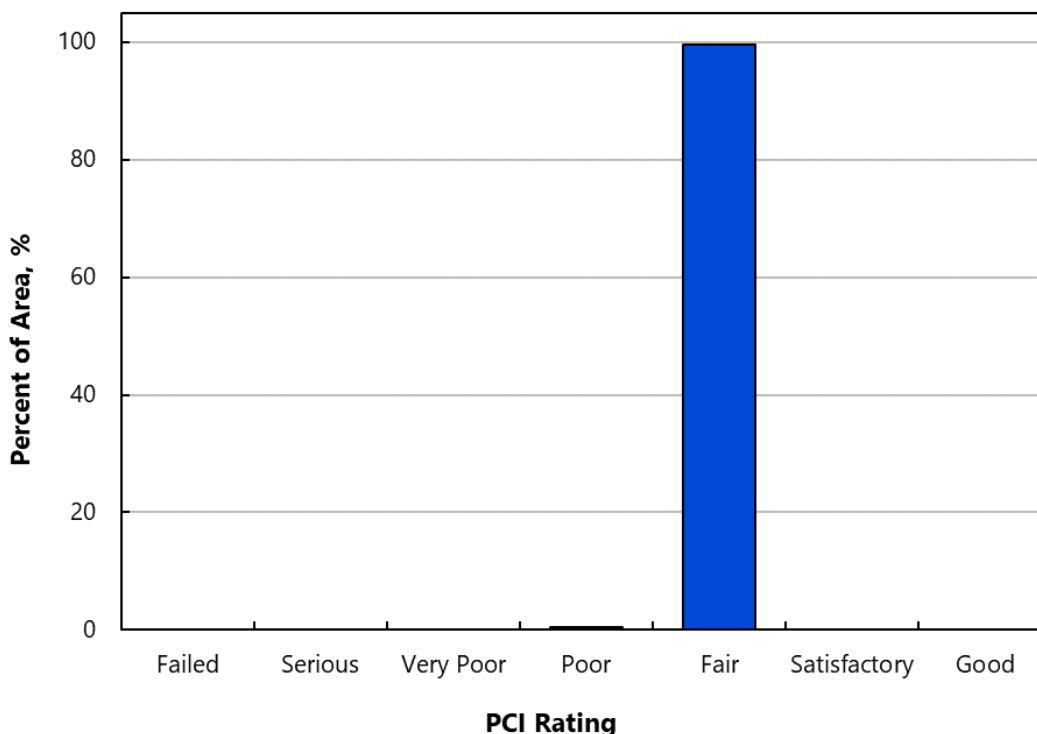
**Figure 3.2 - MONUMENT MUNICIPAL AIRPORT PAVEMENT CONDITION RATING BY PERCENT OF AREA**

The condition distribution of the network by percent of total pavement area is provided on the Monument Municipal Airport Pavement Condition Rating by Percent of Area, Figure 3.2. A summary of the pavement condition results by branch and section are included in Tables 2B and 3B of Appendix B, respectively. A comparison between the previous inspection and the 2022 inspection is provided in Table 4B in Appendix B. The re-inspection report that includes inspection details for individual sample units is provided in Table 1E in Appendix E.

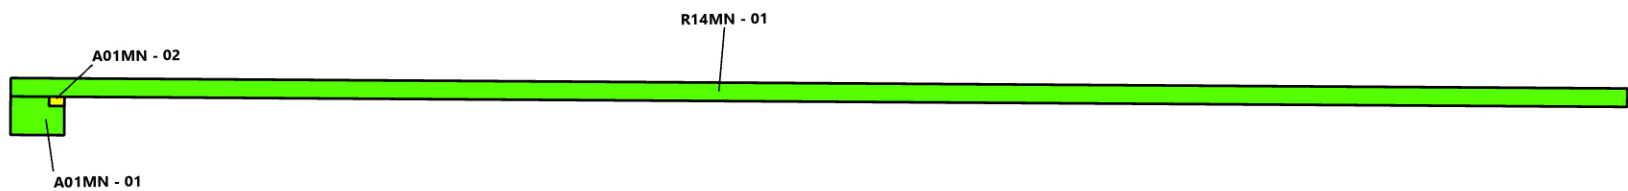
FUTURE PAVEMENT CONDITION  
MONUMENT MUNICIPAL AIRPORT

project the PCI to decrease from a current value of 65 to a value of 55 in 2027 and 44 in 2032 if no maintenance or rehabilitation work is performed. The projected pavement condition in 5 years and 10 years for each pavement section at Monument Municipal Airport is displayed spatially on the Future Pavement Condition Monument Municipal Airport, Figure 4.1, and listed in Table 1C in Appendix C, along with the past and present PCI values for the pavement network.

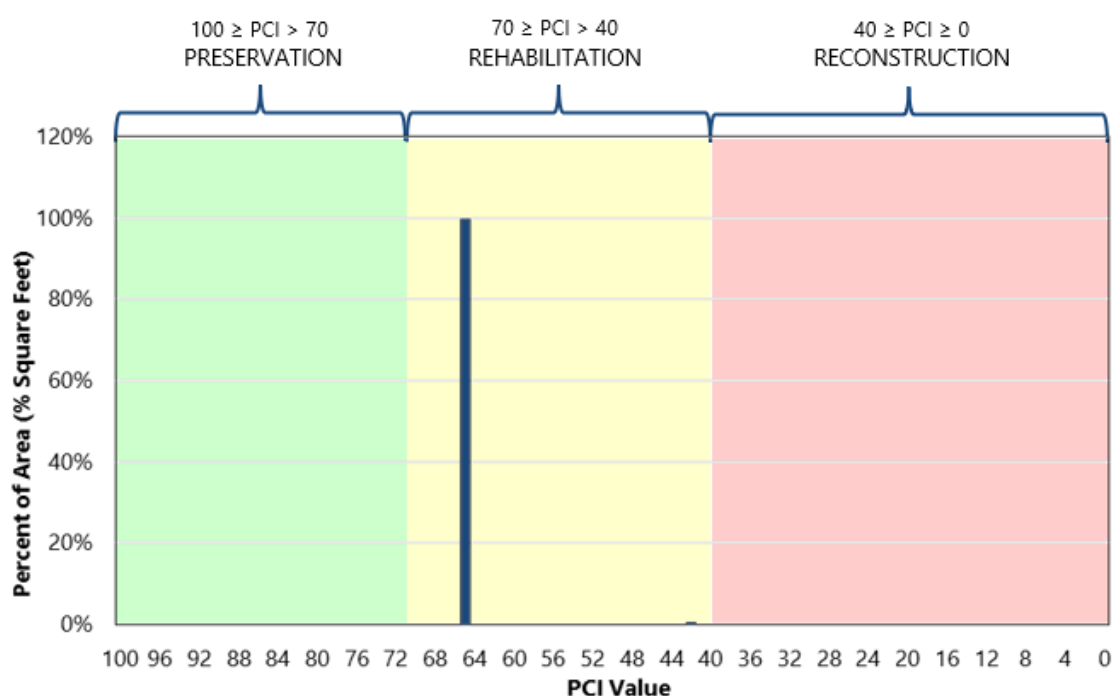
**Figure 5.1: MONUMENT MUNICIPAL AIRPORT PAVEMENT NETWORK GENERAL TREATMENT TYPE DISTRIBUTION BASED ON PCI**

Based on the 2022 PCI-survey results shown on the Monument Municipal Airport Pavement Network General Treatment Type Distribution Based on PCI, Figure 5.1 displays a breakdown of the Monument Municipal Airport network pavement condition by percent of area and general M&R treatment categories. 100% of the area requires rehabilitation.
