Pavement
Evaluation/
Maintenance
Management Program
2011

Wasco State
Airport

**2011 Pavement Evaluation / Maintenance
Management Program**

**Final Report – Individual Airports
Functional Category 4**

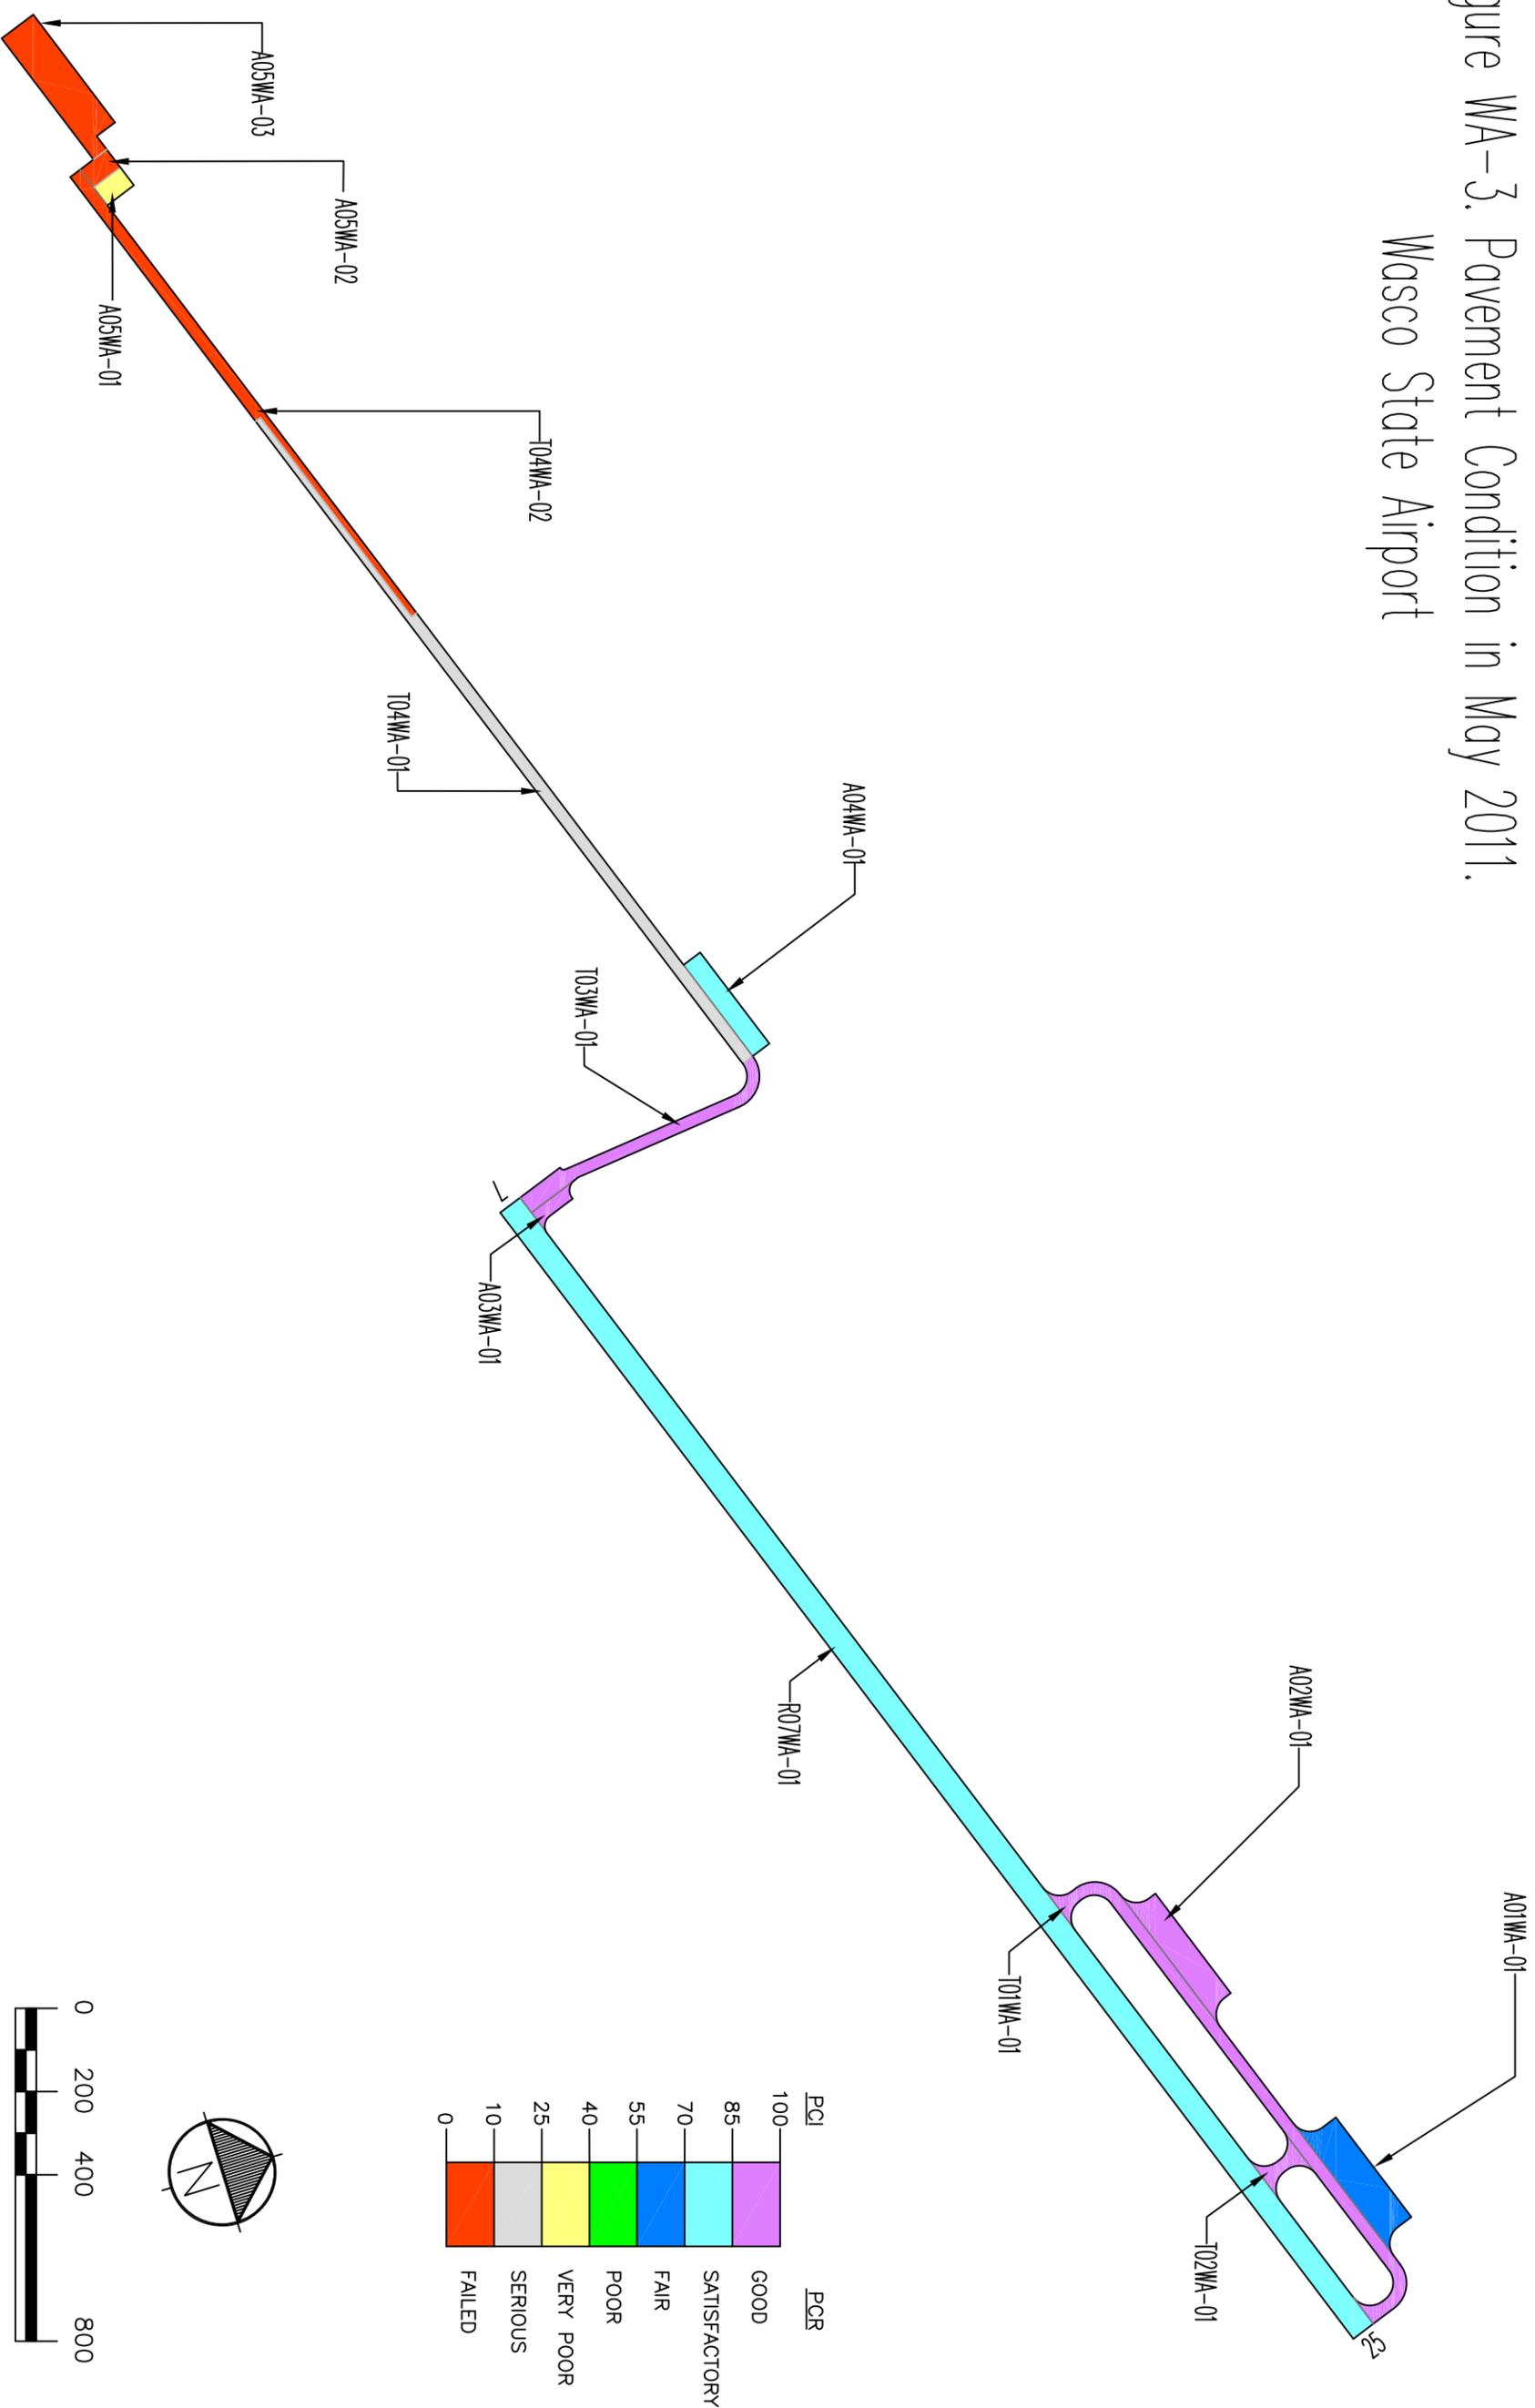
Figure WA-3. Pavement Condition in May 2011.
 Wasco State Airport

The Branch Condition Report in Appendix 1 summarizes current pavement condition by branch while the Section Condition Report in Appendix 2 lists pavement condition by section. The current PCR is shown graphically in Figure WA-3.

Section PCIs at Wasco State Airport range from a low of 0 (a PCR of "Failed") to a high of 95 (a PCR of "Good"). The area-weighted average PCI for all airport pavements is 65, corresponding to an overall PCR of "Fair". Figure WA-4 shows how much pavement area is associated with each Pavement Condition Rating category and also shows pavement condition distribution from the inspections conducted in 2003 and 2006.

The primary distresses observed during the inspection were: weathering, raveling, block cracking, alligator cracking, depression, and longitudinal and transverse cracking with isolated occurrence of oil spillage.
