# BOARDMAN AIRPORT

This report describes how your Pavement Maintenance Management Program (PMMP) was developed. Your Program was developed as part of the Oregon Continuous Aviation System Plan sponsored in part by the Oregon Department of Aviation and the Federal Aviation Administration (FAA). The information and data contained in this report ensures you are in compliance with the requirements of FAA Grant Assurance Number 11 which states that any airport requesting federal funds for pavement improvement projects must have implemented a pavement maintenance management program.

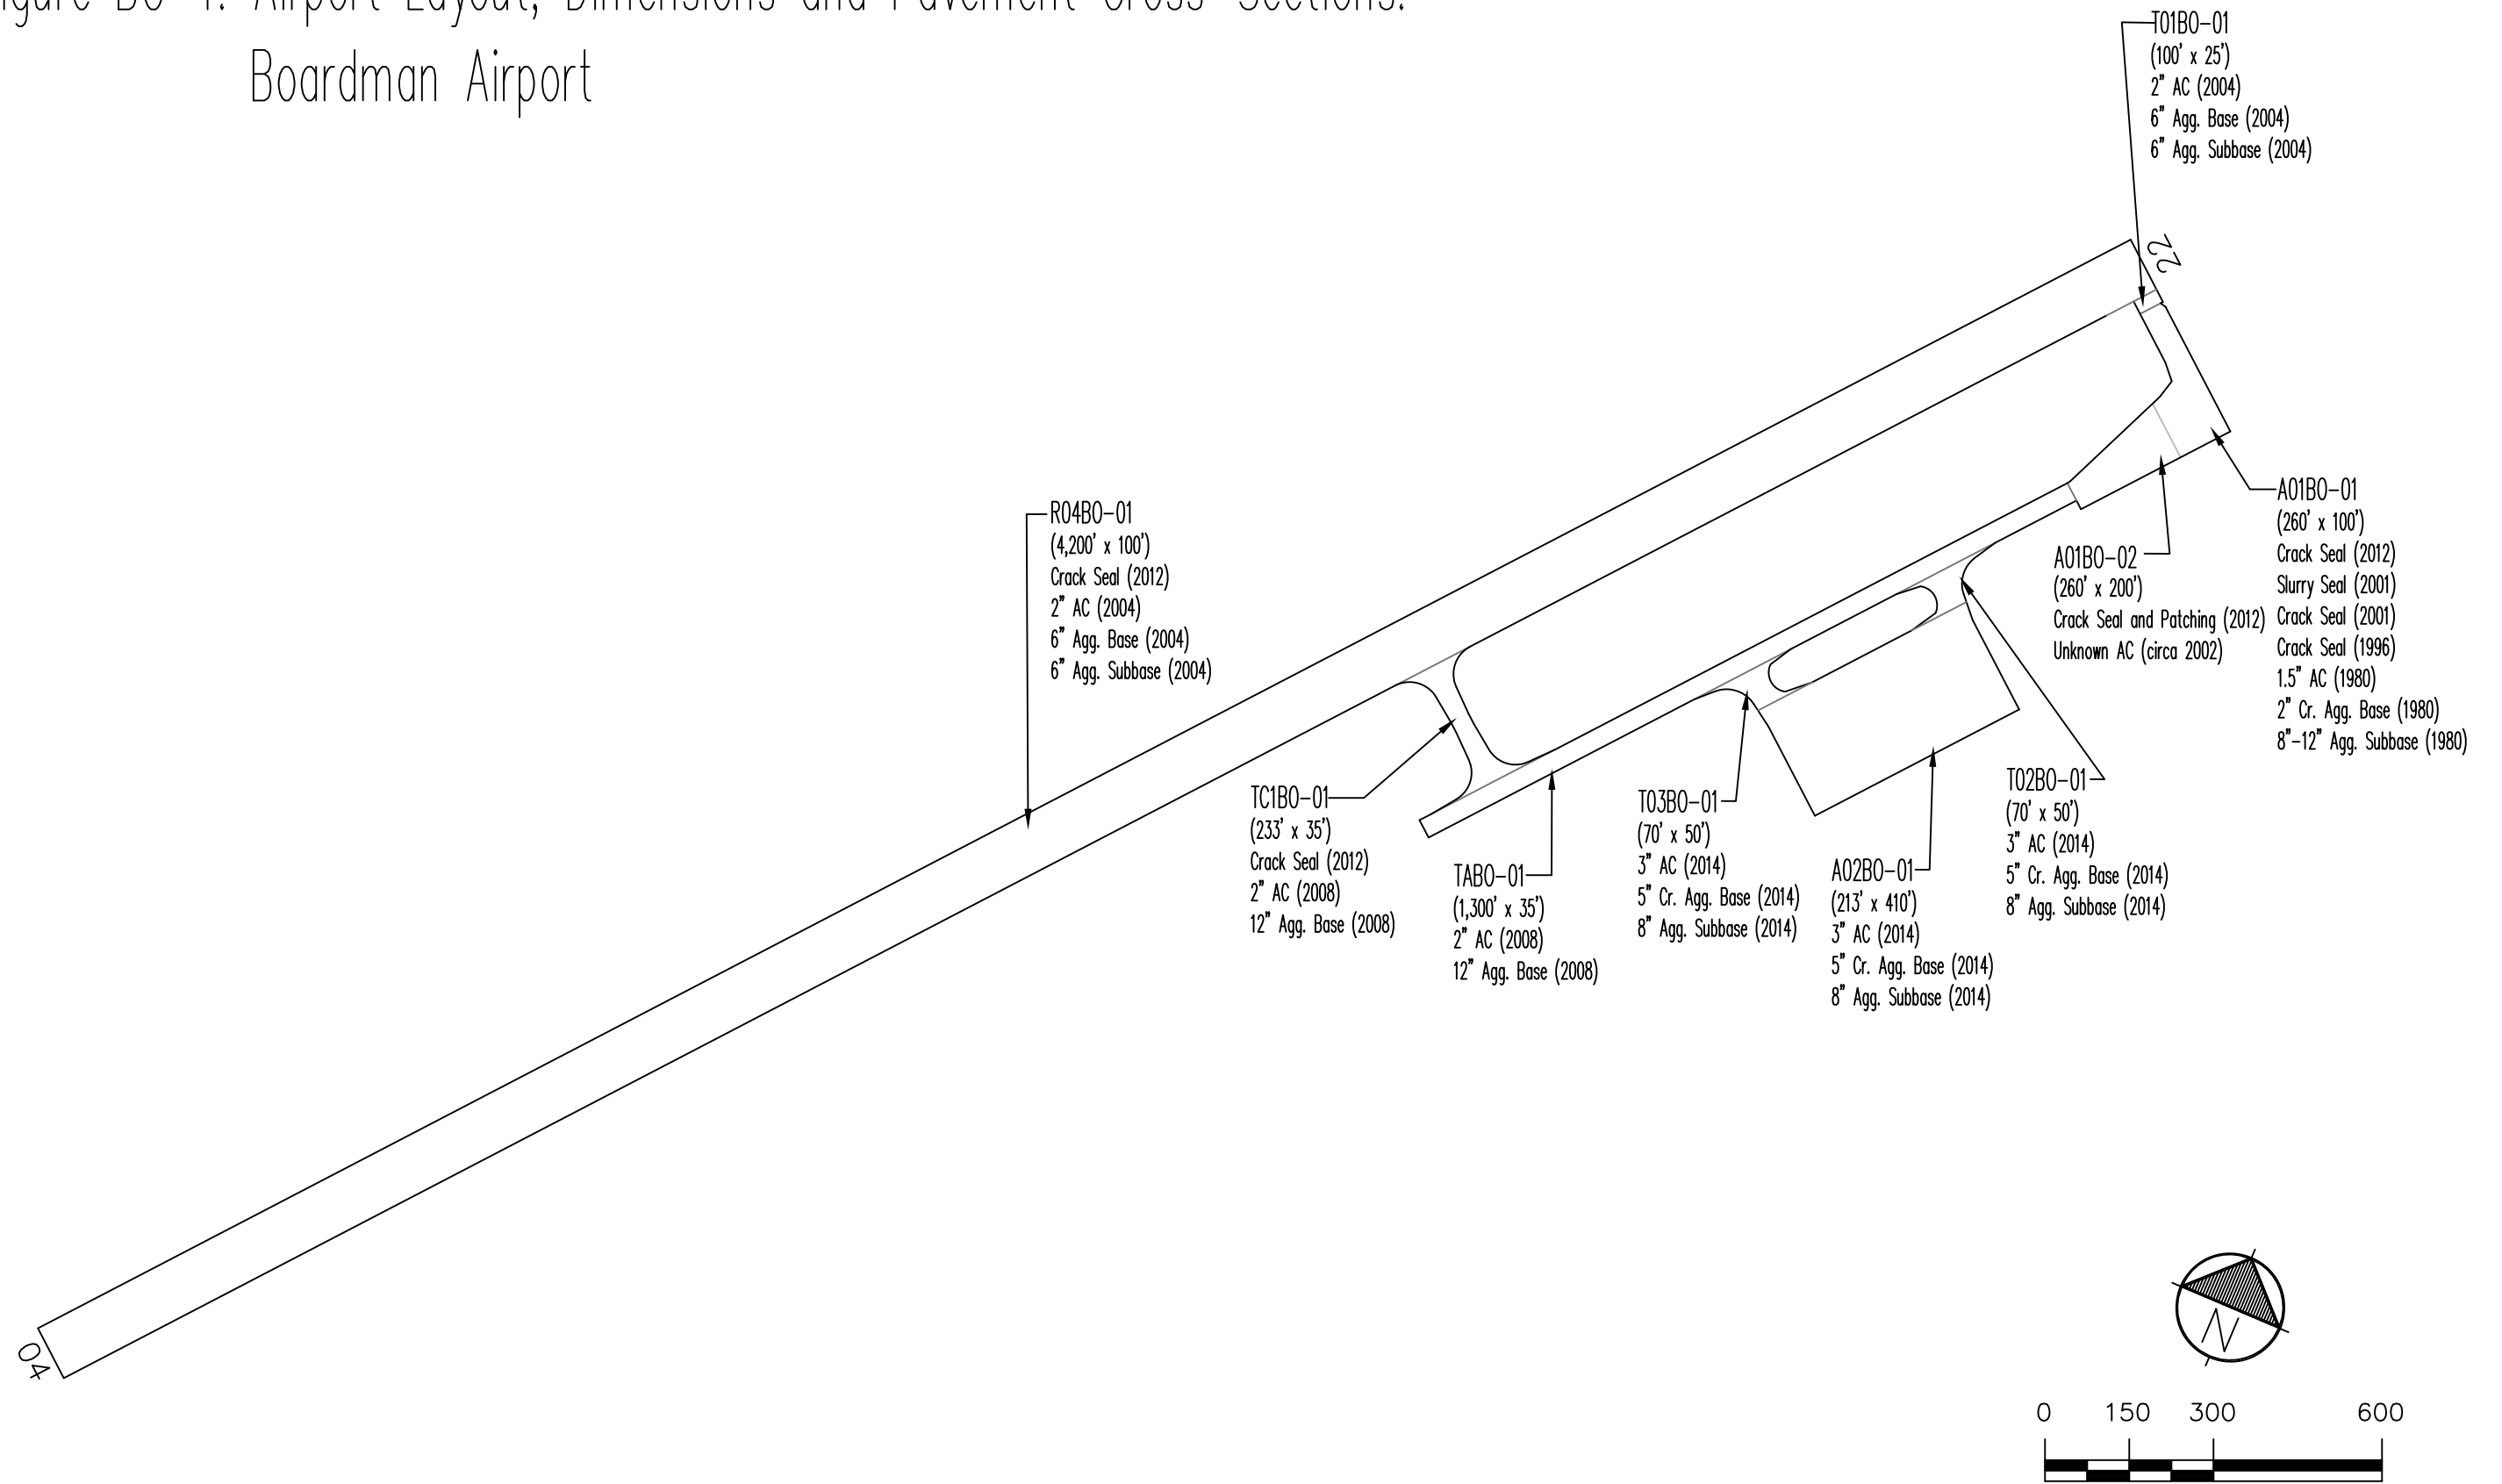
Figure B0-1. Airport Layout, Dimensions and Pavement Cross-Sections.  
Boardman Airport

To determine how your pavements were constructed and their age, a records review was conducted. Figure BO-1 shows the records review results. This figure identifies pavement boundaries, dimensions, pavement layer types, thicknesses and dates of construction. The most recent construction date for each pavement can also be found in the Section Condition Report in Appendix 2. Figure BO-1 and the information contained in Appendices 1, 2 and 4 ensure that your airport complies with the “pavement inventory” requirement of FAA’s PMMP guidelines.

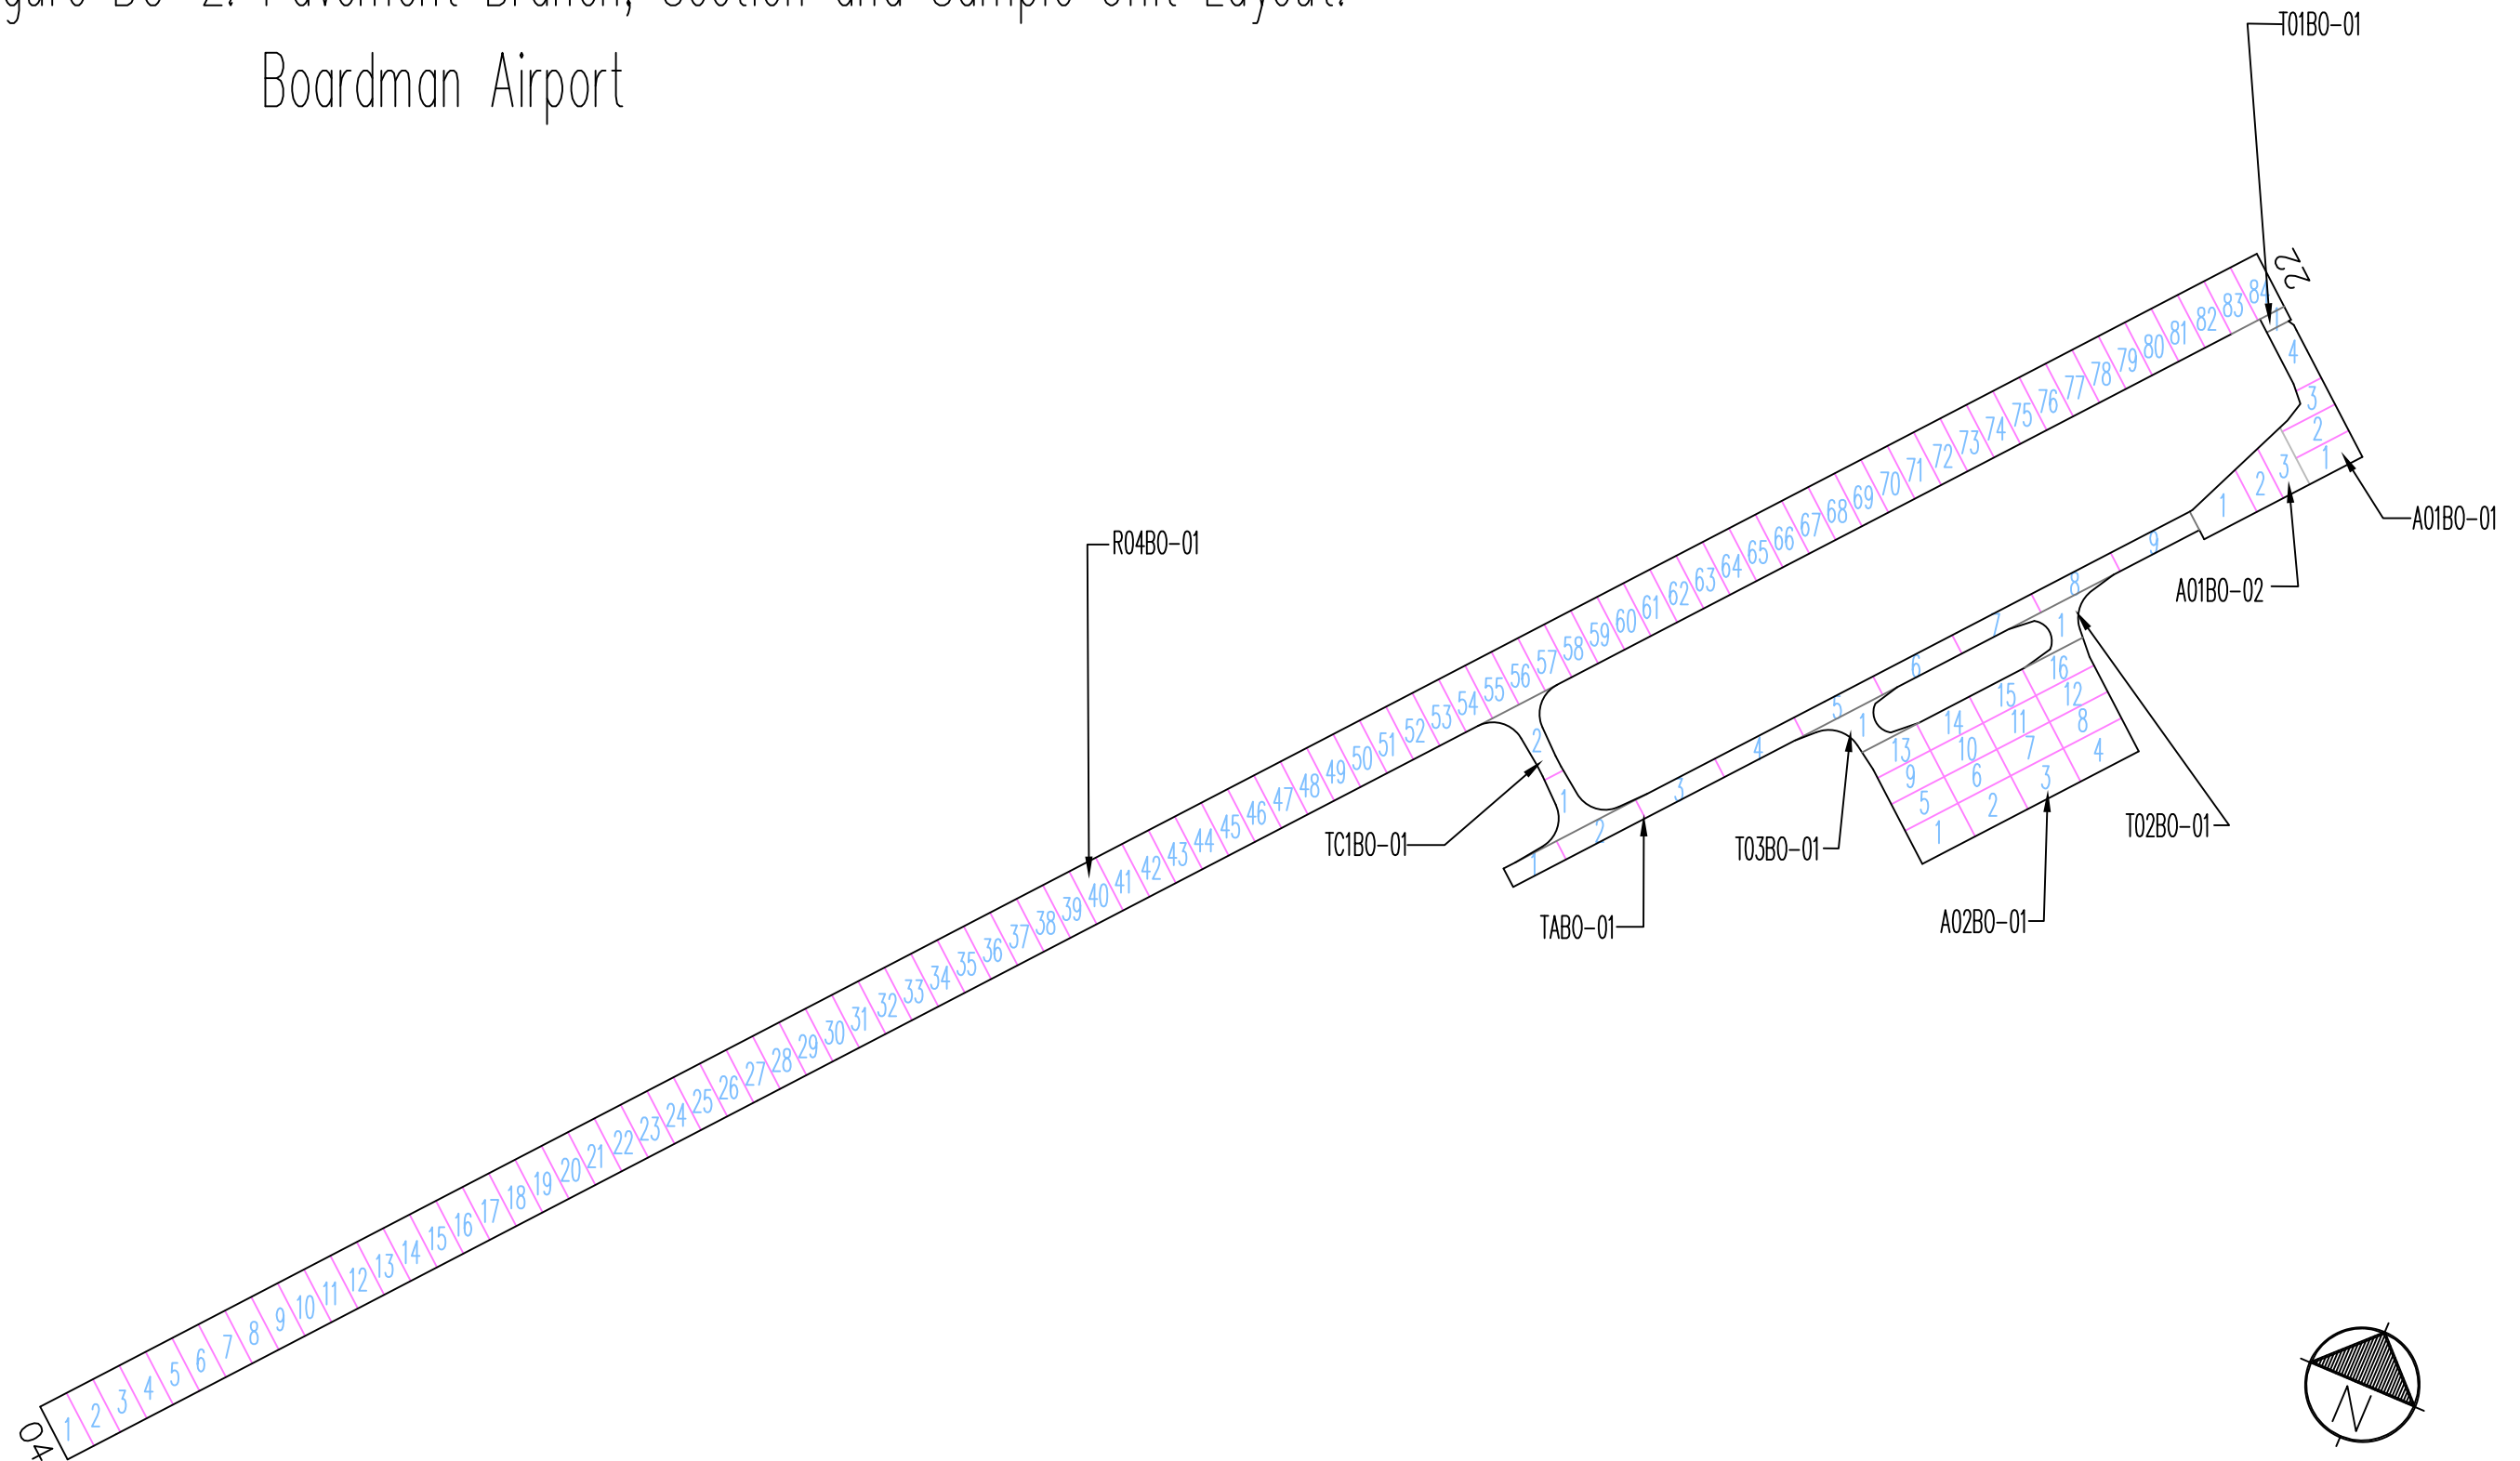
Figure B0-2. Pavement Branch, Section and Sample Unit Layout.  
Boardman Airport

The pavements at your airport were divided into branches, sections and sample units in accordance with the methodology outlined in the current edition of ASTM D5430, *Standard Test Method for Airport Condition Index Surveys*. The branches, sections and sample units established at your airport are shown in Figure BO-2. A Branch Condition Report showing all branches, their associated areas, and their area-weighted average condition is provided in Appendix 1. Additionally, the Appendix 2 Section Condition Report provides information used to define each branch and section in the Micro PAVER database.

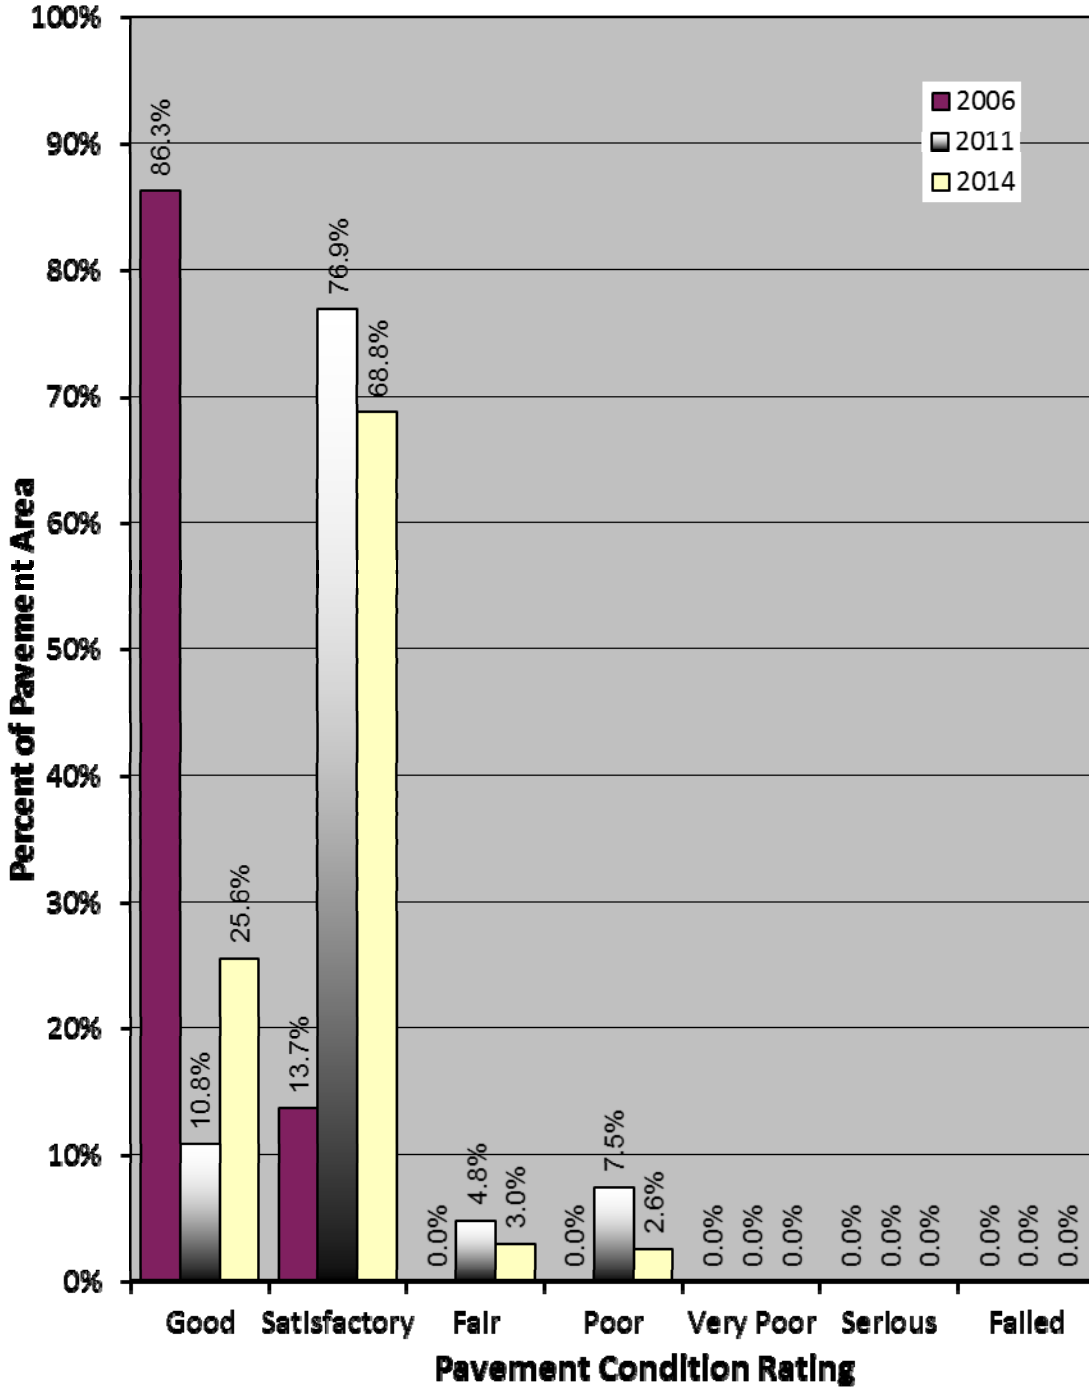
**Figure BO-4. Distribution of Pavement Condition Boardman Airport**

Section PCIs at Boardman Airport range from a low of 54 (a PCR of “Poor”) to a high of 100 (a PCR of “Good”). The area-weighted average PCI for all airport pavements is 87, corresponding to an overall PCR of “Good”. Figure BO-4 shows how much pavement area is associated with each Pavement Condition Rating category and also shows pavement condition distribution from the inspections conducted in 2006 and 2011.

The primary distresses observed during the inspection were: longitudinal and transverse cracking, block cracking, weathering, and with isolated occurrences of patching and alligator cracking.

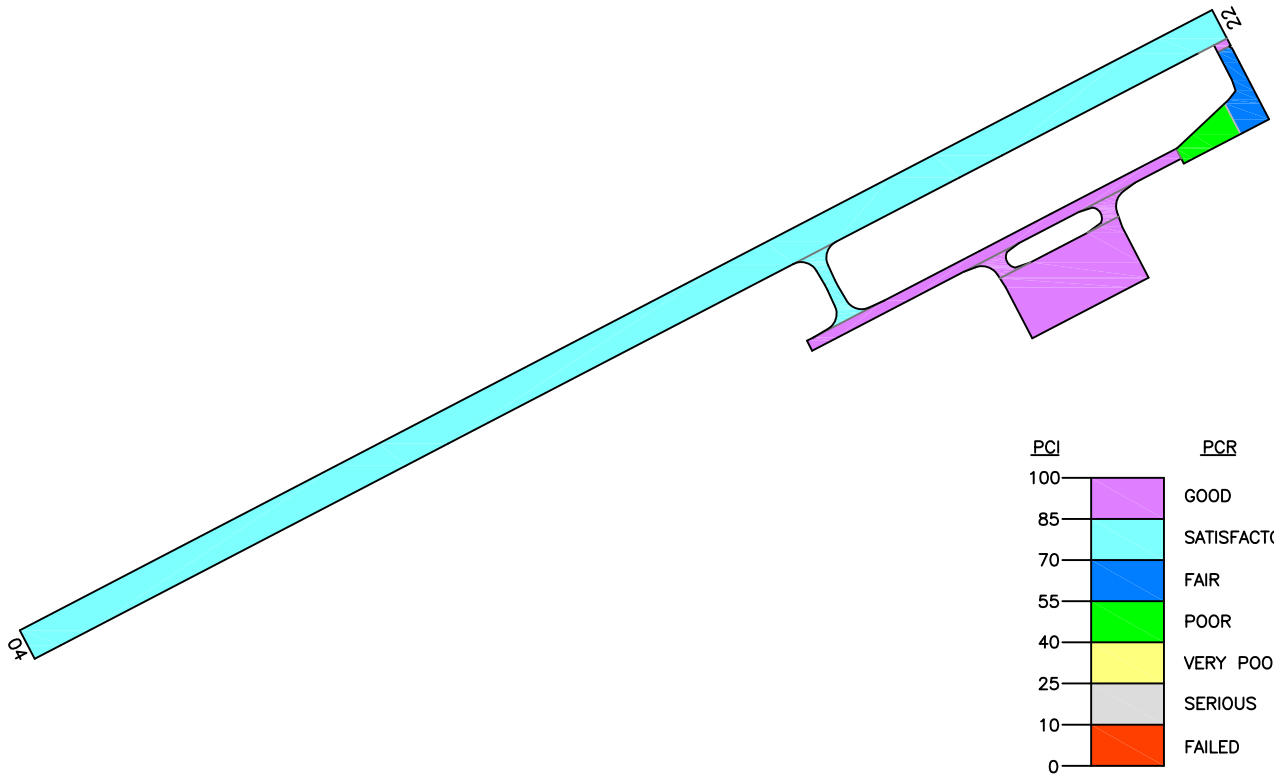
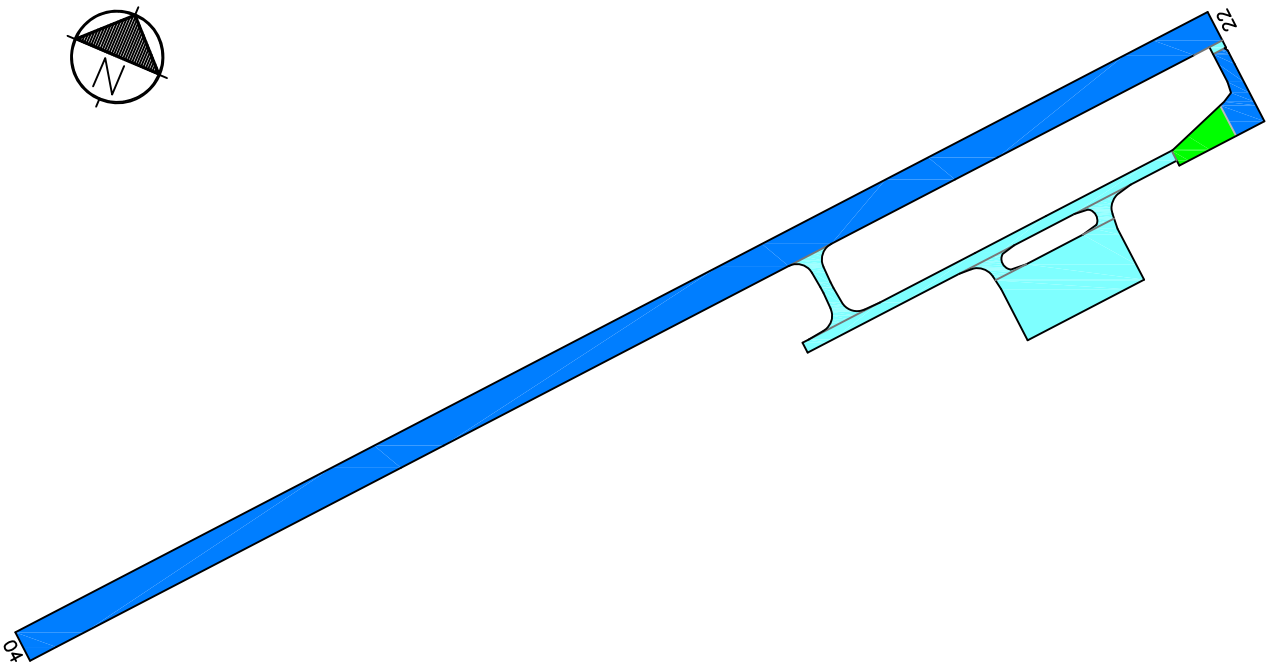
Figure BO-5. Future Pavement Condition.

A graphical representation of the projected PCIs listed in Table 1 is shown in Figure BO-5.
