BURNS MUNICIPAL AIRPORT

This report describes how your Pavement Maintenance Management Program (PMMP) was developed. Your Program was developed as part of the Oregon Continuous Aviation System Plan sponsored in part by the Oregon Department of Aviation and the Federal Aviation Administration (FAA). The information and data contained in this report ensures you are in compliance with the requirements of FAA Grant Assurance Number 11 which states that any airport requesting federal funds for pavement improvement projects must have implemented a pavement maintenance management program.

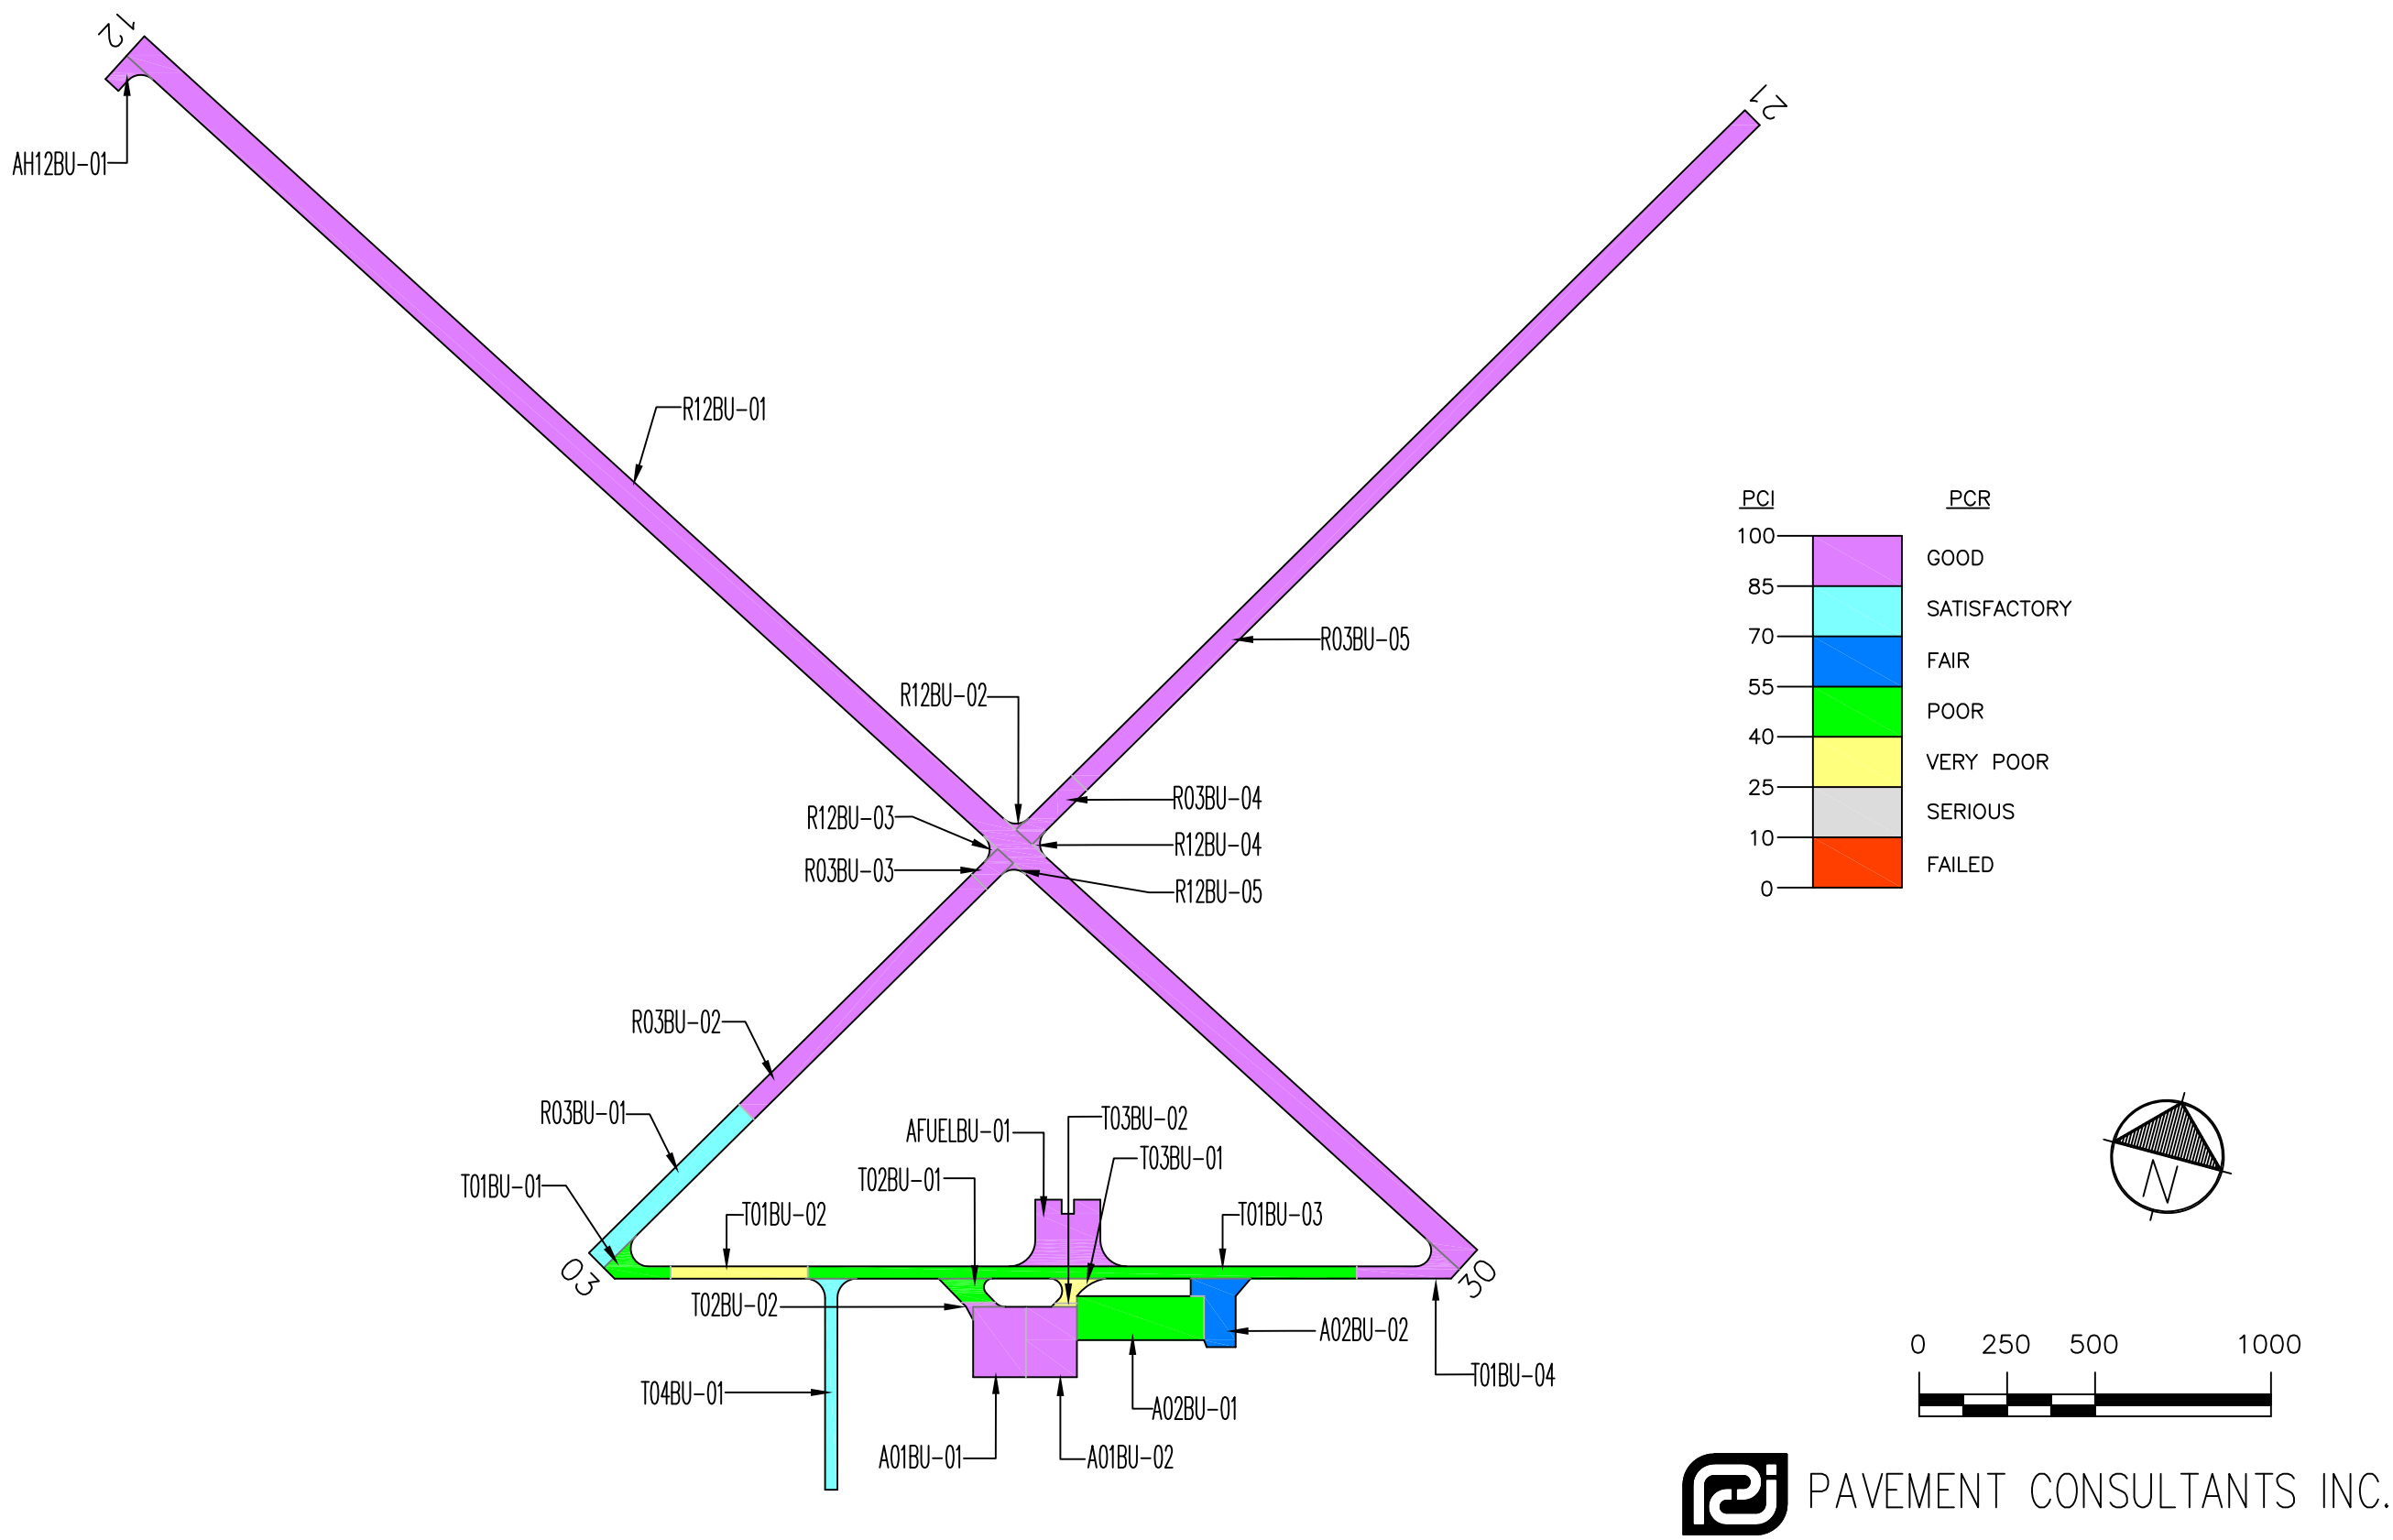
Figure BU-3. Pavement Condition in July 2014.
Burns Municipal Airport

Section PCIs at Burns Municipal Airport range from a low of 31 (a PCR of “Very Poor”) to a high of 100 (a PCR of “Good”). The area-weighted average PCI for all airport pavements is 86, corresponding to an overall PCR of “Good”. Figure BU-4 shows how much pavement area is associated with each Pavement Condition Rating category and also shows pavement condition distribution from the inspections conducted in 2006 and 2011.

The primary distresses observed during the inspection of asphalt concrete pavements were: longitudinal and transverse cracking, weathering, alligator cracking and block cracking, with isolated occurrences of depressions, patching, bleeding and oil spills. The primary distresses observed during the inspection of portland cement concrete pavements were: joint seal damage, joint spalls, corner spalls and small patches, with isolated occurrences of corner breaks, shrinkage cracks, scaling and linear cracks.
