CASCADE LOCKS STATE AIRPORT

This report describes how your Pavement Maintenance Management Program (PMMP) was developed. Your Program was developed as part of the Oregon Continuous Aviation System Plan sponsored in part by the Oregon Department of Aviation and the Federal Aviation Administration (FAA). The information and data contained in this report ensures you are in compliance with the requirements of FAA Grant Assurance Number 11 which states that any airport requesting federal funds for pavement improvement projects must have implemented a pavement maintenance management program.

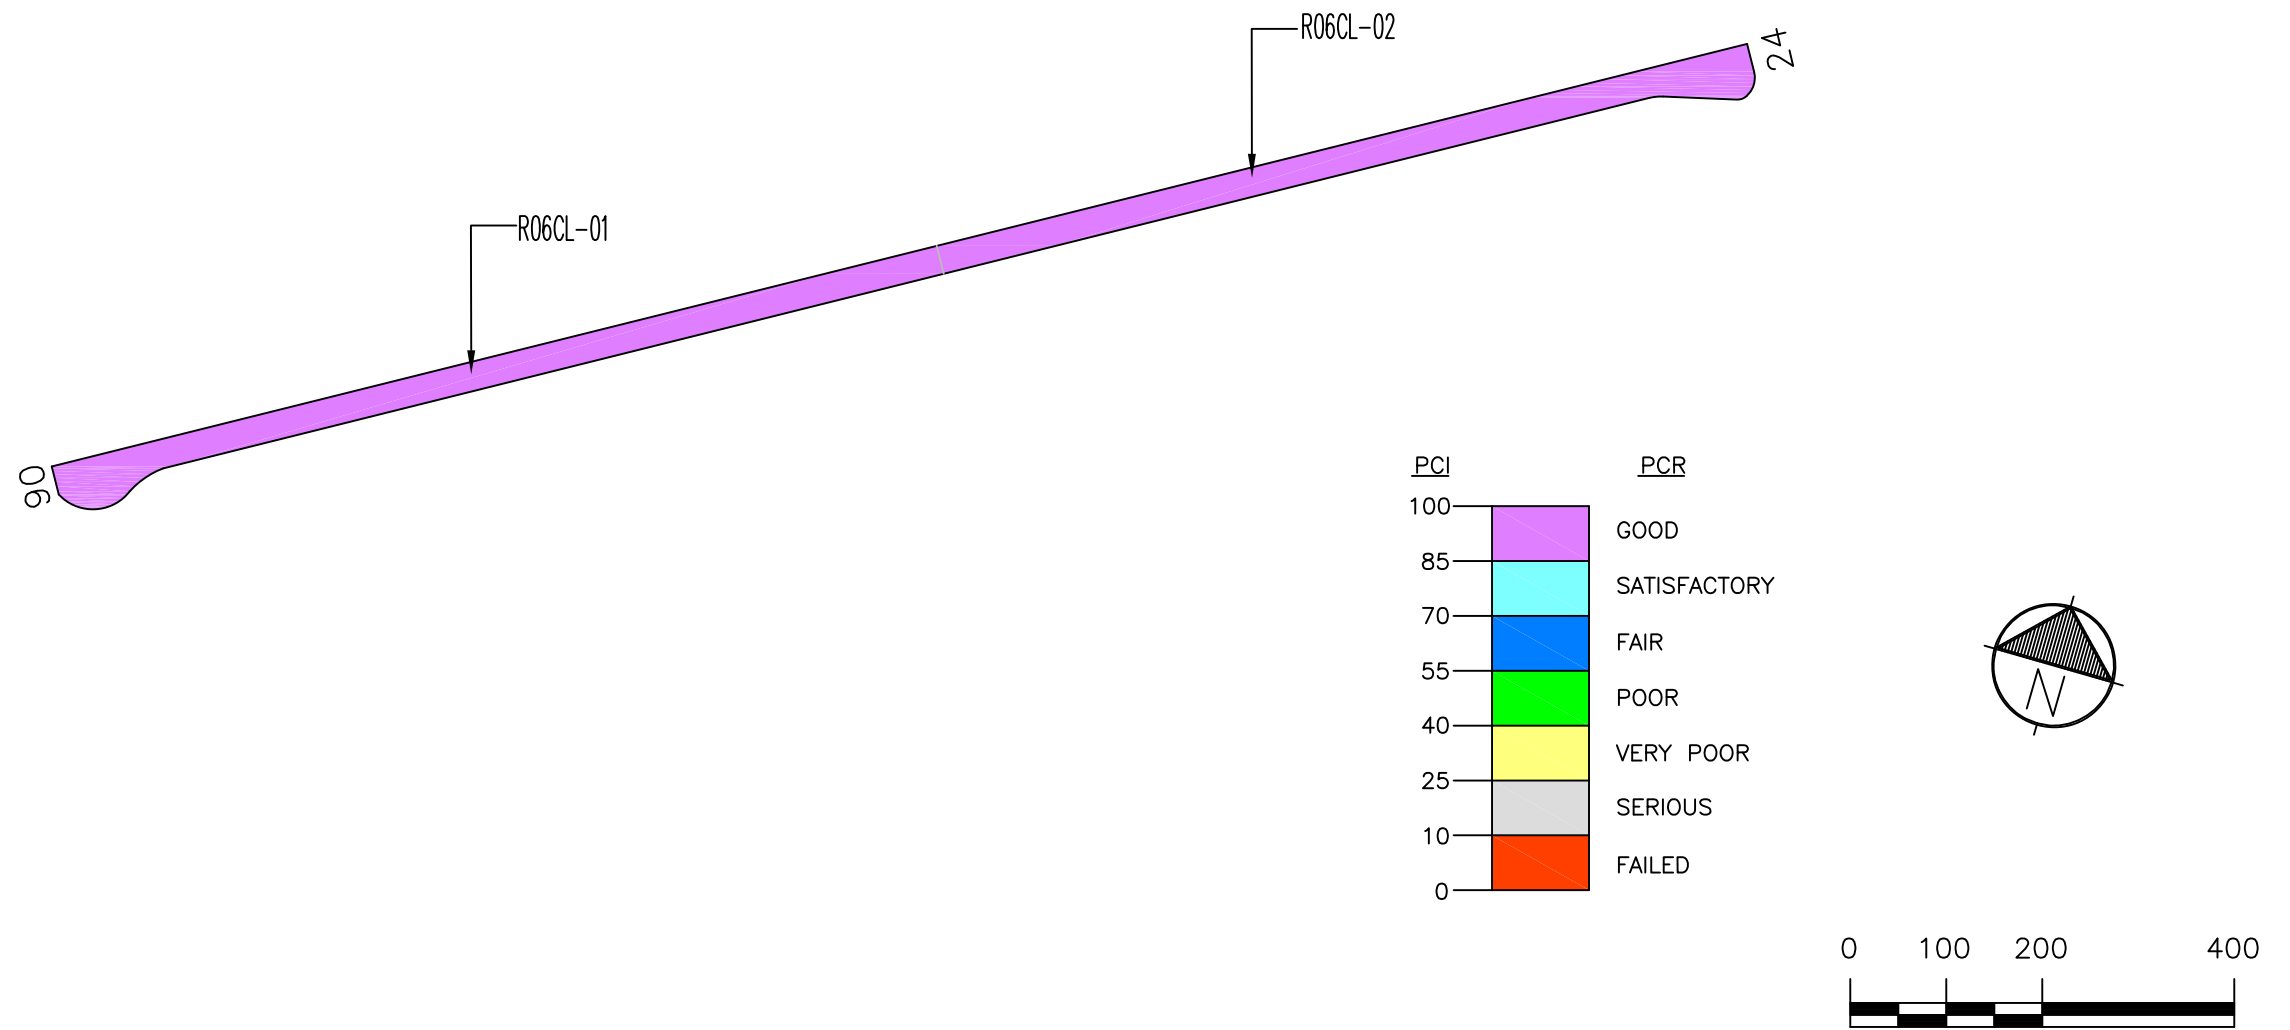
Figure CL-3. Pavement Condition in June 2014.
Cascade Locks State Airport

The Branch Condition Report in Appendix 1 summarizes current pavement condition by branch while the Section Condition Report in Appendix 2 lists pavement condition by section. The current PCR is shown graphically in Figure CL-3.

Section PCIs at Cascade Locks State Airport range from a low of 92 (a PCR of "Good") to a high of 95 (a PCR of "Good"). The area-weighted average PCI for all airport pavements is 94, corresponding to an overall PCR of "Good". Figure CL-4 shows how much pavement area is associated with each Pavement Condition Rating category and also shows pavement condition distribution from the inspections conducted in 2006 and 2011.

The primary distress observed during the inspection was longitudinal and transverse cracking.

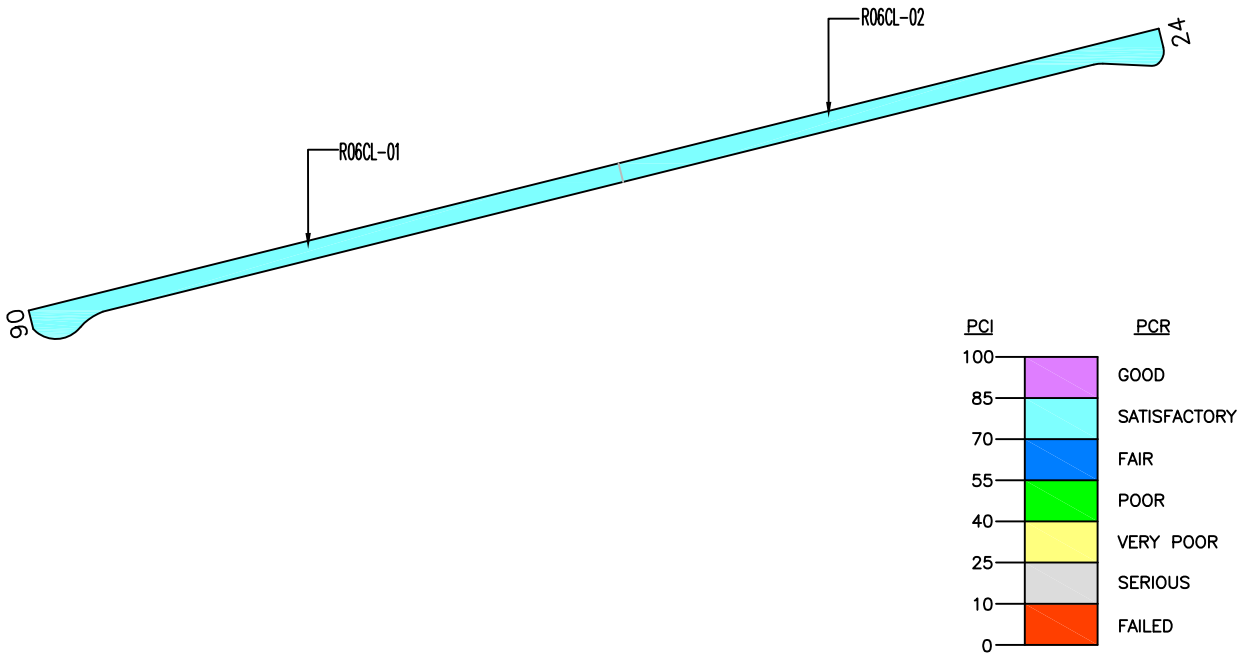
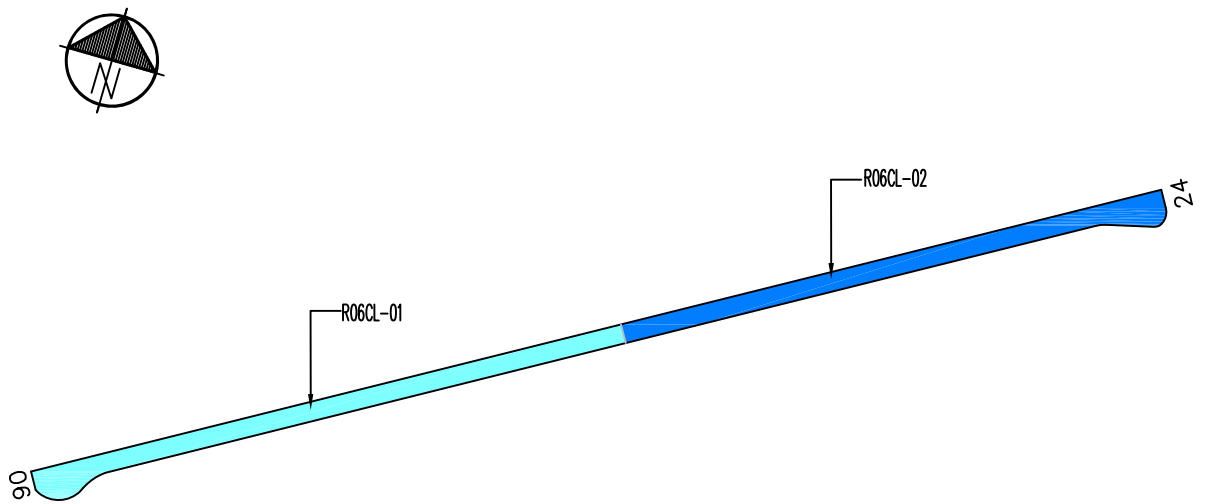
Figure CL-5. Future Pavement Condition.

Branch	Section	Inspections			Forecast	
		2006	2011	2014	2019	2024
R06CL	01	100	97	95	84	73
R06CL	02	98	91	92	81	70

A graphical representation of the projected PCIs listed in Table 1 is shown in Figure CL-5.
