# CONDON STATE AIRPORT

This report describes how your Pavement Maintenance Management Program (PMMP) was developed. Your Program was developed as part of the Oregon Continuous Aviation System Plan sponsored in part by the Oregon Department of Aviation and the Federal Aviation Administration (FAA). The information and data contained in this report ensures you are in compliance with the requirements of FAA Grant Assurance Number 11 which states that any airport requesting federal funds for pavement improvement projects must have implemented a pavement maintenance management program.

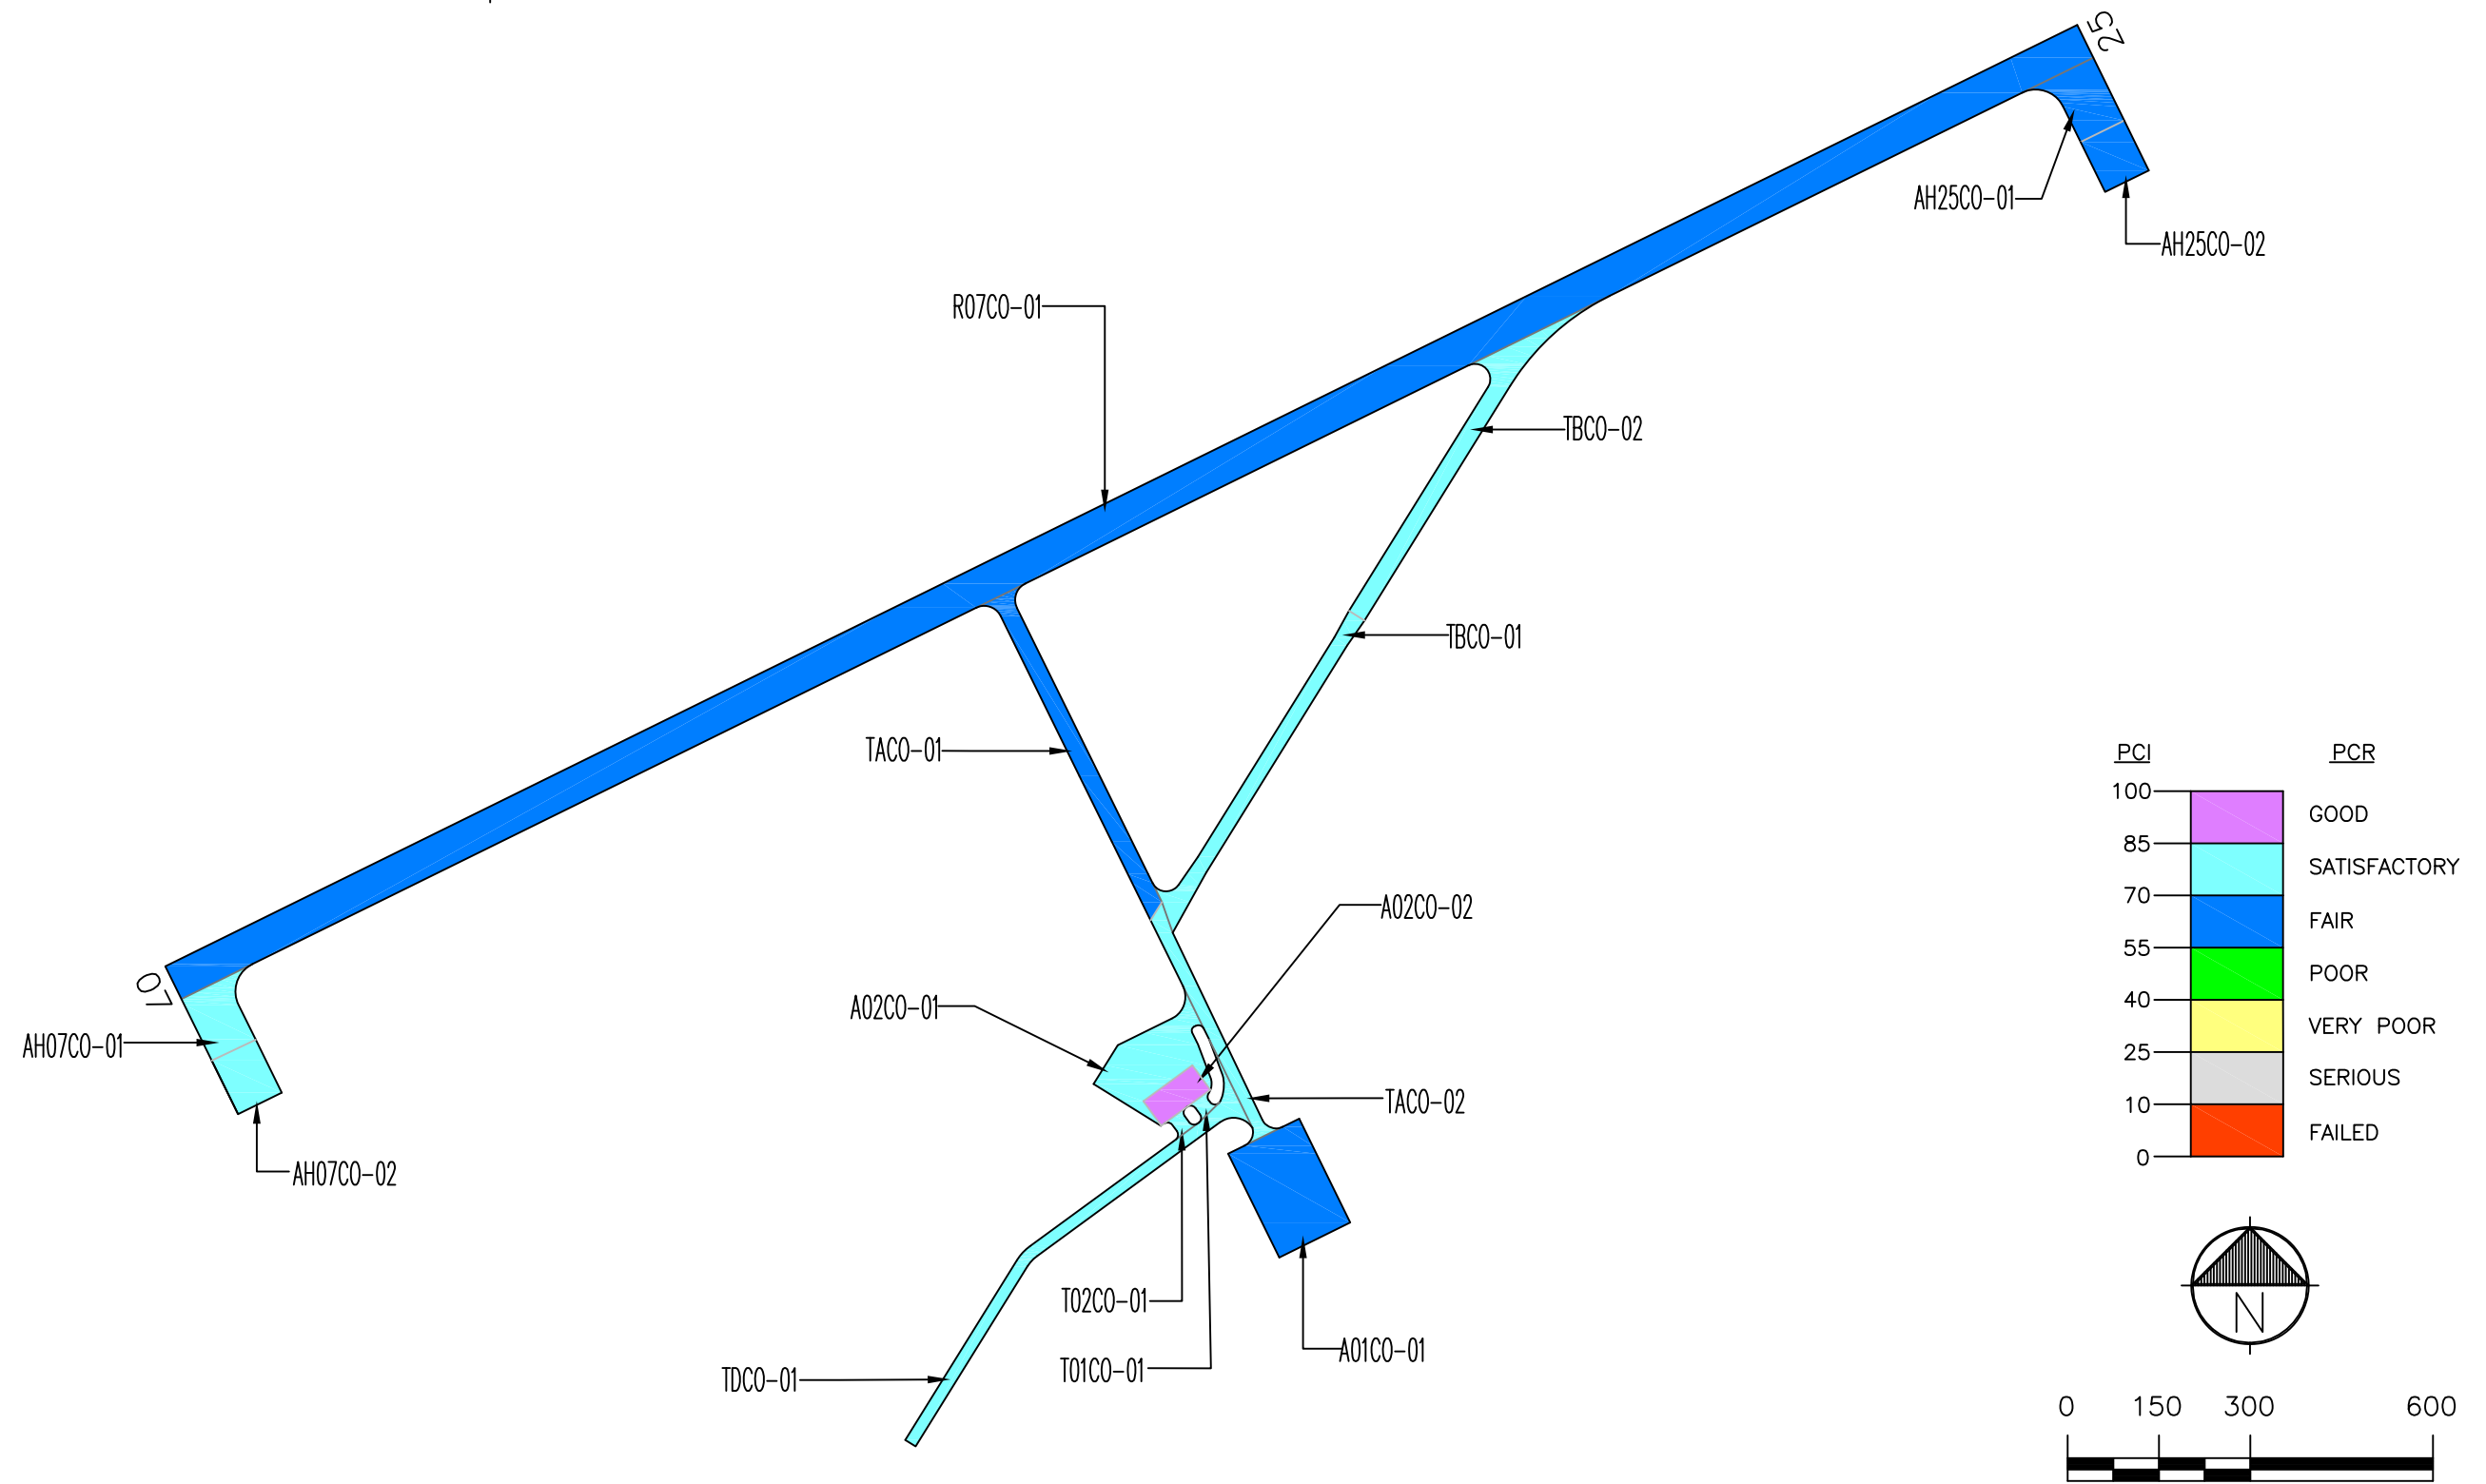
Figure CO-3. Pavement Condition in July 2014.  
 Condon State Airport

The Branch Condition Report in Appendix 1 summarizes current pavement condition by branch while the Section Condition Report in Appendix 2 lists pavement condition by section. The current PCR is shown graphically in Figure CO-3.

Section PCIs at Condon State Airport range from a low of 65 (a PCR of "Fair") to a high of 100 (a PCR of "Good"). The area-weighted average PCI for all airport pavements is 71, corresponding to an overall PCR of "Satisfactory". Figure CO-4 shows how much pavement area is associated with each Pavement Condition Rating category and also shows pavement condition distribution from the inspections conducted in 2006 and 2011.

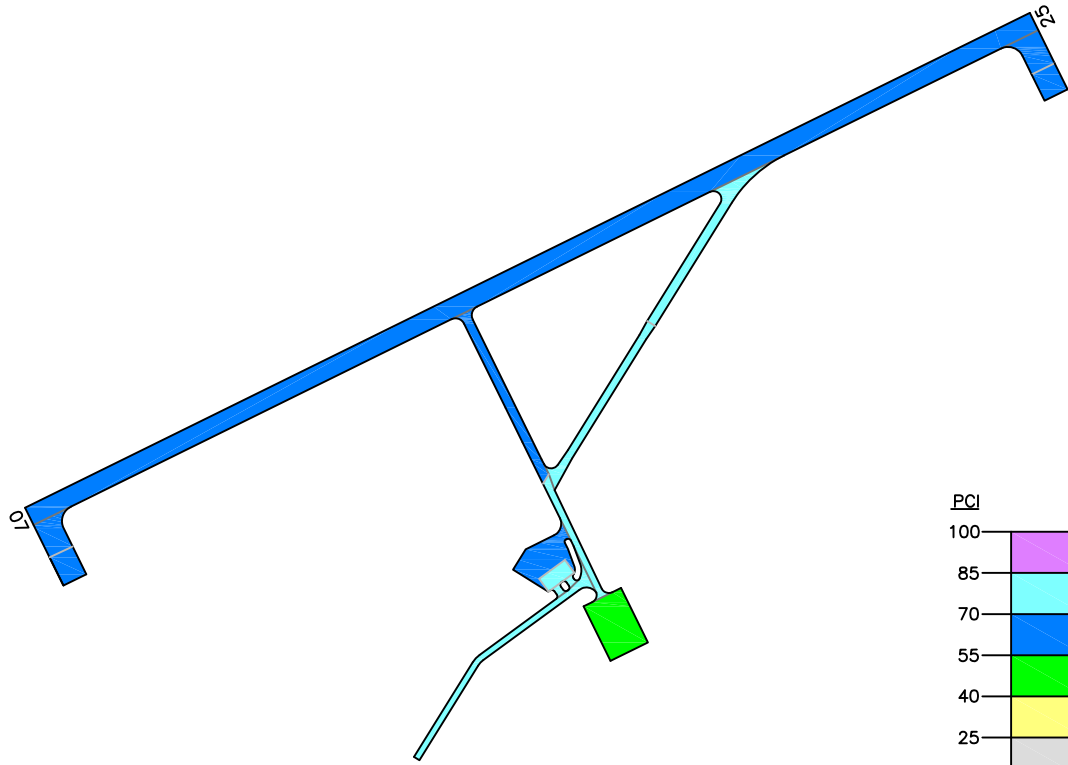
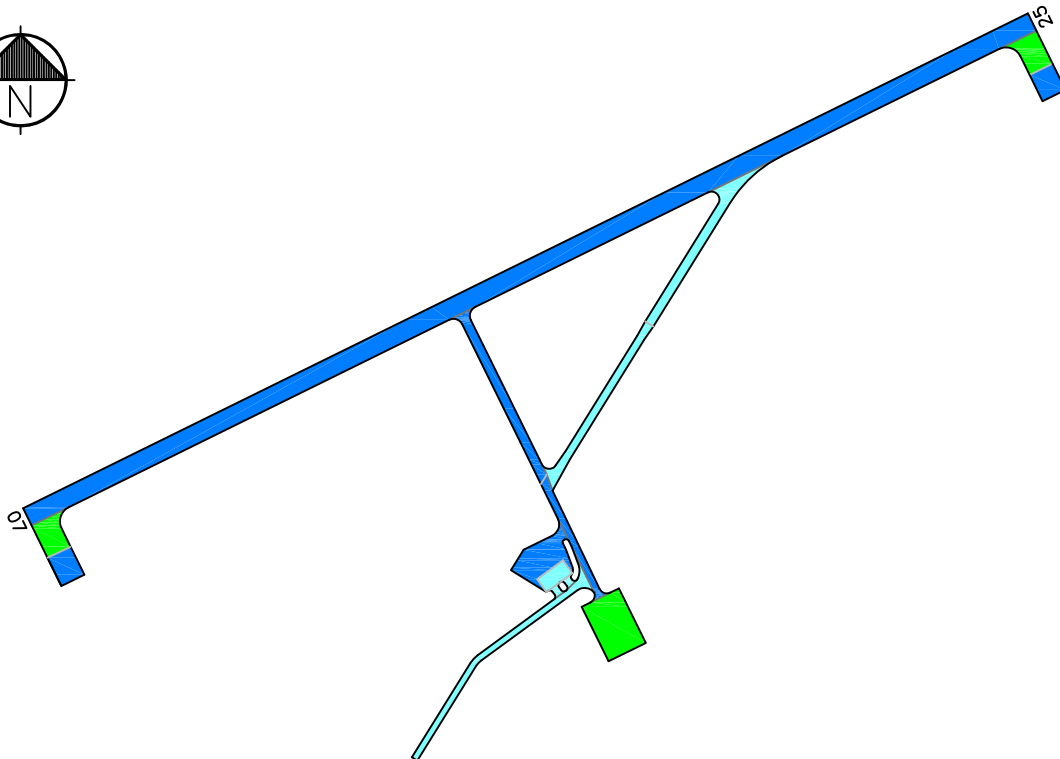
**Figure CO-5. Future Pavement Condition.**

A graphical representation of the projected PCIs listed in Table 1 is shown in Figure CO-5.
