ENTERPRISE MUNICIPAL AIRPORT

This report describes how your Pavement Maintenance Management Program (PMMP) was developed. Your Program was developed as part of the Oregon Continuous Aviation System Plan sponsored in part by the Oregon Department of Aviation and the Federal Aviation Administration (FAA). The information and data contained in this report ensures you are in compliance with the requirements of FAA Grant Assurance Number 11 which states that any airport requesting federal funds for pavement improvement projects must have implemented a pavement maintenance management program.

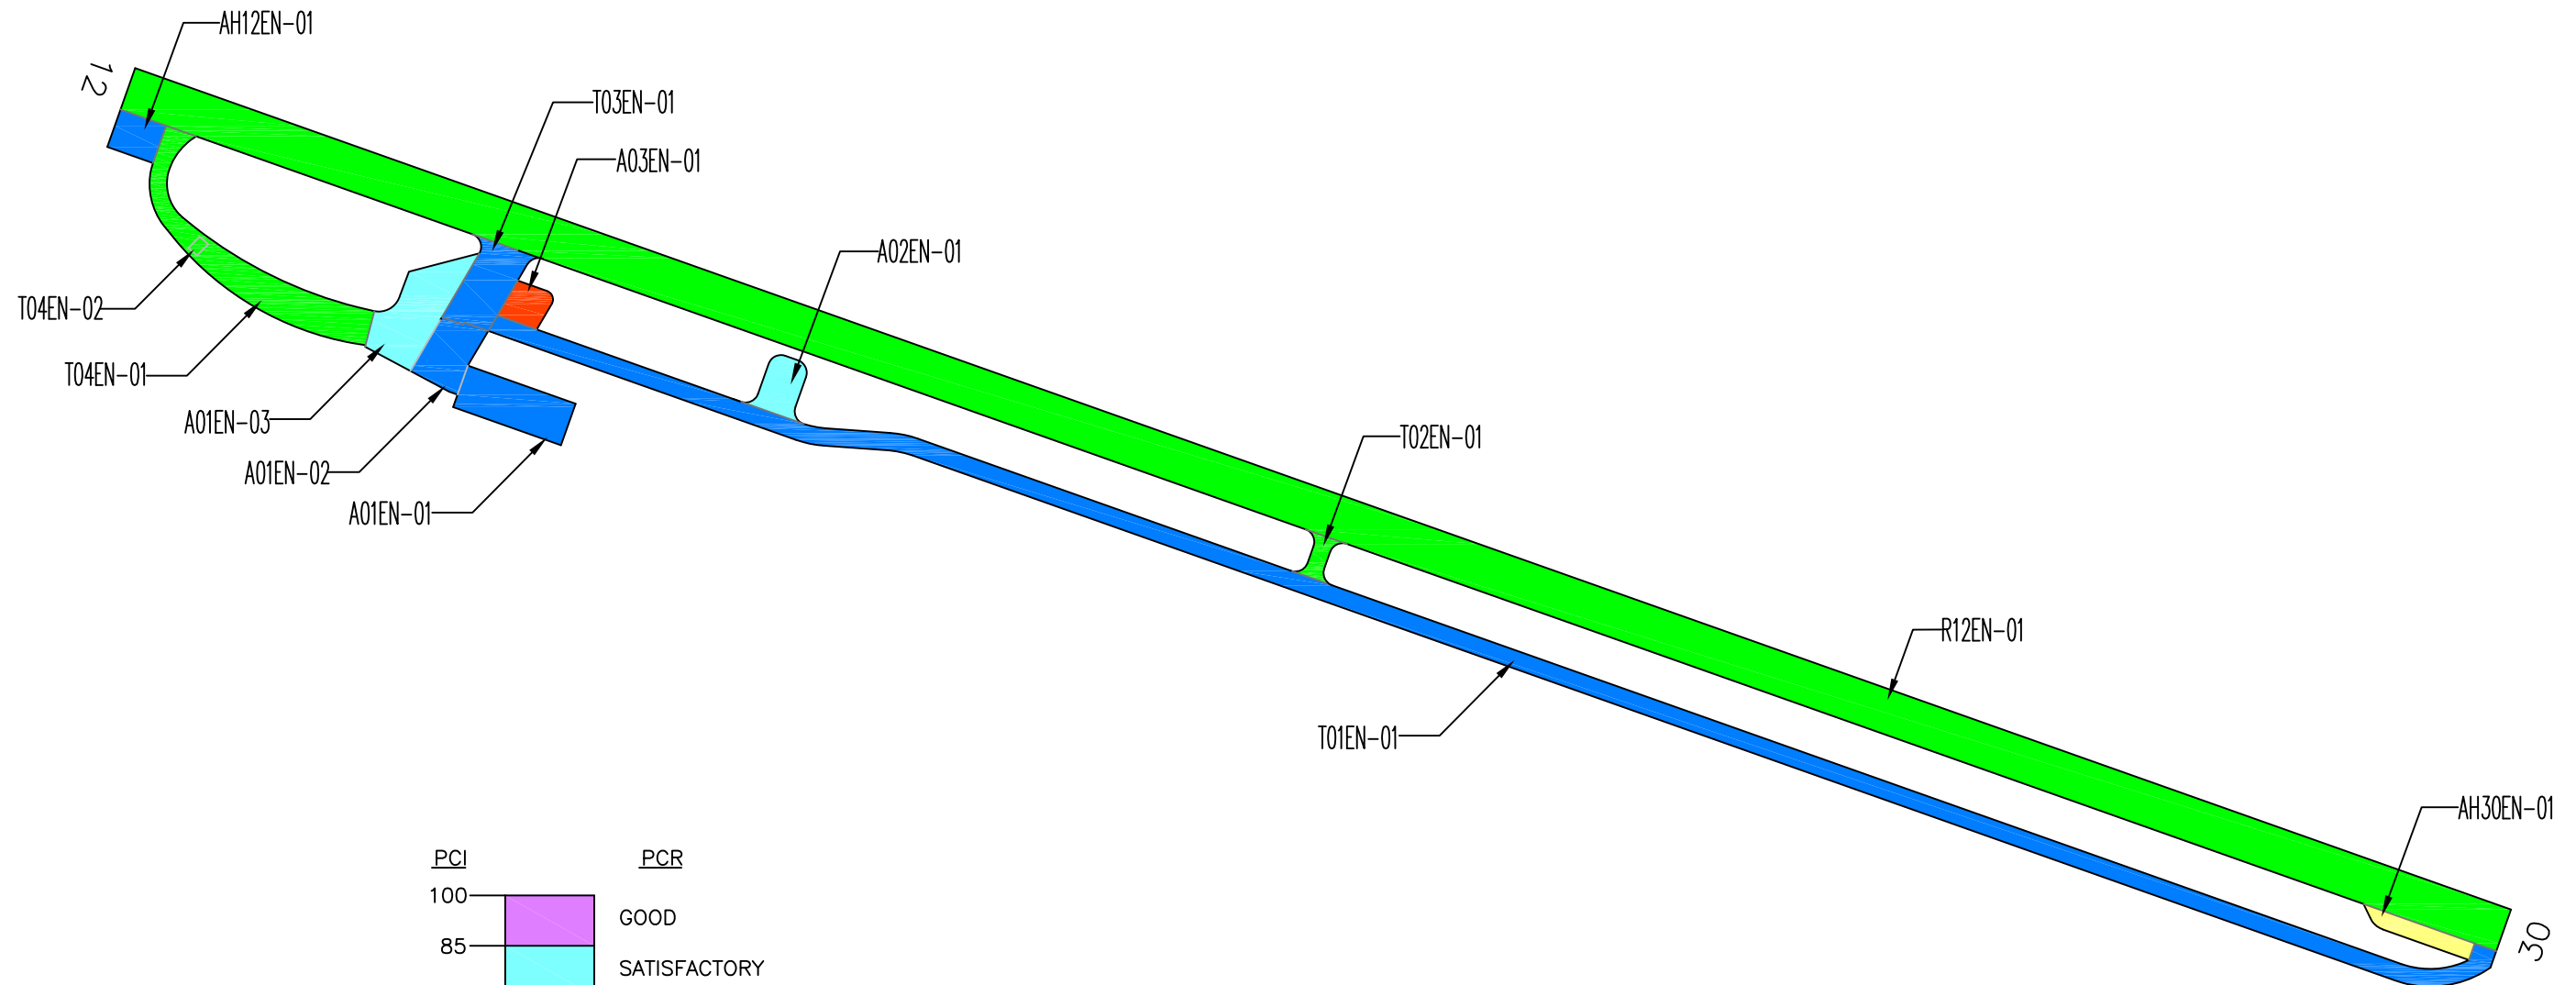
Figure EN-3. Pavement Condition in July 2014.
Enterprise Municipal Airport

Section PCIs at Enterprise Municipal Airport range from a low of 5 (a PCR of “Failed”) to a high of 96 (a PCR of “Satisfactory”). The area-weighted average PCI for all airport pavements is 58, corresponding to an overall PCR of “Fair”. Figure EN-4 shows how much pavement area is associated with each Pavement Condition Rating category and also shows pavement condition distribution from the inspections conducted in 2006 and 2011.

The primary distresses observed during the inspection of asphalt concrete pavements were: weathering, longitudinal and transverse cracking, block cracking, depressions, alligator cracking, bleeding, and patching with isolated occurrences of raveling. The primary distress observed during the inspection of portland cement concrete pavement was shattered slab.

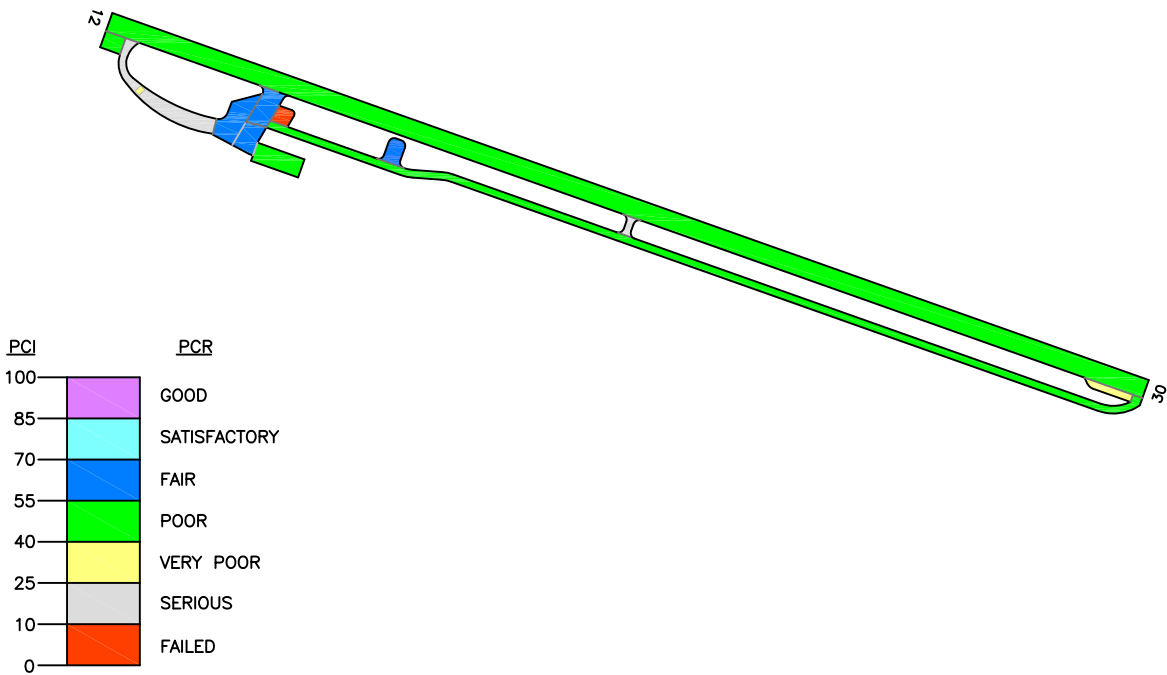
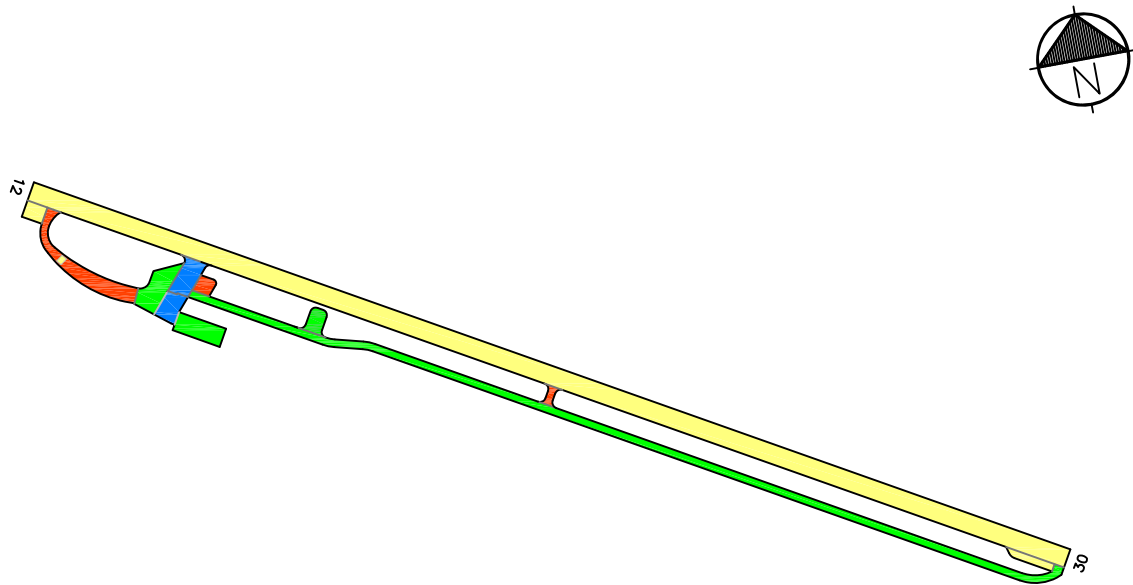
Figure EN-5. Future Pavement Condition.

A graphical representation of the projected PCIs listed in Table 1 is shown in Figure EN-5.
