# JOSEPH STATE AIRPORT

This report describes how your Pavement Maintenance Management Program (PMMP) was developed. Your Program was developed as part of the Oregon Continuous Aviation System Plan sponsored in part by the Oregon Department of Aviation and the Federal Aviation Administration (FAA). The information and data contained in this report ensures you are in compliance with the requirements of FAA Grant Assurance Number 11 which states that any airport requesting federal funds for pavement improvement projects must have implemented a pavement maintenance management program.

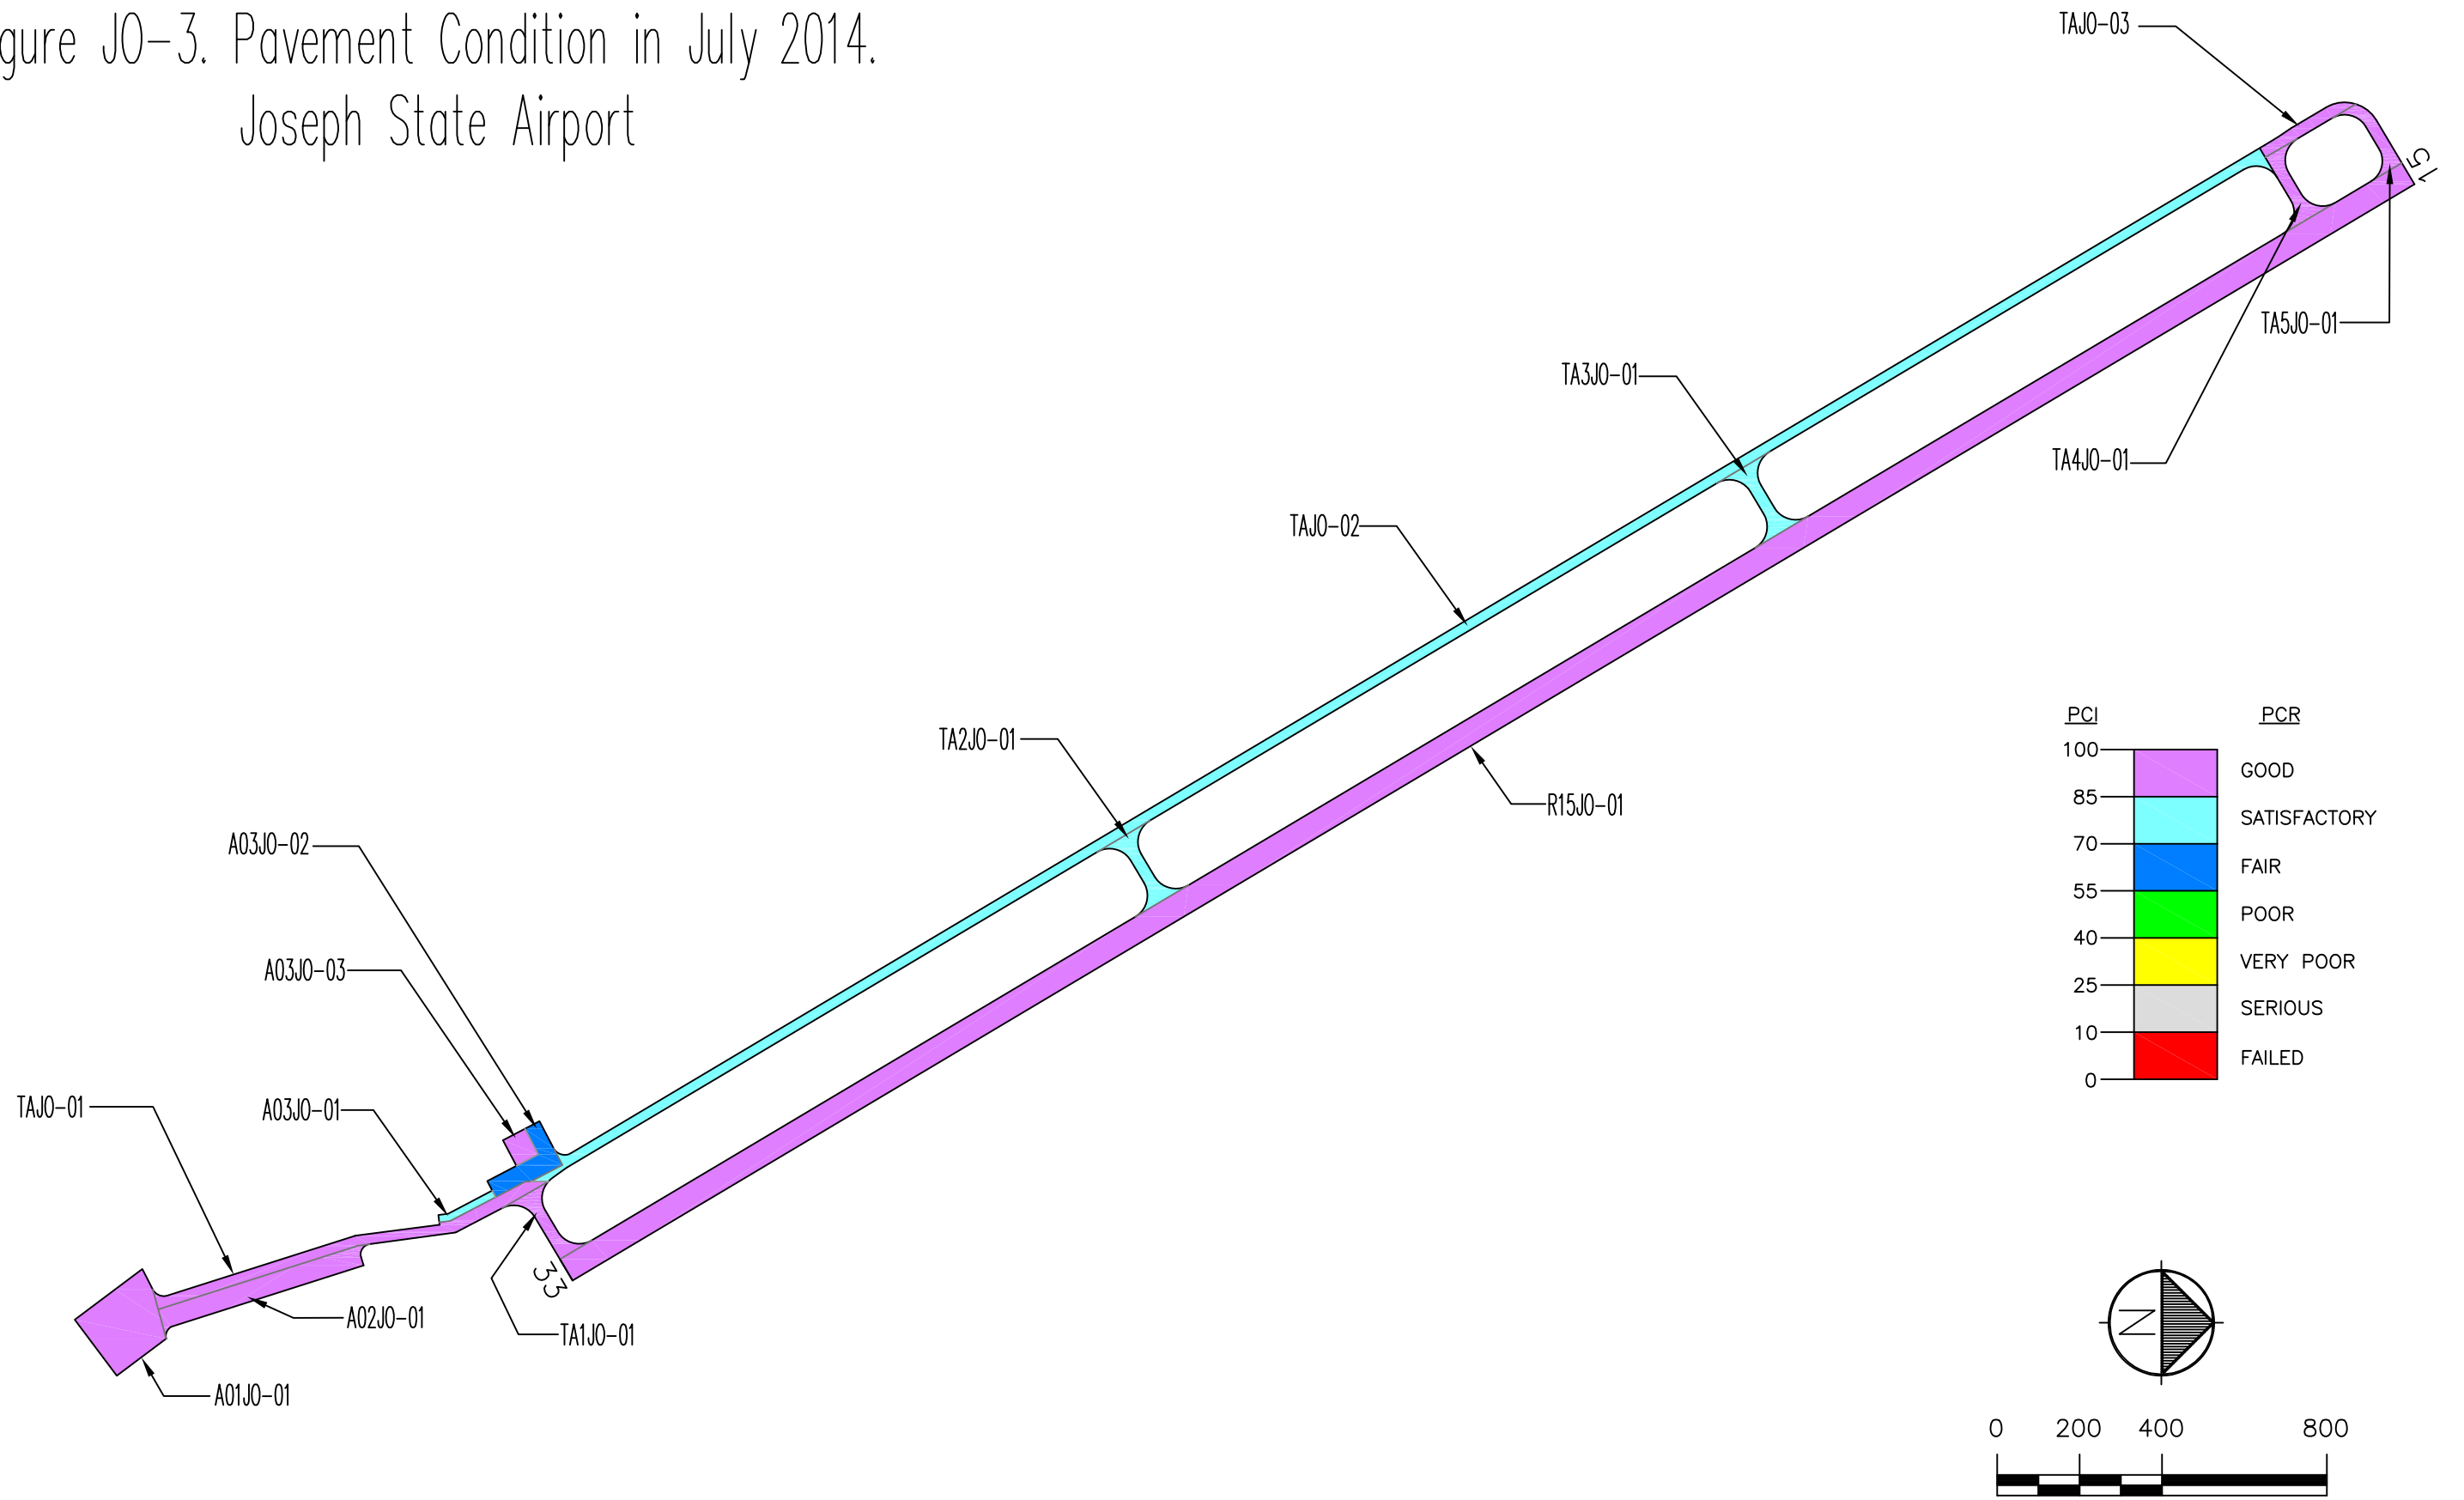
Figure J0-3. Pavement Condition in July 2014.  
Joseph State Airport

Section PCIs at Joseph State Airport range from a low of 62 (a PCR of "Fair") to a high of 100 (a PCR of "Good"). The area-weighted average PCI for all airport pavements is 92, corresponding to an overall PCR of "Good". Figure JO-4 shows how much pavement area is associated with each Pavement Condition Rating category and also shows pavement condition distribution from the inspection conducted in 2006. Joseph State Airport was not inspected in 2011.

The primary distresses observed during the inspection of asphalt concrete pavements were: longitudinal and transverse cracking, weathering and alligator cracking, with an isolated occurrence of raveling. The primary distresses observed during the inspection of portland cement concrete pavements were corner spalls and joint spalls.

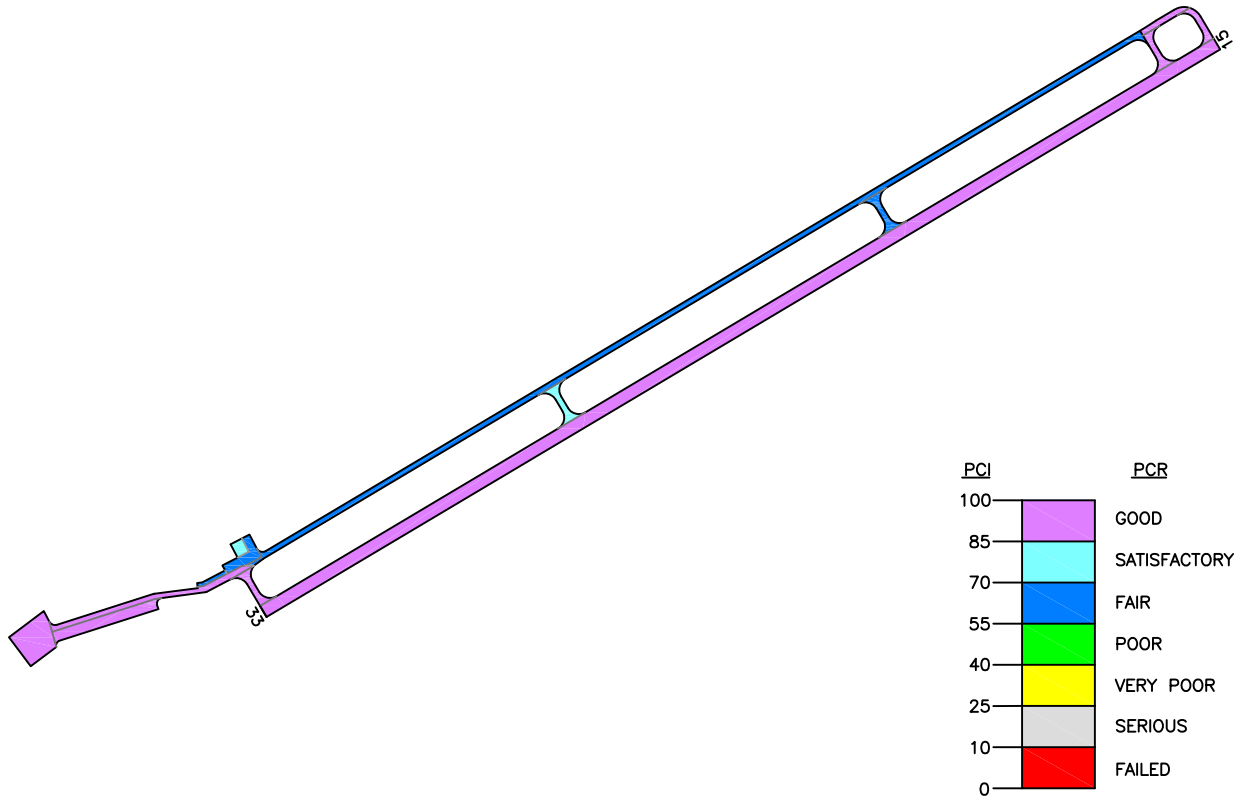
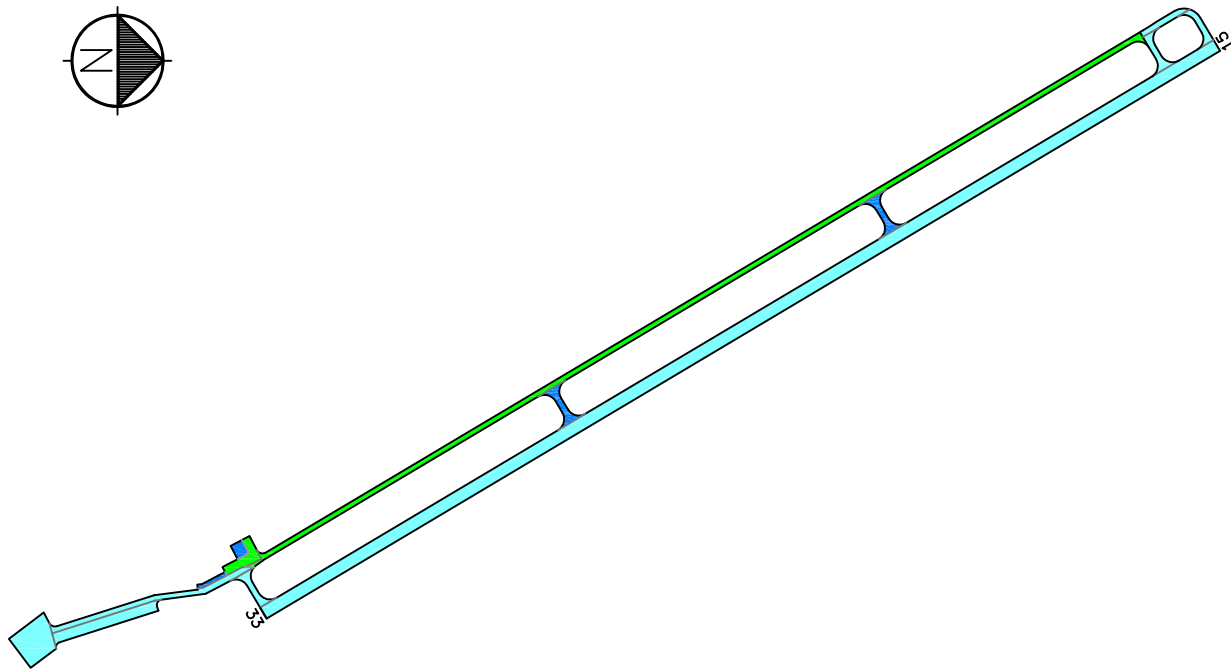
Figure JO-5. Future Pavement Condition.

A graphical representation of the projected PCIs listed in Table 1 is shown in Figure JO-5.
