KEN JERNSTEDT AIRFIELD

This report describes how your Pavement Maintenance Management Program (PMMP) was developed. Your Program was developed as part of the Oregon Continuous Aviation System Plan sponsored in part by the Oregon Department of Aviation and the Federal Aviation Administration (FAA). The information and data contained in this report ensures you are in compliance with the requirements of FAA Grant Assurance Number 11 which states that any airport requesting federal funds for pavement improvement projects must have implemented a pavement maintenance management program.

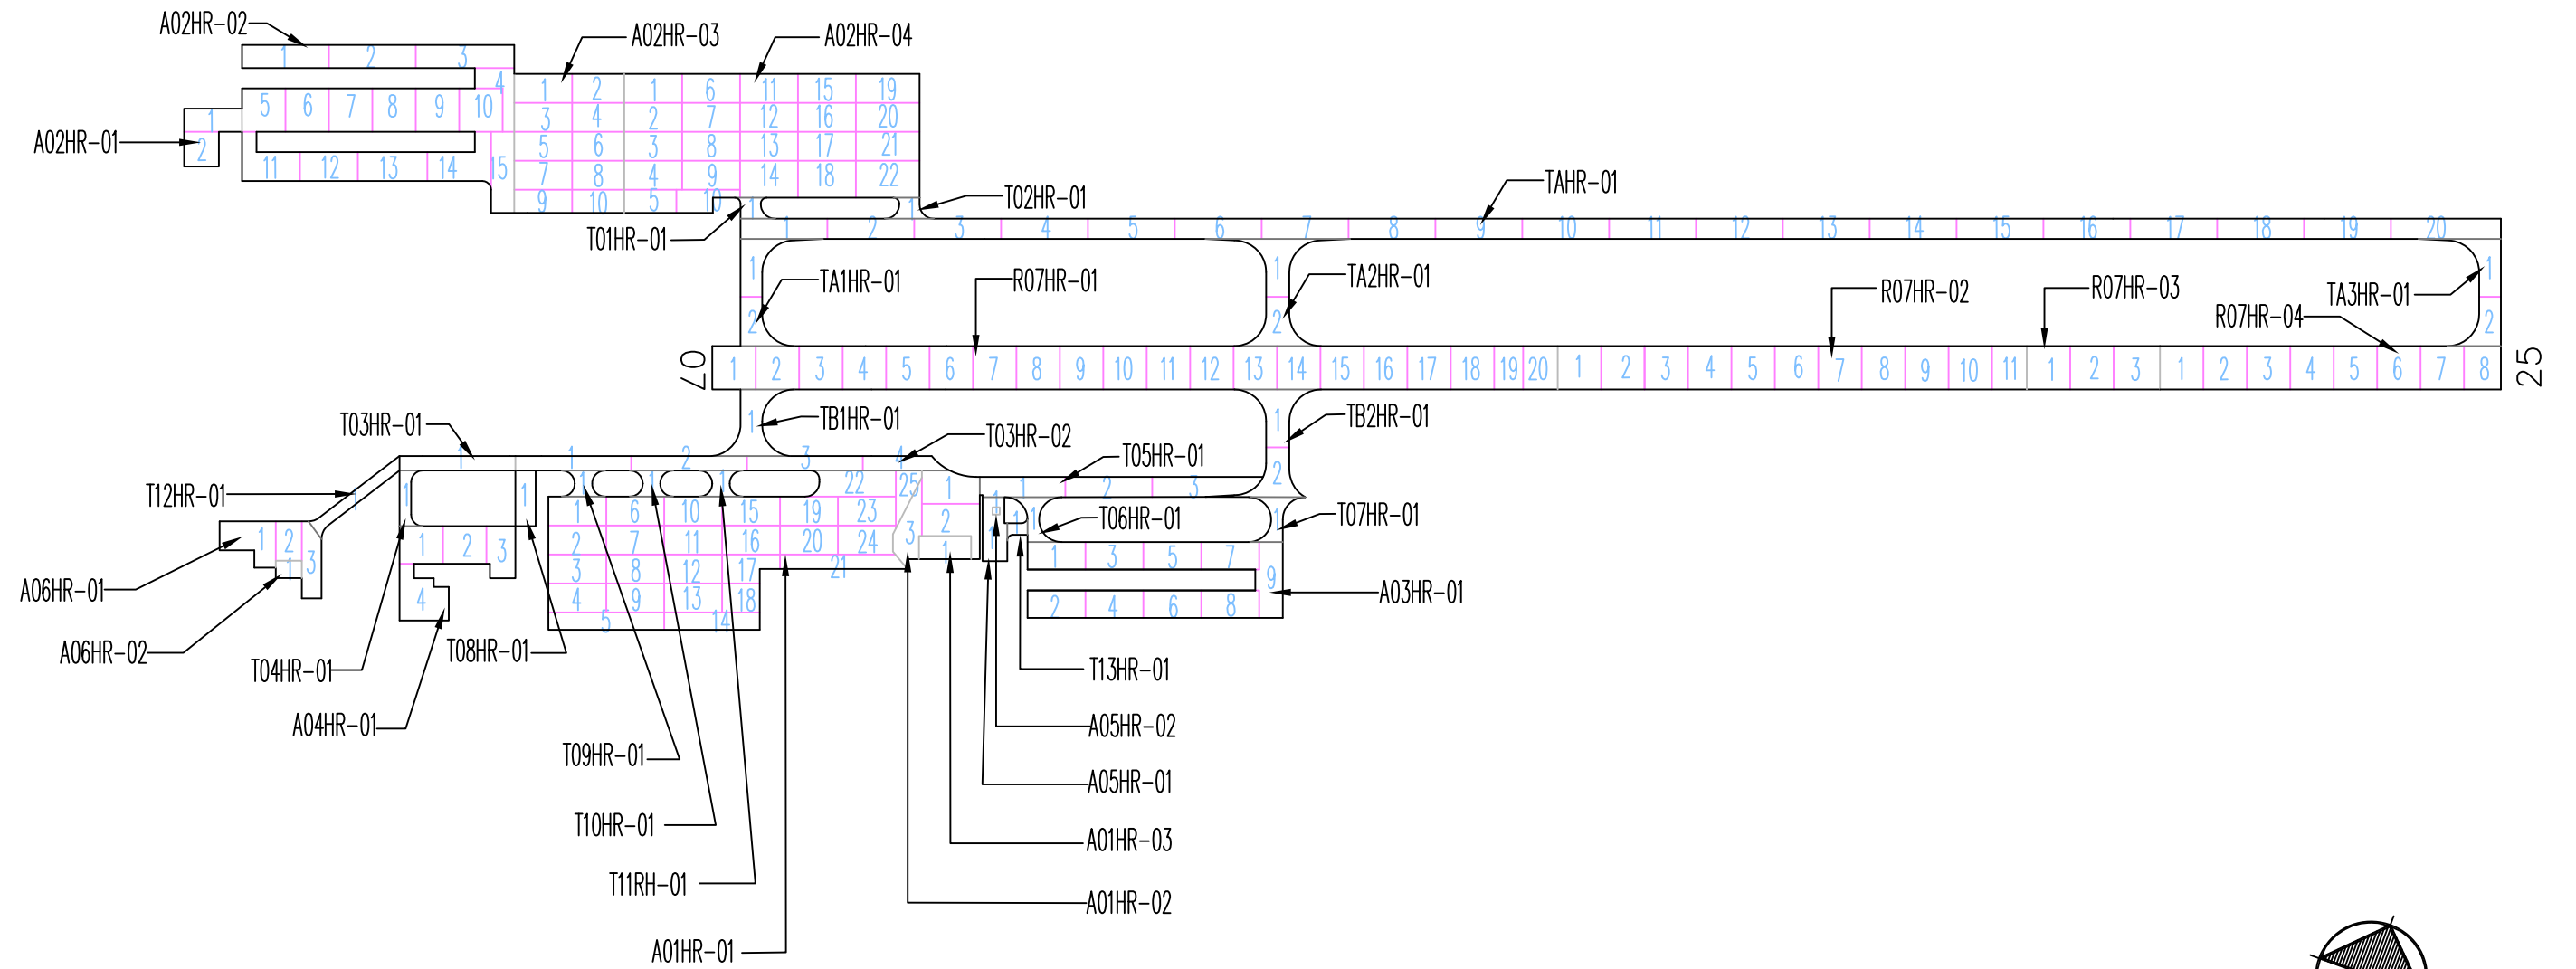
Figure HR-2. Pavement Branch, Section and Sample Unit Layout.
Ken Jernstedt Airfield

The pavements at your airport were divided into branches, sections and sample units in accordance with the methodology outlined in the current edition of ASTM D5430, *Standard Test Method for Airport Condition Index Surveys*. The branches, sections and sample units established at your airport are shown in Figure HR-2. A Branch Condition Report showing all branches, their associated areas, and their area-weighted average condition is provided in Appendix 1. Additionally, the Appendix 2 Section Condition Report provides information used to define each branch and section in the Micro PAVER database.

Using the branch, section and sample unit divisions established, a visual condition survey was conducted at Ken Jernstedt Airfield in July 2014. During the inspection, pavement defects were identified and measured in accordance with the methodology outlined in ASTM D5430. This inspection ensures your airport complies with the “detailed inspection” requirement of FAA’s PMMP guidelines. After collection, the data were entered into the Micro PAVER software for analysis. These data are reproduced in the Re-Inspection Report attached as Appendix 4.

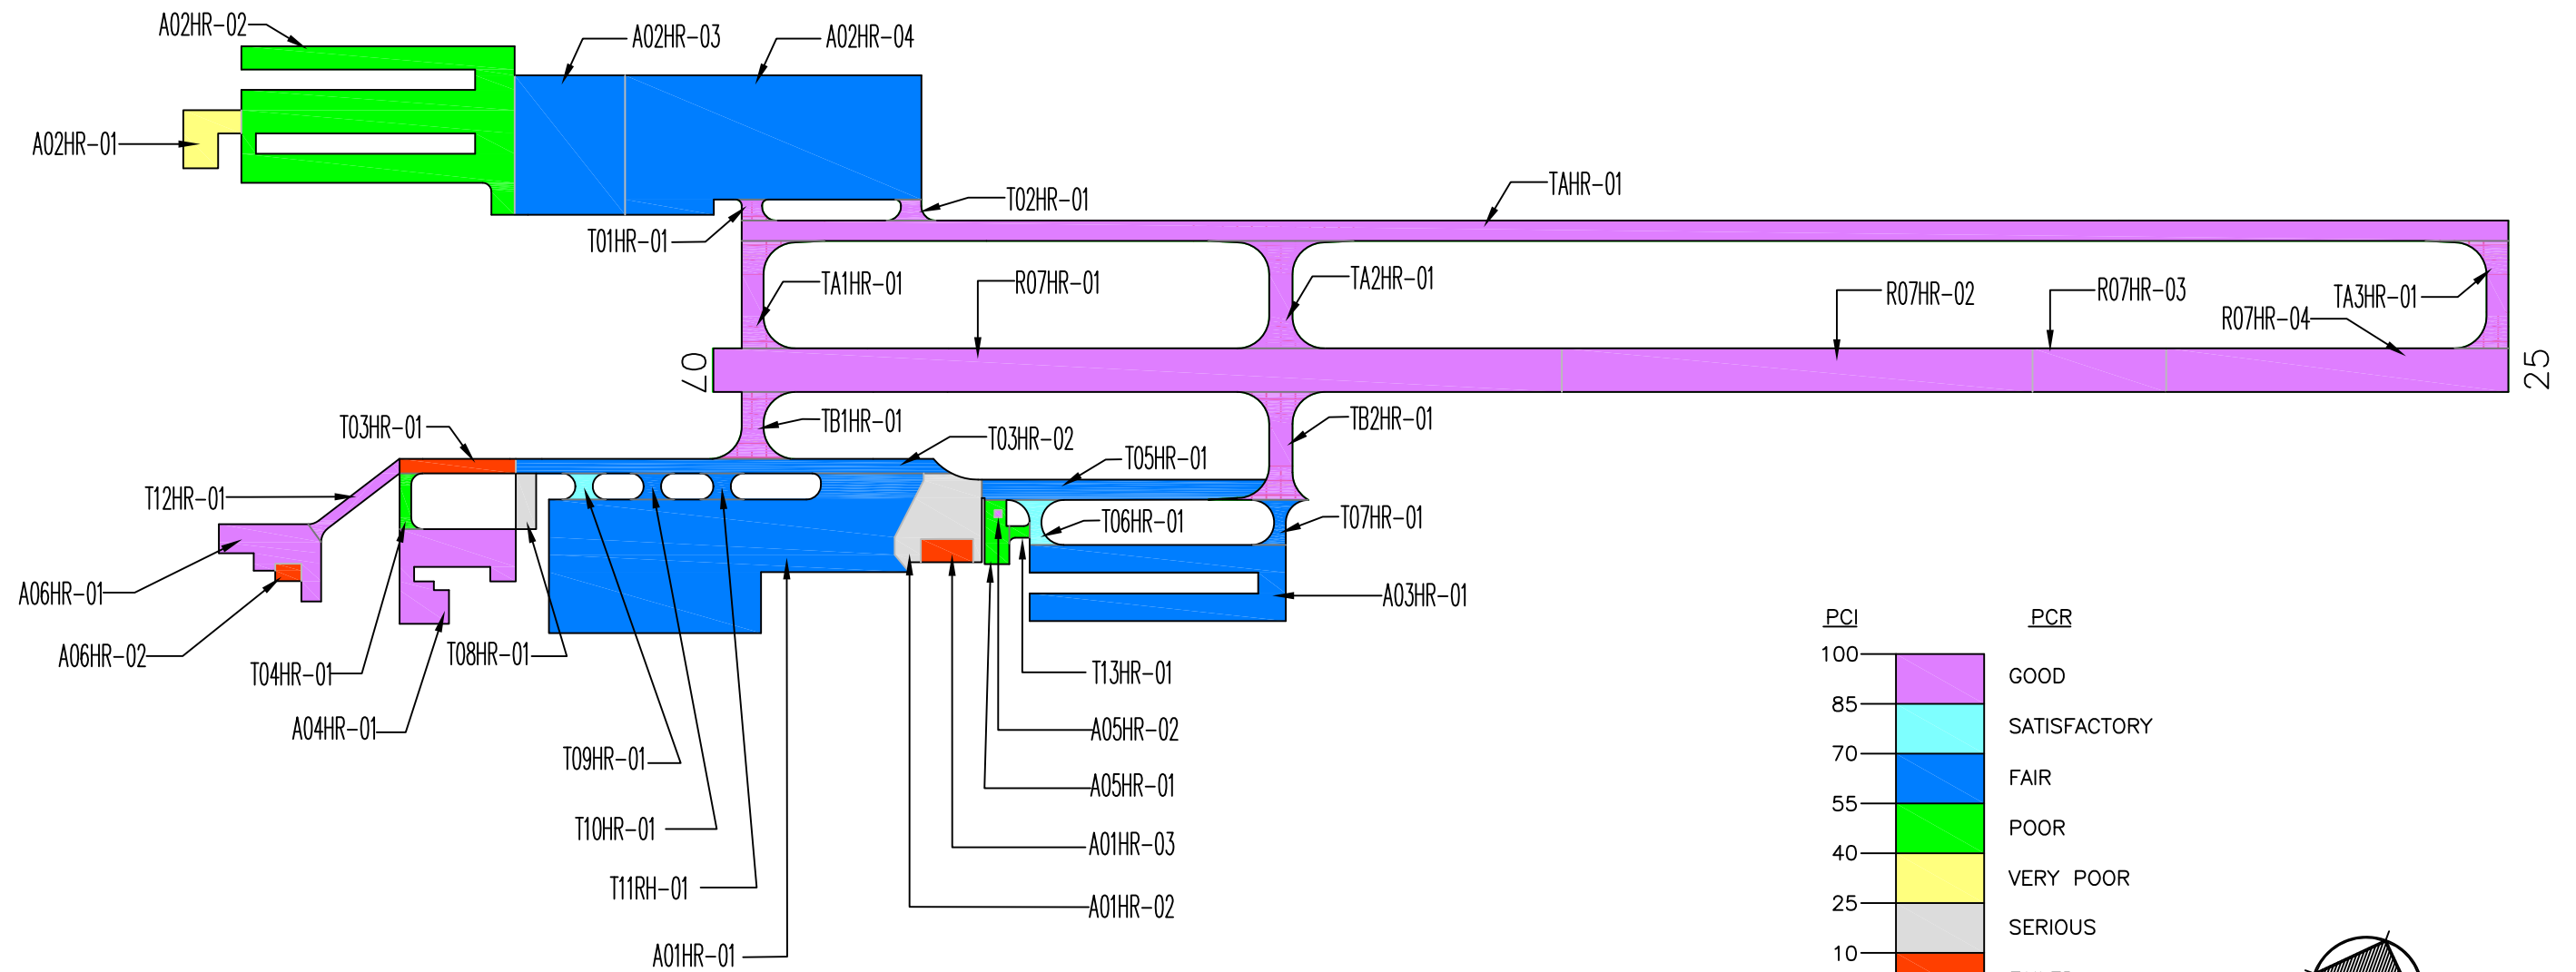
Figure HR-3. Pavement Condition in July 2014.
Ken Jernstedt Airfield

The Branch Condition Report in Appendix 1 summarizes current pavement condition by branch while the Section Condition Report in Appendix 2 lists pavement condition by section. The current PCR is shown graphically in Figure HR-3.

Section PCIs at Ken Jernstedt Airfield range from a low of 0 (a PCR of “Failed”) to a high of 100 (a PCR of “Good”). The area-weighted average PCI for all airport pavements is 76, corresponding to an overall PCR of “Satisfactory”. Figure HR-4 shows how much pavement area is associated with each Pavement Condition Rating category and also shows pavement condition distribution from the inspections conducted in 2006 and 2011.

The primary distresses observed during the inspection of asphalt concrete pavements were: weathering, longitudinal and transverse cracking, block cracking, patching, depressions, alligator cracking and raveling. The primary distresses observed during the inspection of portland cement concrete pavements were: shattered slabs and joint spalls.

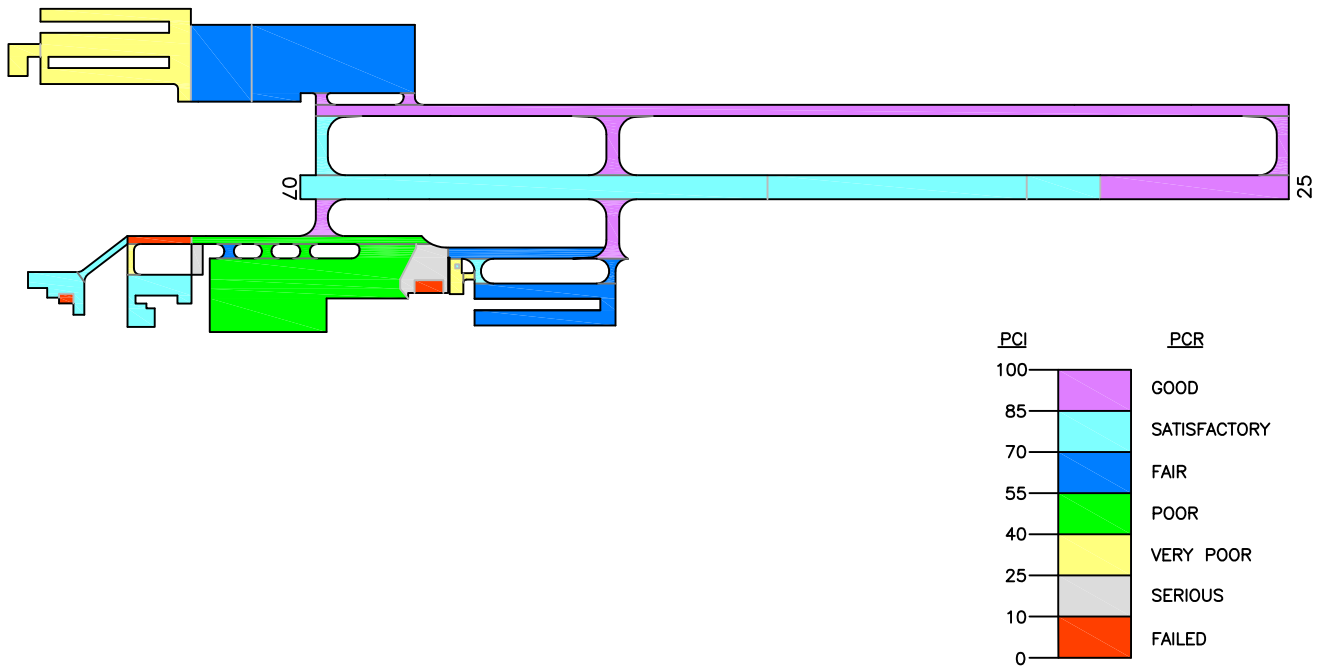
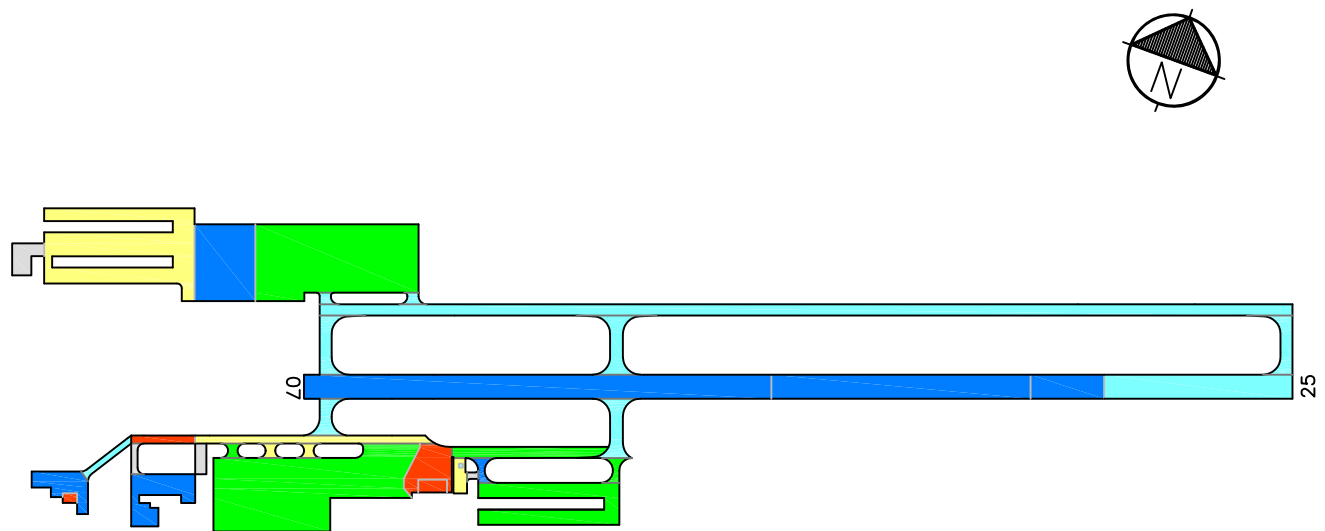
Figure HR-5. Future Pavement Condition.

A graphical representation of the projected PCIs listed in Table 1 is shown in Figure HR-5.
