# LEXINGTON AIRPORT

This report describes how your Pavement Maintenance Management Program (PMMP) was developed. Your Program was developed as part of the Oregon Continuous Aviation System Plan sponsored in part by the Oregon Department of Aviation and the Federal Aviation Administration (FAA). The information and data contained in this report ensures you are in compliance with the requirements of FAA Grant Assurance Number 11 which states that any airport requesting federal funds for pavement improvement projects must have implemented a pavement maintenance management program.

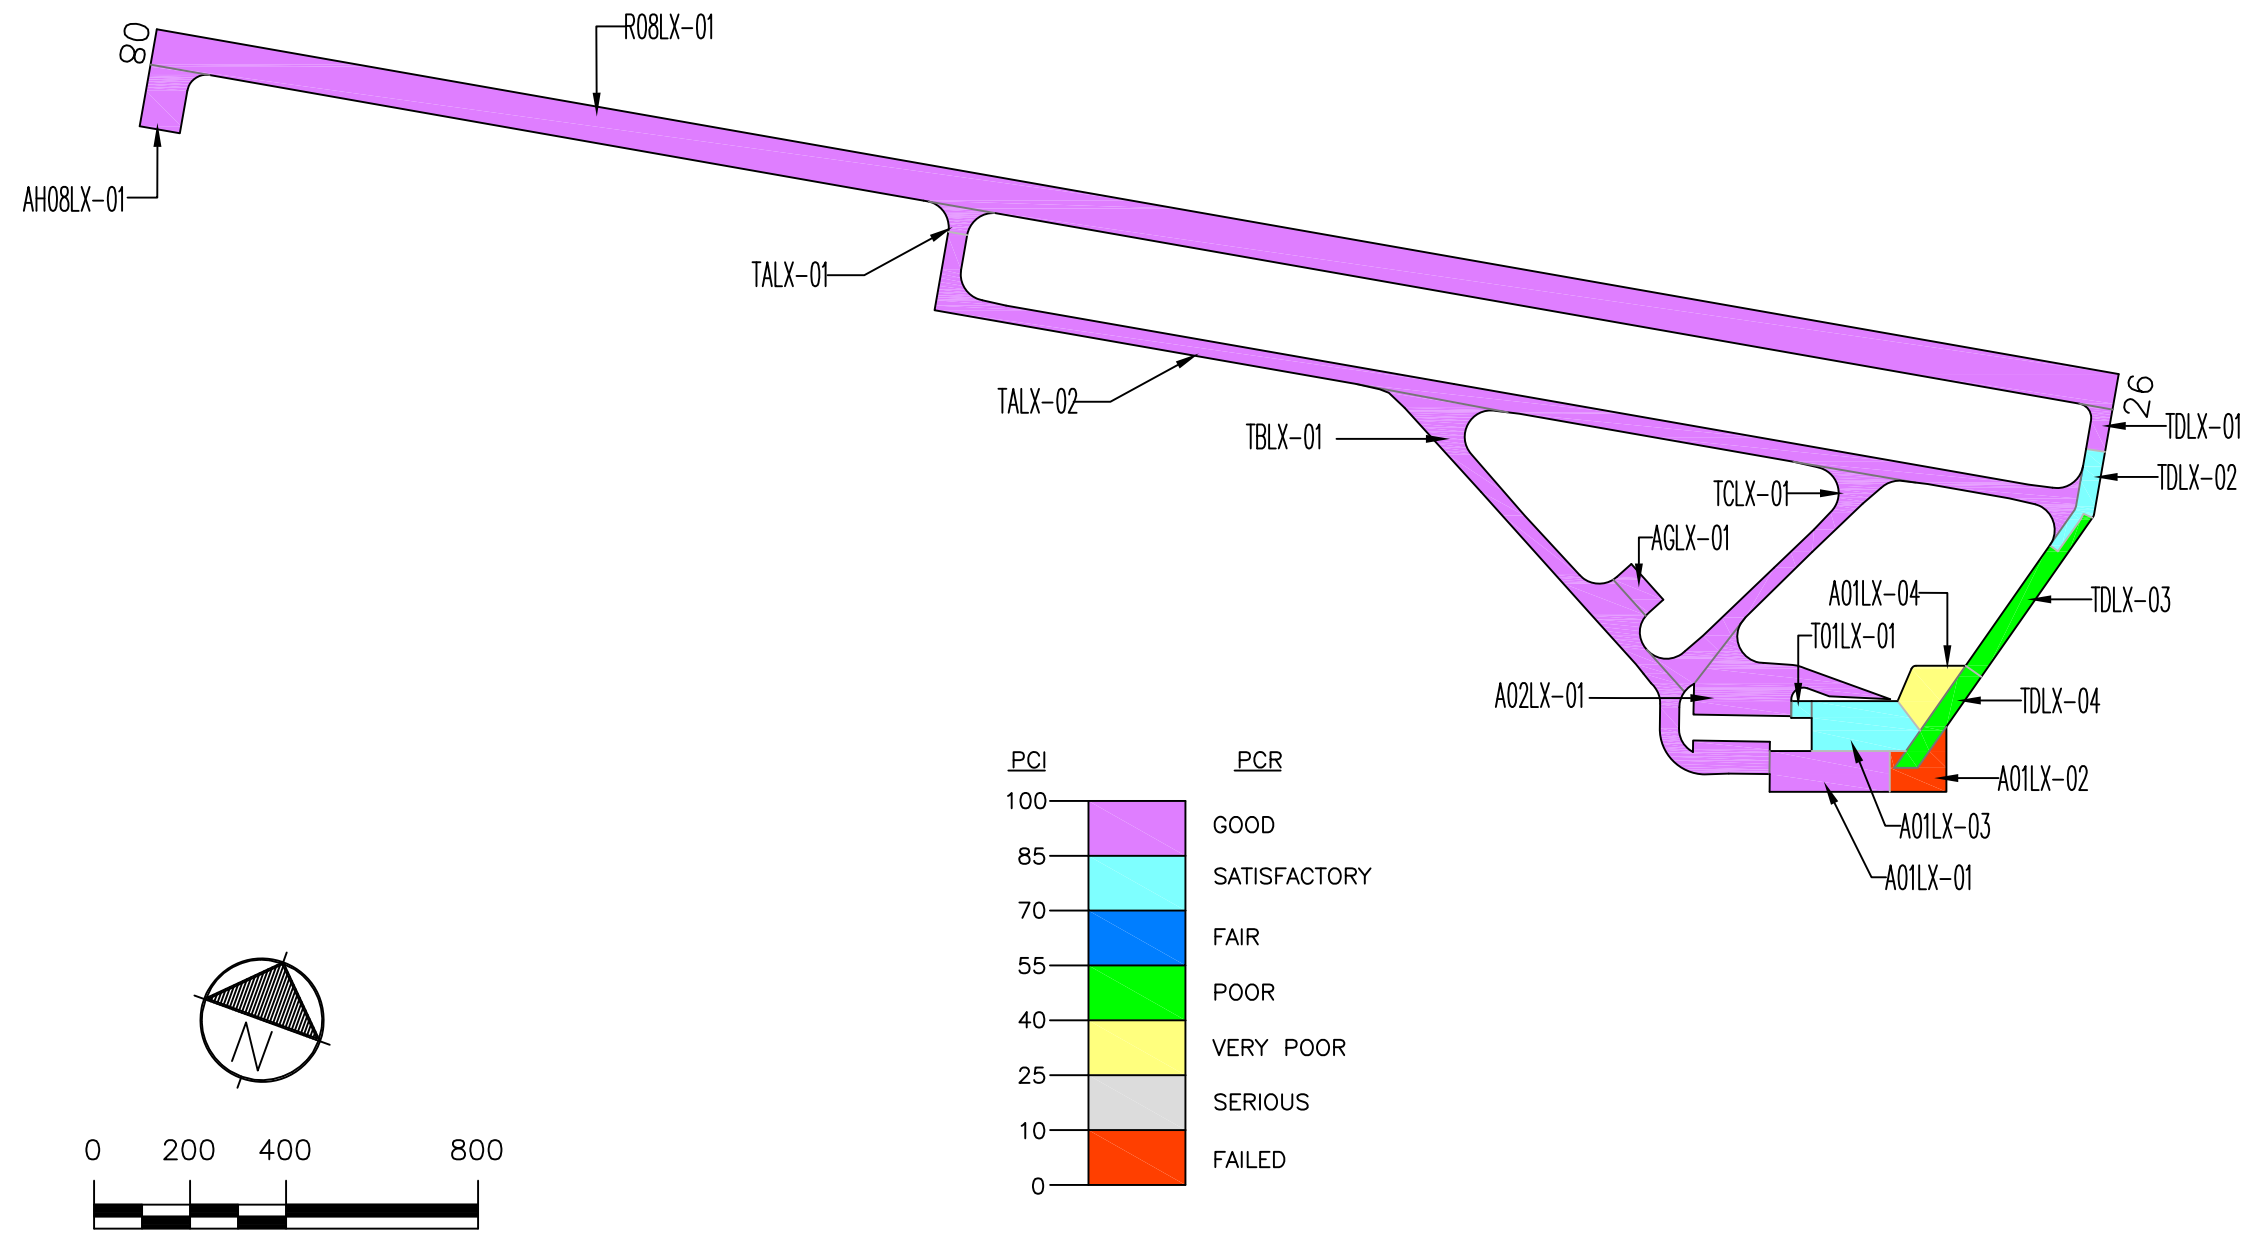
Figure LX-3. Pavement Condition in July 2014.  
Lexington Airport

The Branch Condition Report in Appendix 1 summarizes current pavement condition by branch while the Section Condition Report in Appendix 2 lists pavement condition by section. The current PCR is shown graphically in Figure LX-3.

Section PCIs at Lexington Airport range from a low of 4 (a PCR of "Failed") to a high of 100 (a PCR of "Good"). The area-weighted average PCI for all airport pavements is 93, corresponding to an overall PCR of "Good". Figure LX-4 shows how much pavement area is associated with each Pavement Condition Rating category and also shows pavement condition distribution from the inspections conducted in 2006 and 2011.

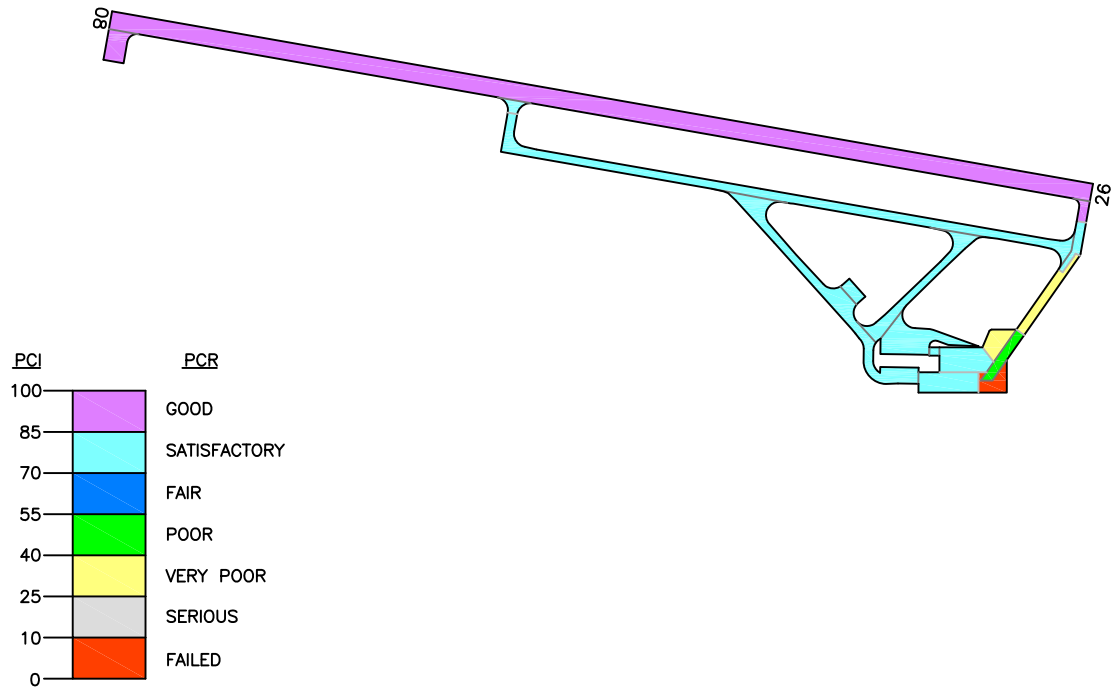
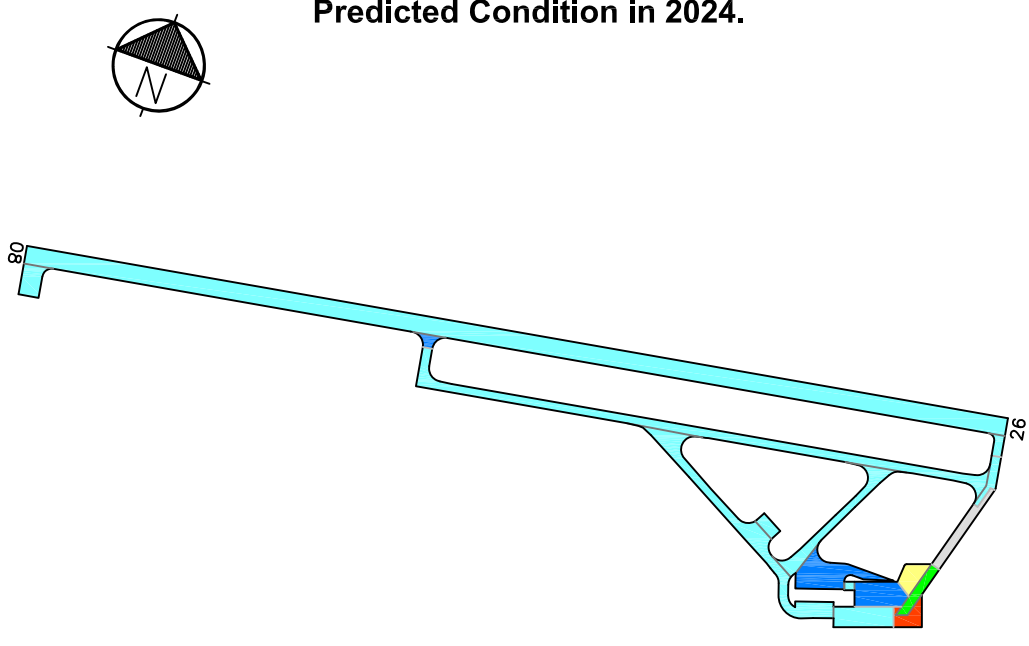
**Figure LX-5. Future Pavement Condition.**

A graphical representation of the projected PCIs listed in Table 1 is shown in Figure LX-5.
