# McDERMITT STATE AIRPORT

This report describes how your Pavement Maintenance Management Program (PMMP) was developed. Your Program was developed as part of the Oregon Continuous Aviation System Plan sponsored in part by the Oregon Department of Aviation and the Federal Aviation Administration (FAA). The information and data contained in this report ensures you are in compliance with the requirements of FAA Grant Assurance Number 11 which states that any airport requesting federal funds for pavement improvement projects must have implemented a pavement maintenance management program.

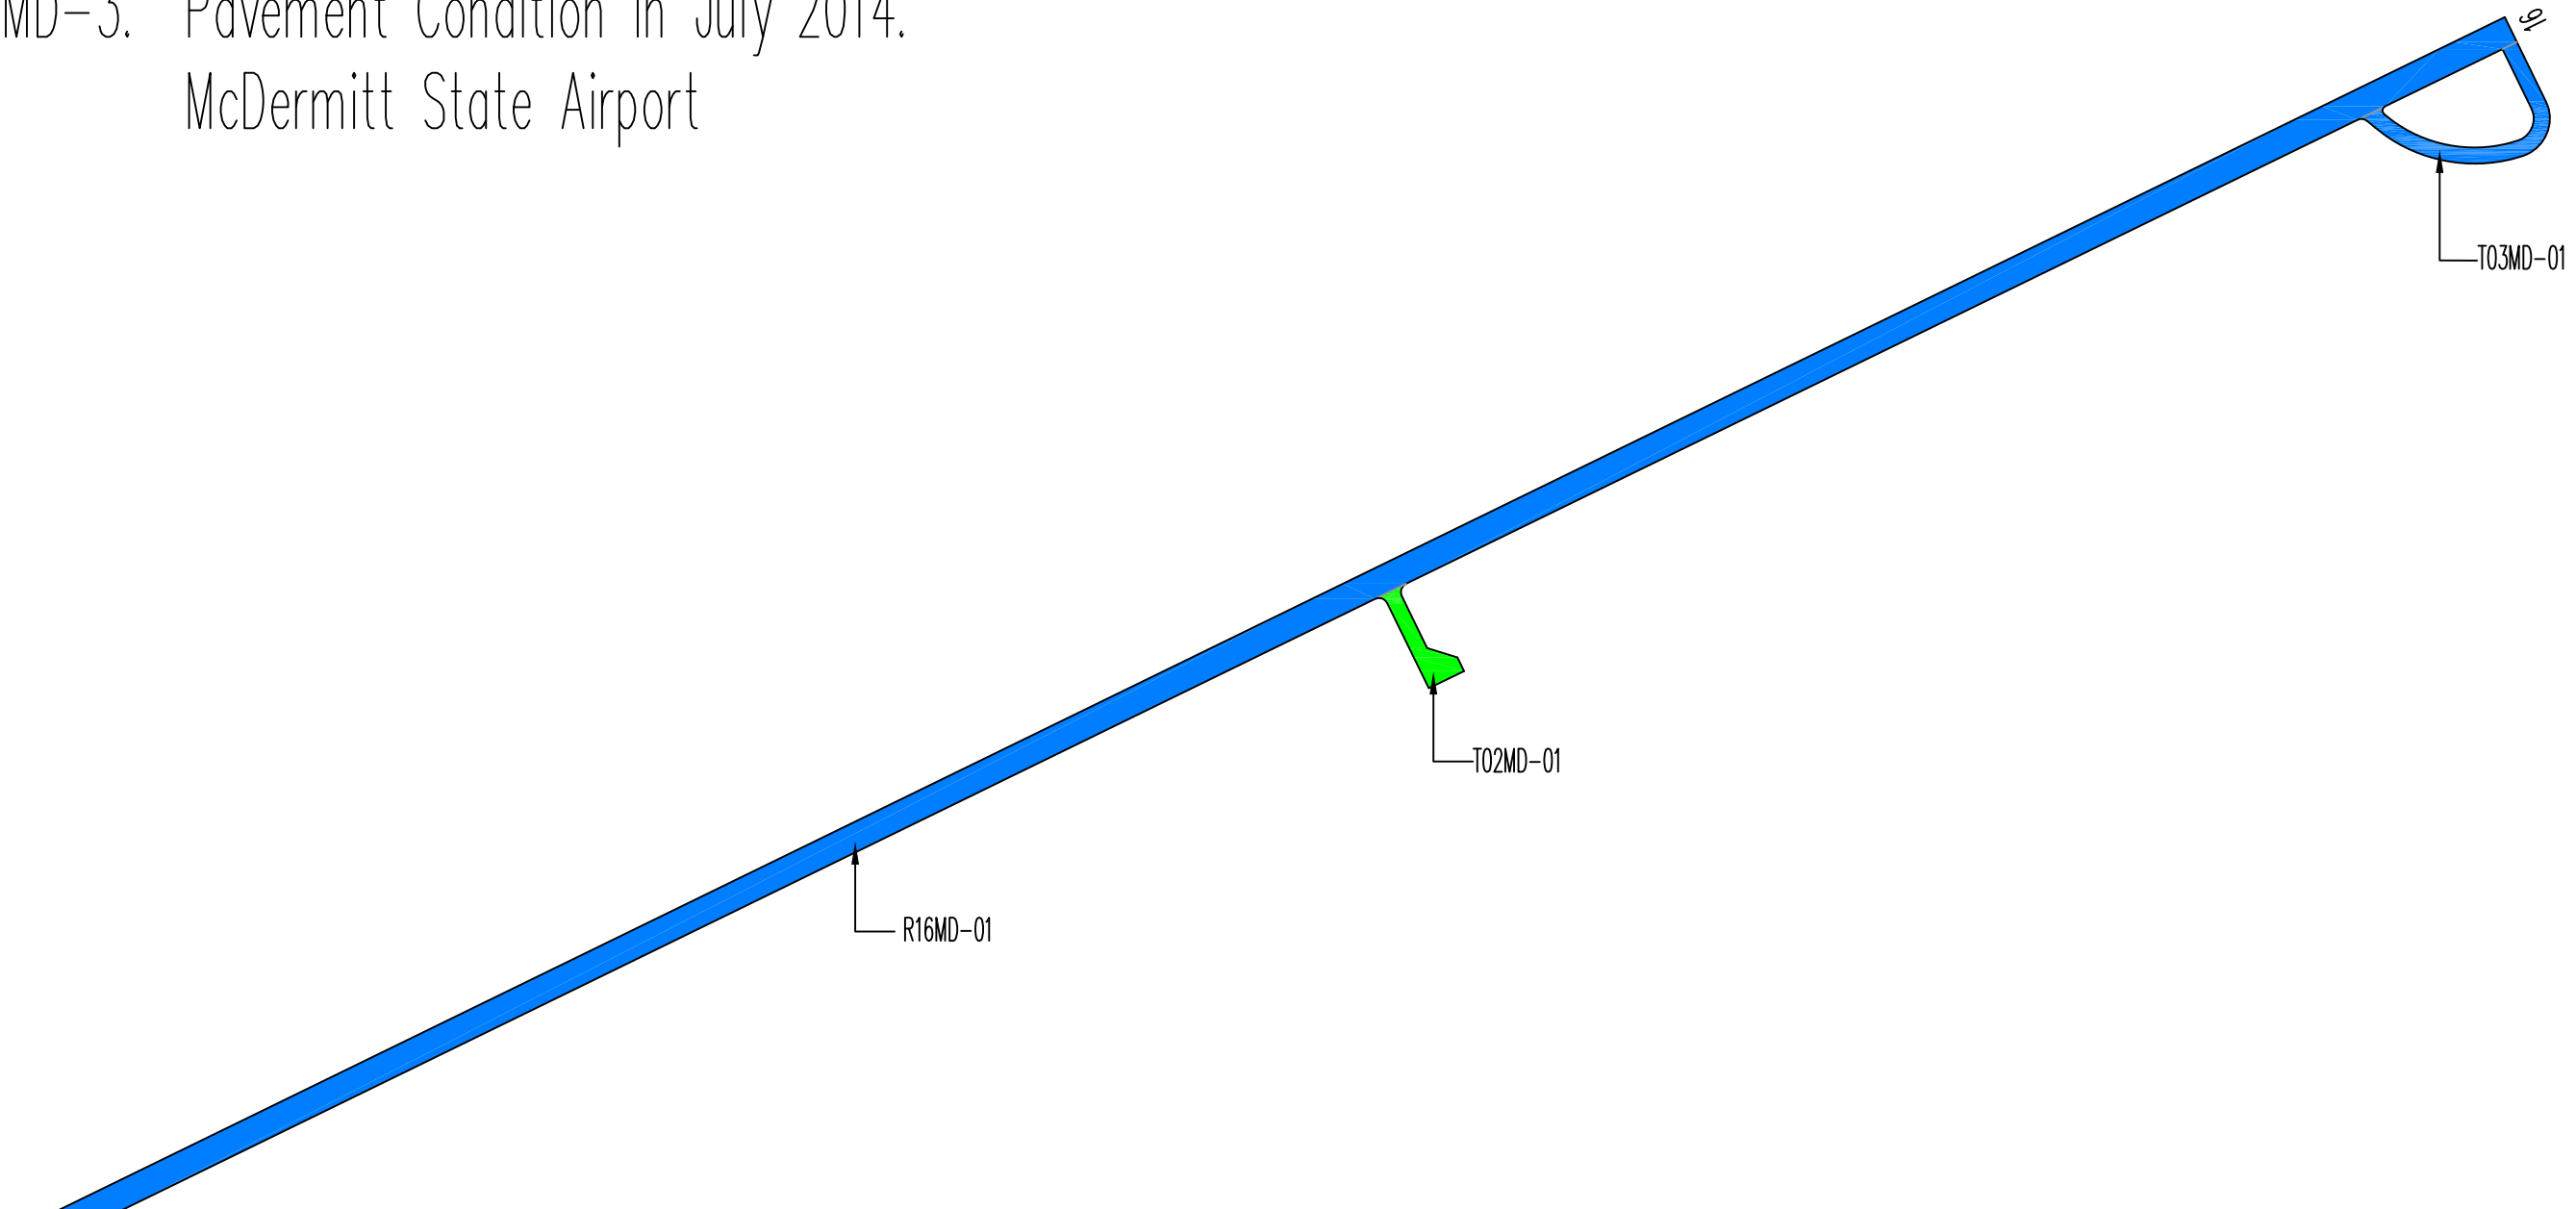
Figure MD-3. Pavement Condition in July 2014.  
McDermitt State Airport

The Branch Condition Report in Appendix 1 summarizes current pavement condition by branch while the Section Condition Report in Appendix 2 lists pavement condition by section. The current PCR is shown graphically in Figure MD-3.

Section PCIs at McDermitt State Airport range from a low of 47 (a PCR of "Poor") to a high of 72 (a PCR of "Satisfactory"). The area-weighted average PCI for all airport pavements is 60, corresponding to an overall PCR of "Fair". Figure MD-4 shows how much pavement area is associated with each Pavement Condition Rating category and also shows pavement condition distribution from the inspection conducted in 2005 and 2009.

The primary distresses observed during the inspection were: longitudinal and transverse cracking, weathering and block cracking, with isolated occurrences of alligator cracking and depressions.

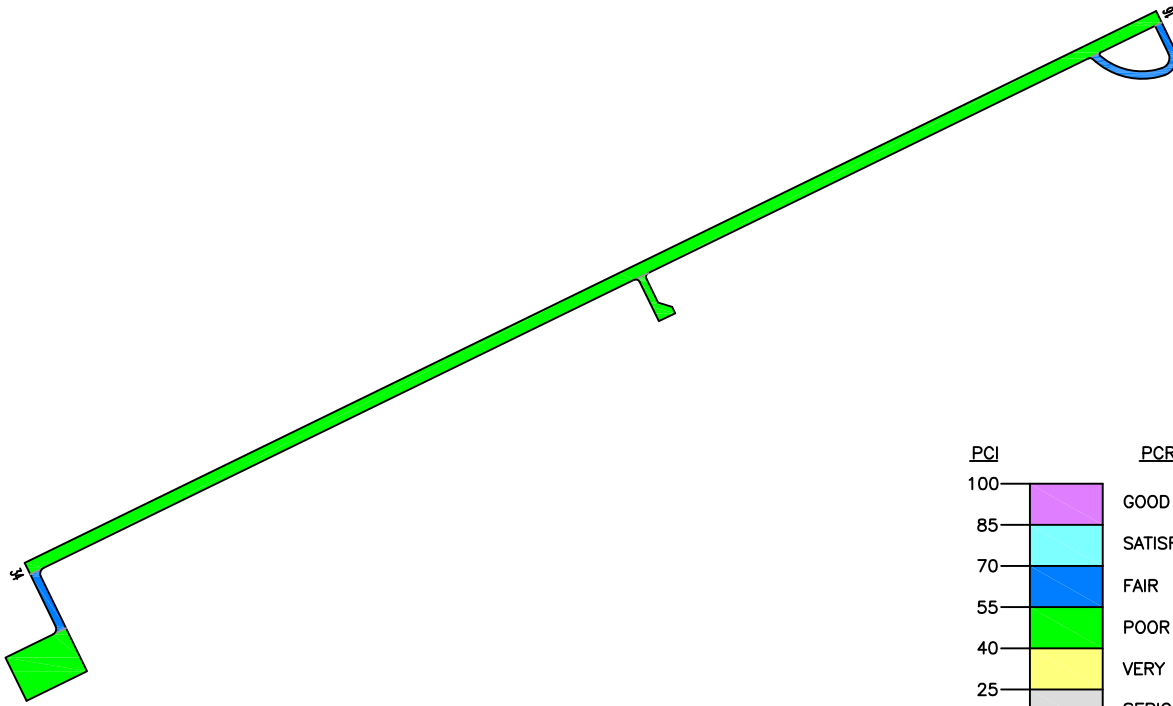
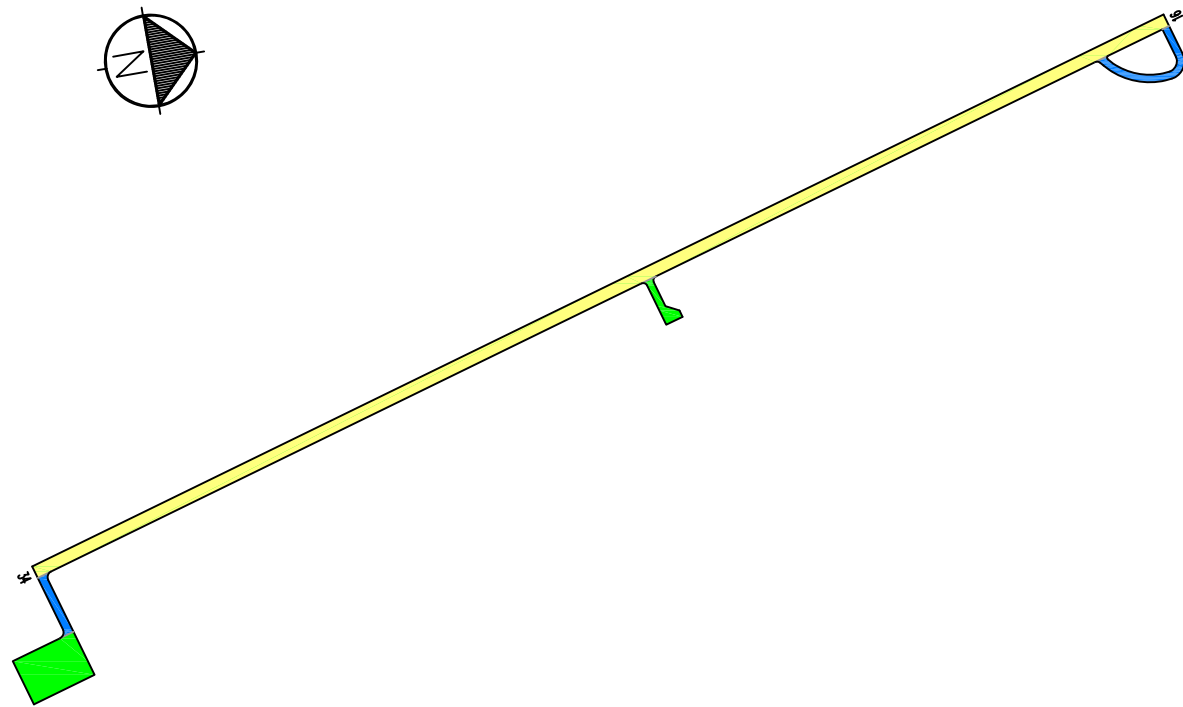
Figure MD-5. Future Pavement Condition.

A graphical representation of the projected PCIs listed in Table 1 is shown in Figure MD-5.
