MONUMENT MUNICIPAL AIRPORT

This report describes how your Pavement Maintenance Management Program (PMMP) was developed. Your Program was developed as part of the Oregon Continuous Aviation System Plan sponsored in part by the Oregon Department of Aviation and the Federal Aviation Administration (FAA). The information and data contained in this report ensures you are in compliance with the requirements of FAA Grant Assurance Number 11 which states that any airport requesting federal funds for pavement improvement projects must have implemented a pavement maintenance management program.

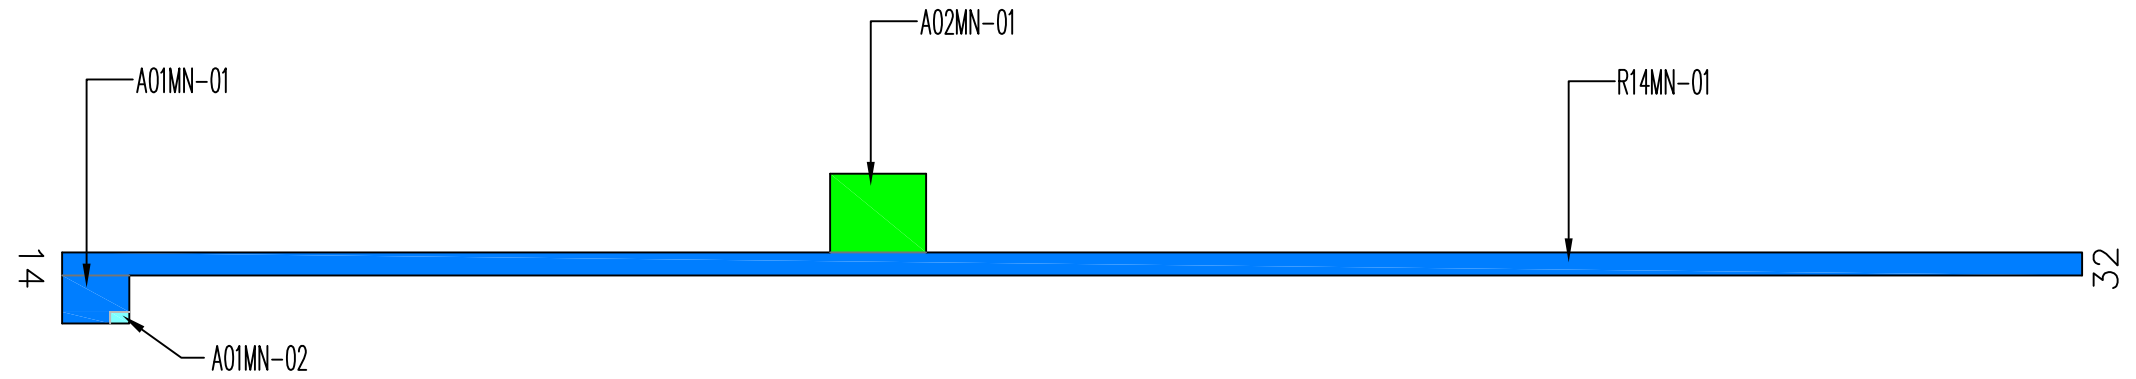
Figure MN-3. Pavement Condition in August 2014.
 Monument Municipal Airport

Section PCIs at Monument Municipal Airport range from a low of 42 (a PCR of "Poor") to a high of 72 (a PCR of "Satisfactory"). The area-weighted average PCI for all airport pavements is 66, corresponding to an overall PCR of "Fair". Figure MN-4 shows how much pavement area is associated with each Pavement Condition Rating category and also shows pavement condition distribution from the inspections conducted in 2006 and 2011.

The primary distresses observed during the inspection asphalt concrete pavements were: longitudinal and transverse cracking, block cracking, raveling, and swell. The primary distress observed during the inspection of portland cement concrete pavement was corner spalls.
