SISTERS EAGLE AIR AIRPORT

This report describes how your Pavement Maintenance Management Program (PMMP) was developed. Your Program was developed as part of the Oregon Continuous Aviation System Plan sponsored in part by the Oregon Department of Aviation and the Federal Aviation Administration (FAA). The information and data contained in this report ensures you are in compliance with the requirements of FAA Grant Assurance Number 11 which states that any airport requesting federal funds for pavement improvement projects must have implemented a pavement maintenance management program.

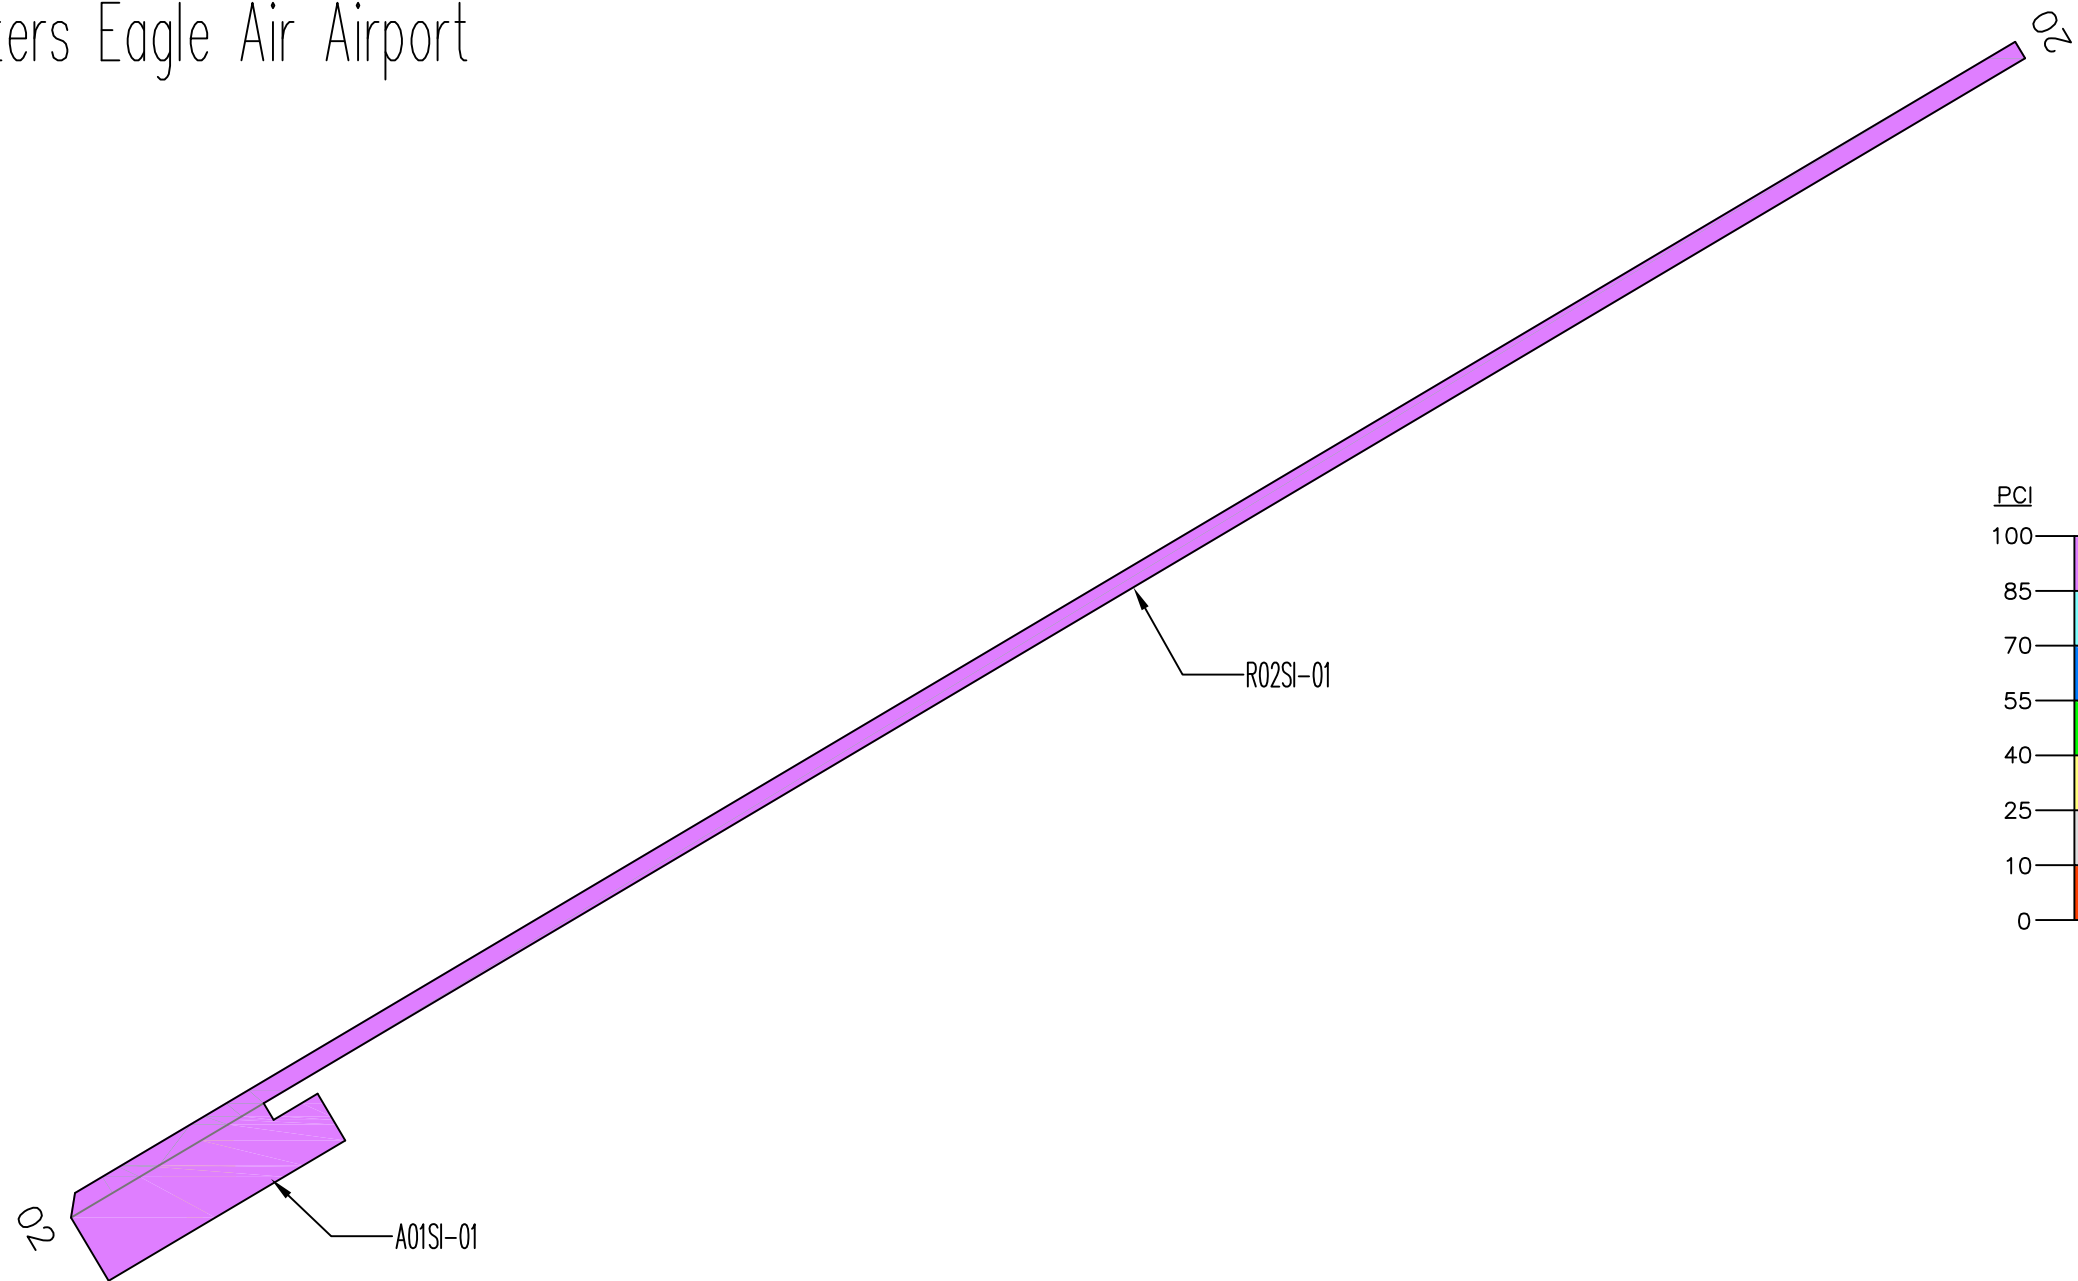
Figure SI-3. Pavement Condition in August 2014.
Sisters Eagle Air Airport

A new apron was built in 2013 and the old apron area was abandoned. The runway was also rehabilitated in 2013. Section PCIs at Sisters Eagle Air Airport range from a low of 100 (a PCR of "Good") to a high of 100 (a PCR of "Good"). The area-weighted average PCI for all airport pavements is 100, corresponding to an overall PCR of "Good". Figure SI-4 shows how much pavement area is associated with each Pavement Condition Rating category and also shows pavement condition distribution from the inspections conducted in 2006 and 2011.

No distresses were observed during the pavement inspection.

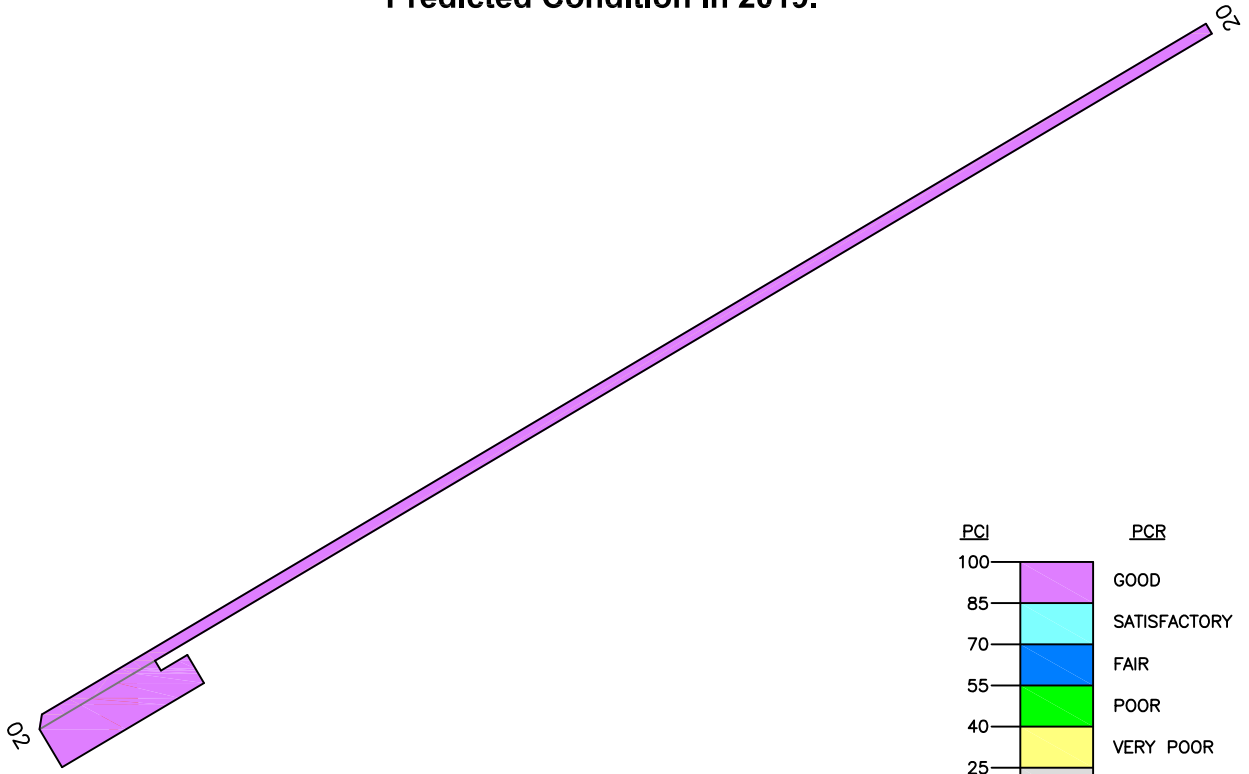
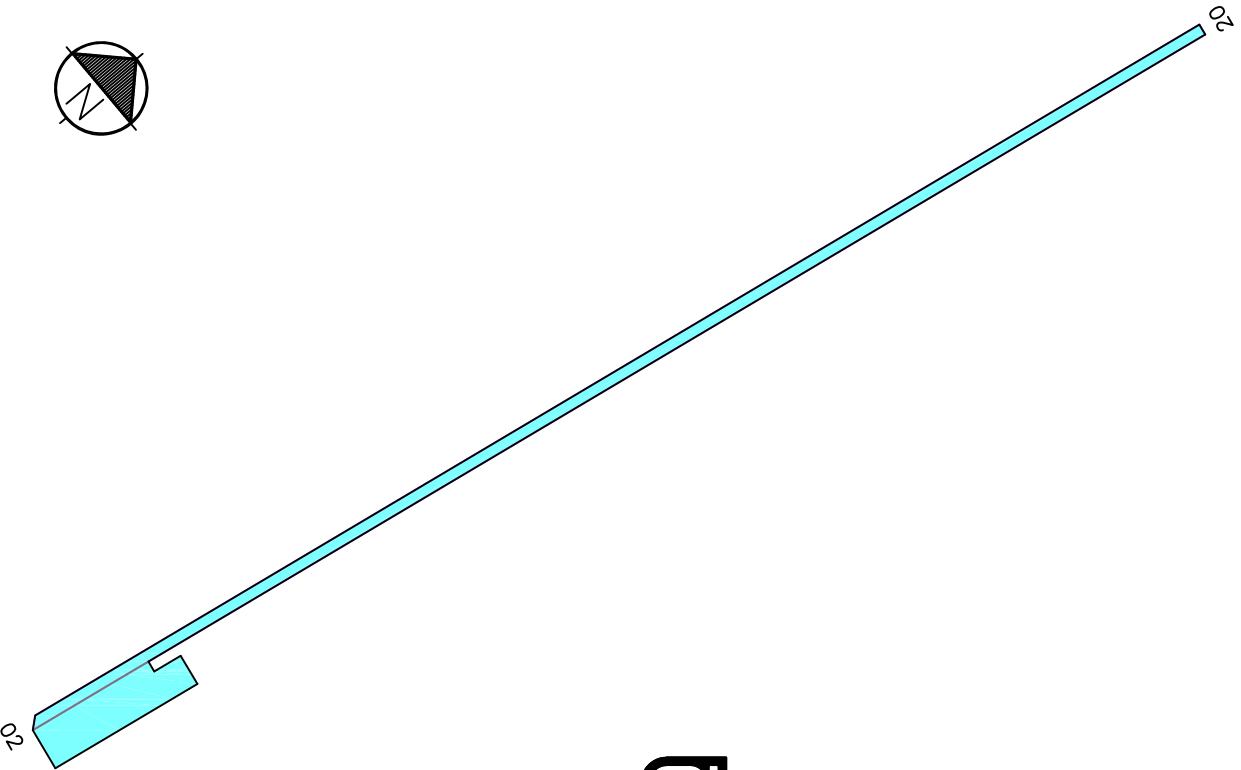
Figure SI-5. Future Pavement Condition.

A graphical representation of the projected PCIs listed in Table 1 is shown in Figure SI-5.
