SUNRIVER AIRPORT

Using the branch, section and sample unit divisions established, a visual condition survey was conducted at Sunriver Airport in August 2014. During the inspection, pavement defects were identified and measured in accordance with the methodology outlined in ASTM D5430. This inspection ensures your airport complies with the “detailed inspection” requirement of FAA’s PMMP guidelines. After collection, the data were entered into the Micro PAVER software for analysis. These data are reproduced in the Re-Inspection Report attached as Appendix 4.

Figure SU-1. Airport Layout, Dimensions and Pavement Cross-Sections.
Sunriver Airport

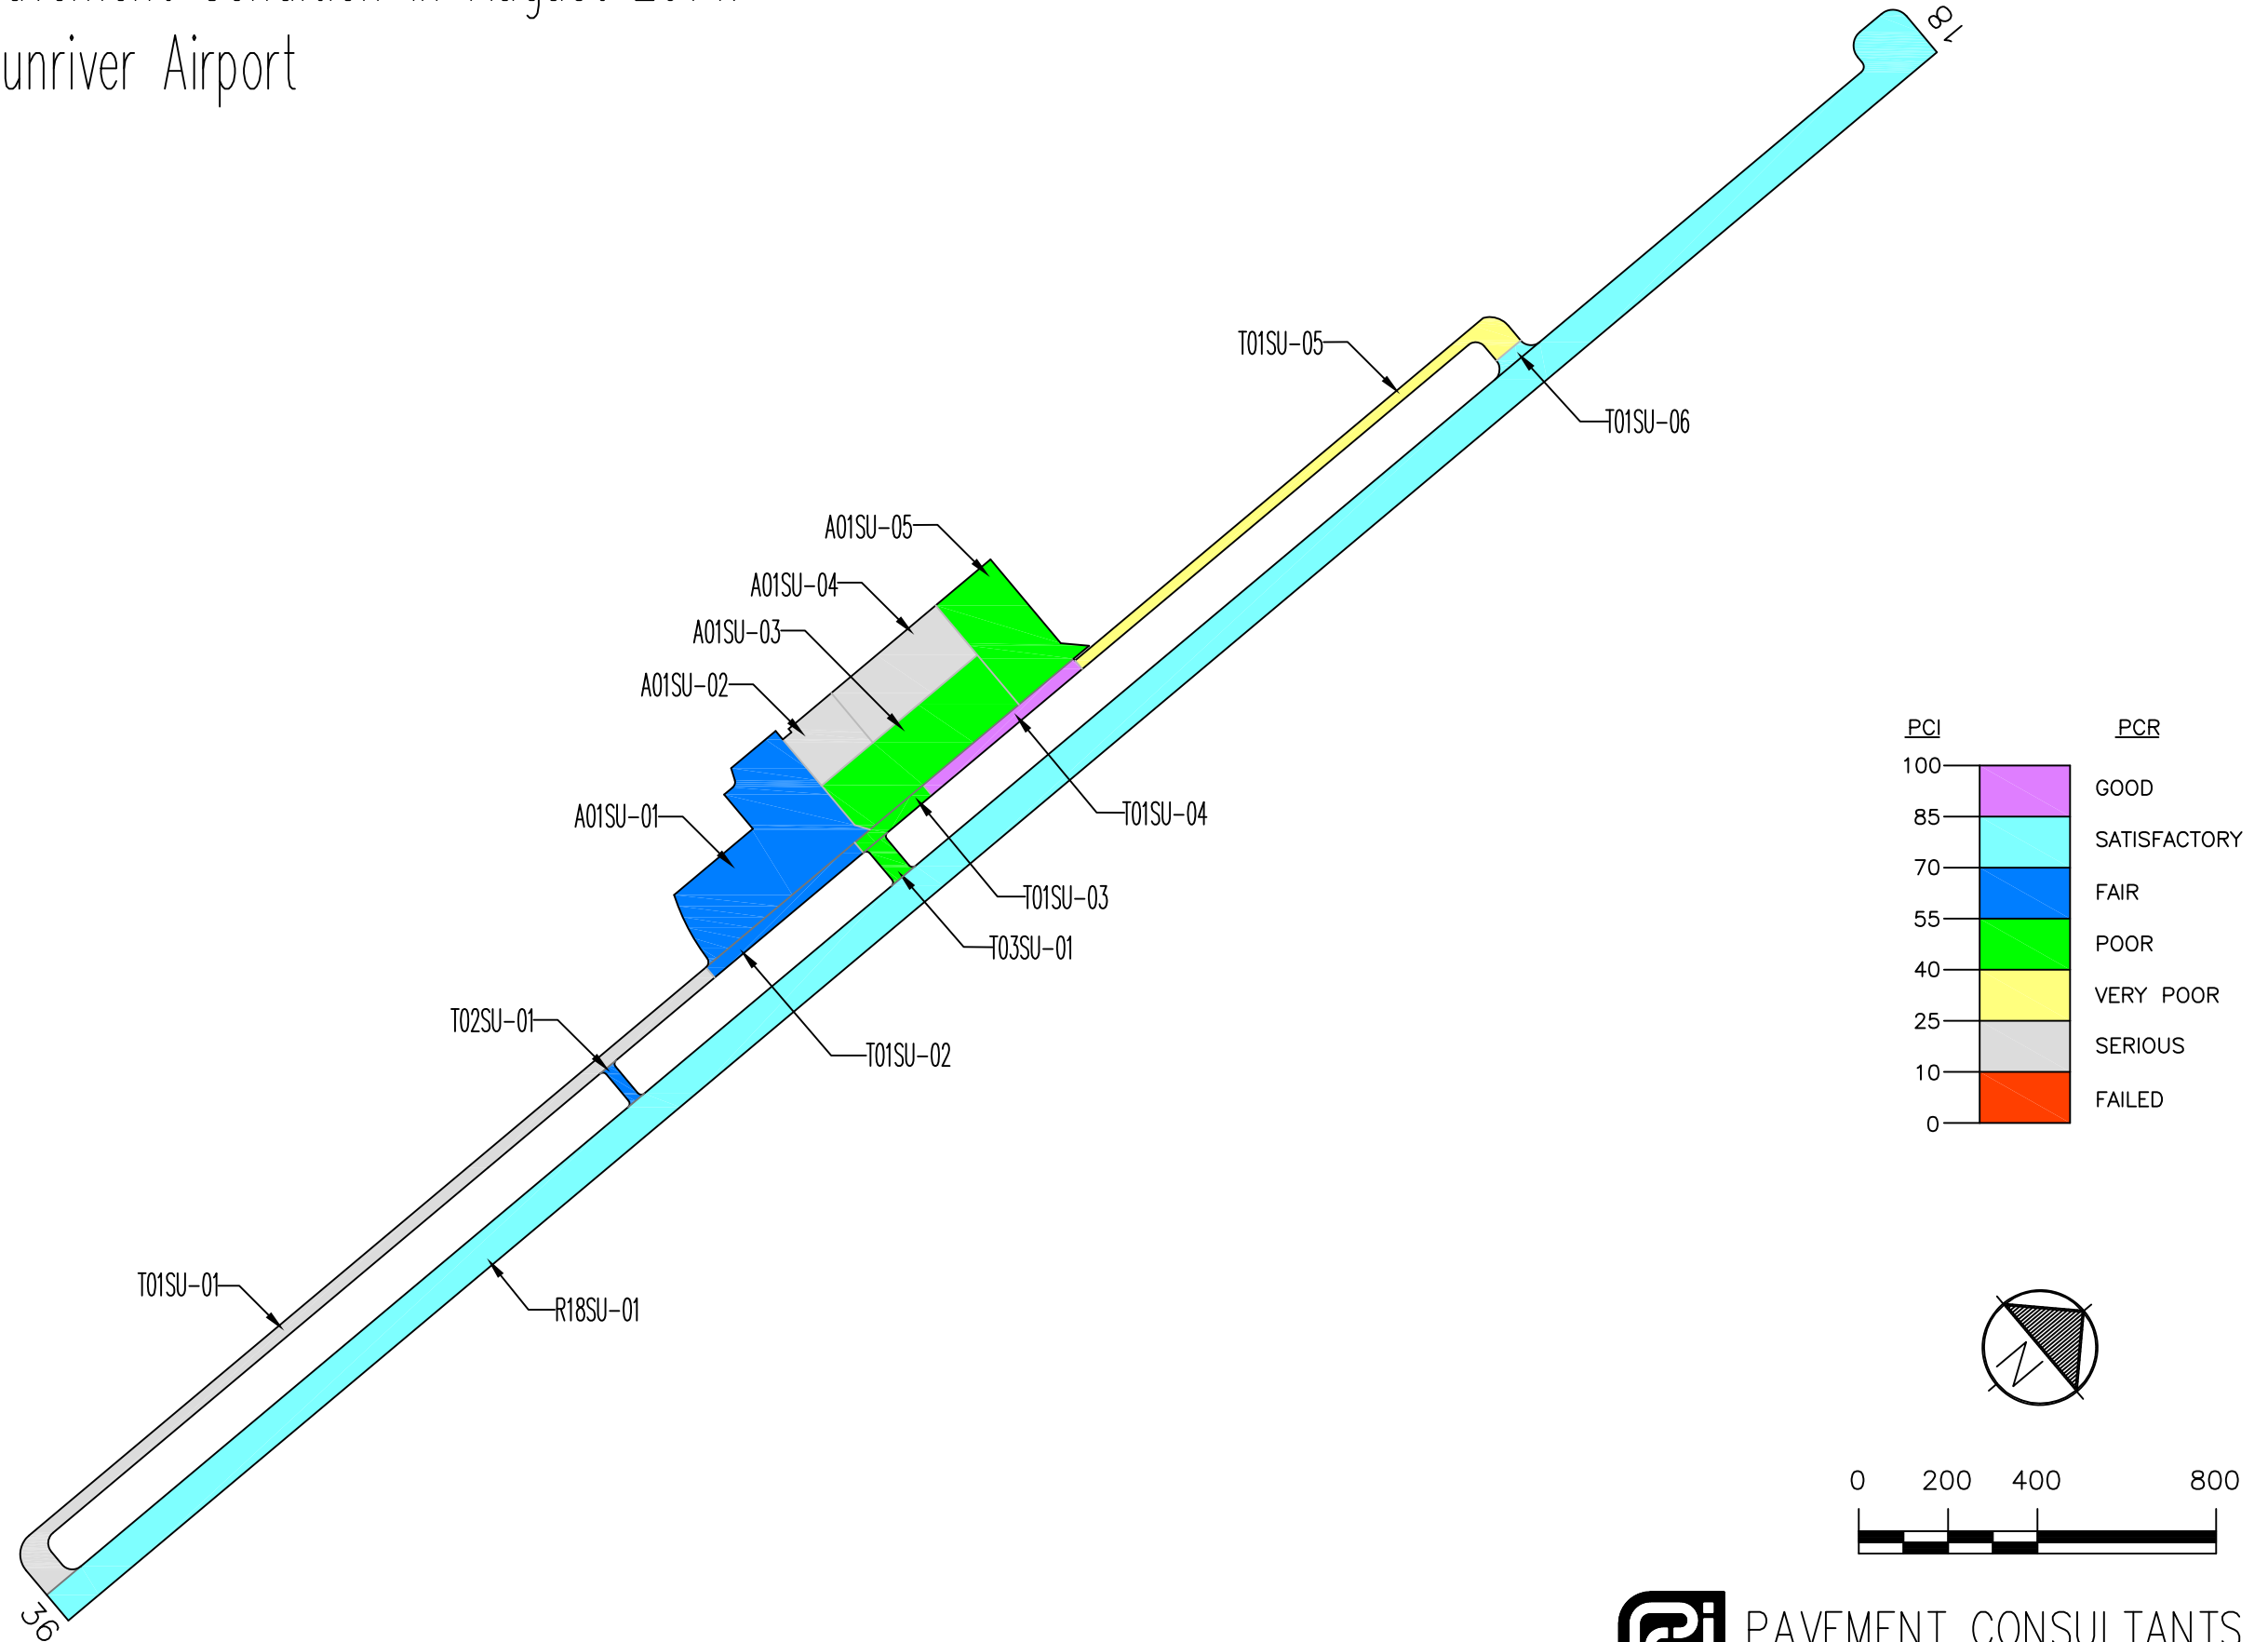
Figure SU-3. Pavement Condition in August 2014.
Sunriver Airport

The Branch Condition Report in Appendix 1 summarizes current pavement condition by branch while the Section Condition Report in Appendix 2 lists pavement condition by section. The current PCR is shown graphically in Figure SU-3.

Section PCIs at Sunriver Airport range from a low of 12 (a PCR of "Serious") to a high of 100 (a PCR of "Good"). The area-weighted average PCI for all airport pavements is 63, corresponding to an overall PCR of "Fair". Figure SU-4 shows how much pavement area is associated with each Pavement Condition Rating category and also shows pavement condition distribution from the inspections conducted in 2006 and 2011.

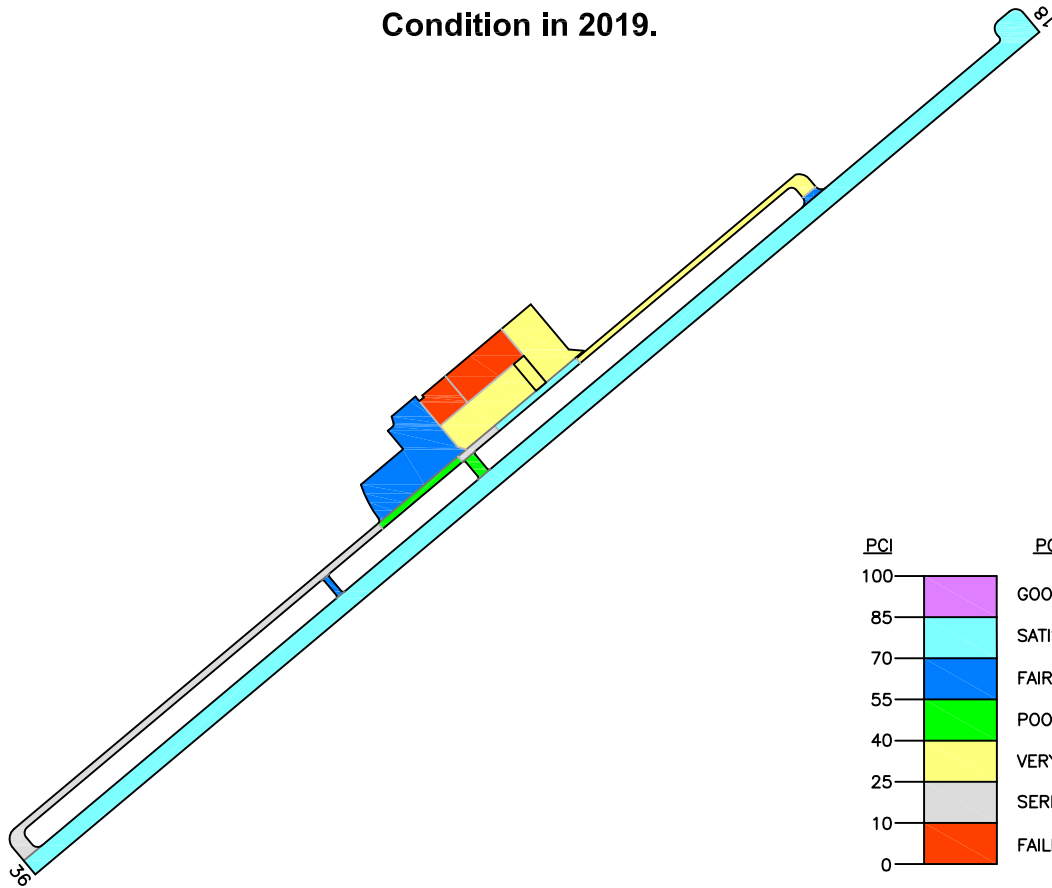
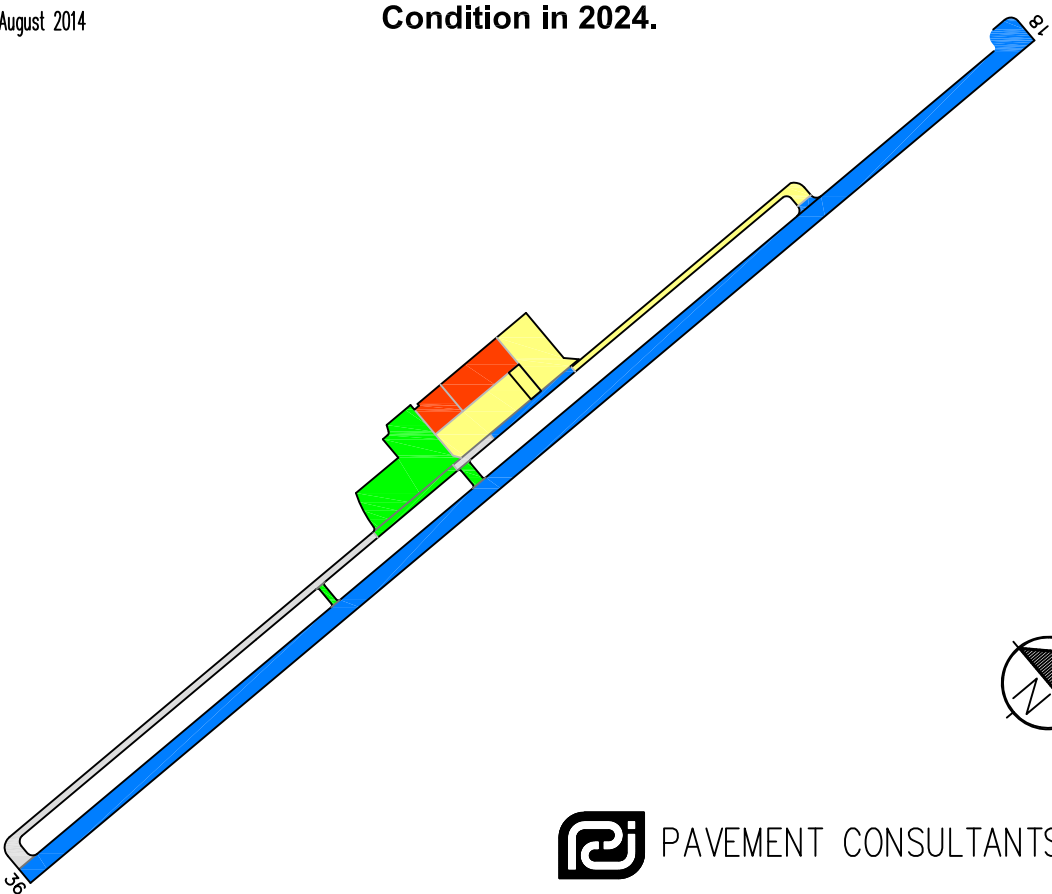
Figure SU-5. Future Pavement Condition.

A graphical representation of the projected PCIs listed in Table 1 is shown in Figure SU-5.
