WASCO STATE AIRPORT

This report describes how your Pavement Maintenance Management Program (PMMP) was developed. Your Program was developed as part of the Oregon Continuous Aviation System Plan sponsored in part by the Oregon Department of Aviation and the Federal Aviation Administration (FAA). The information and data contained in this report ensures you are in compliance with the requirements of FAA Grant Assurance Number 11 which states that any airport requesting federal funds for pavement improvement projects must have implemented a pavement maintenance management program.

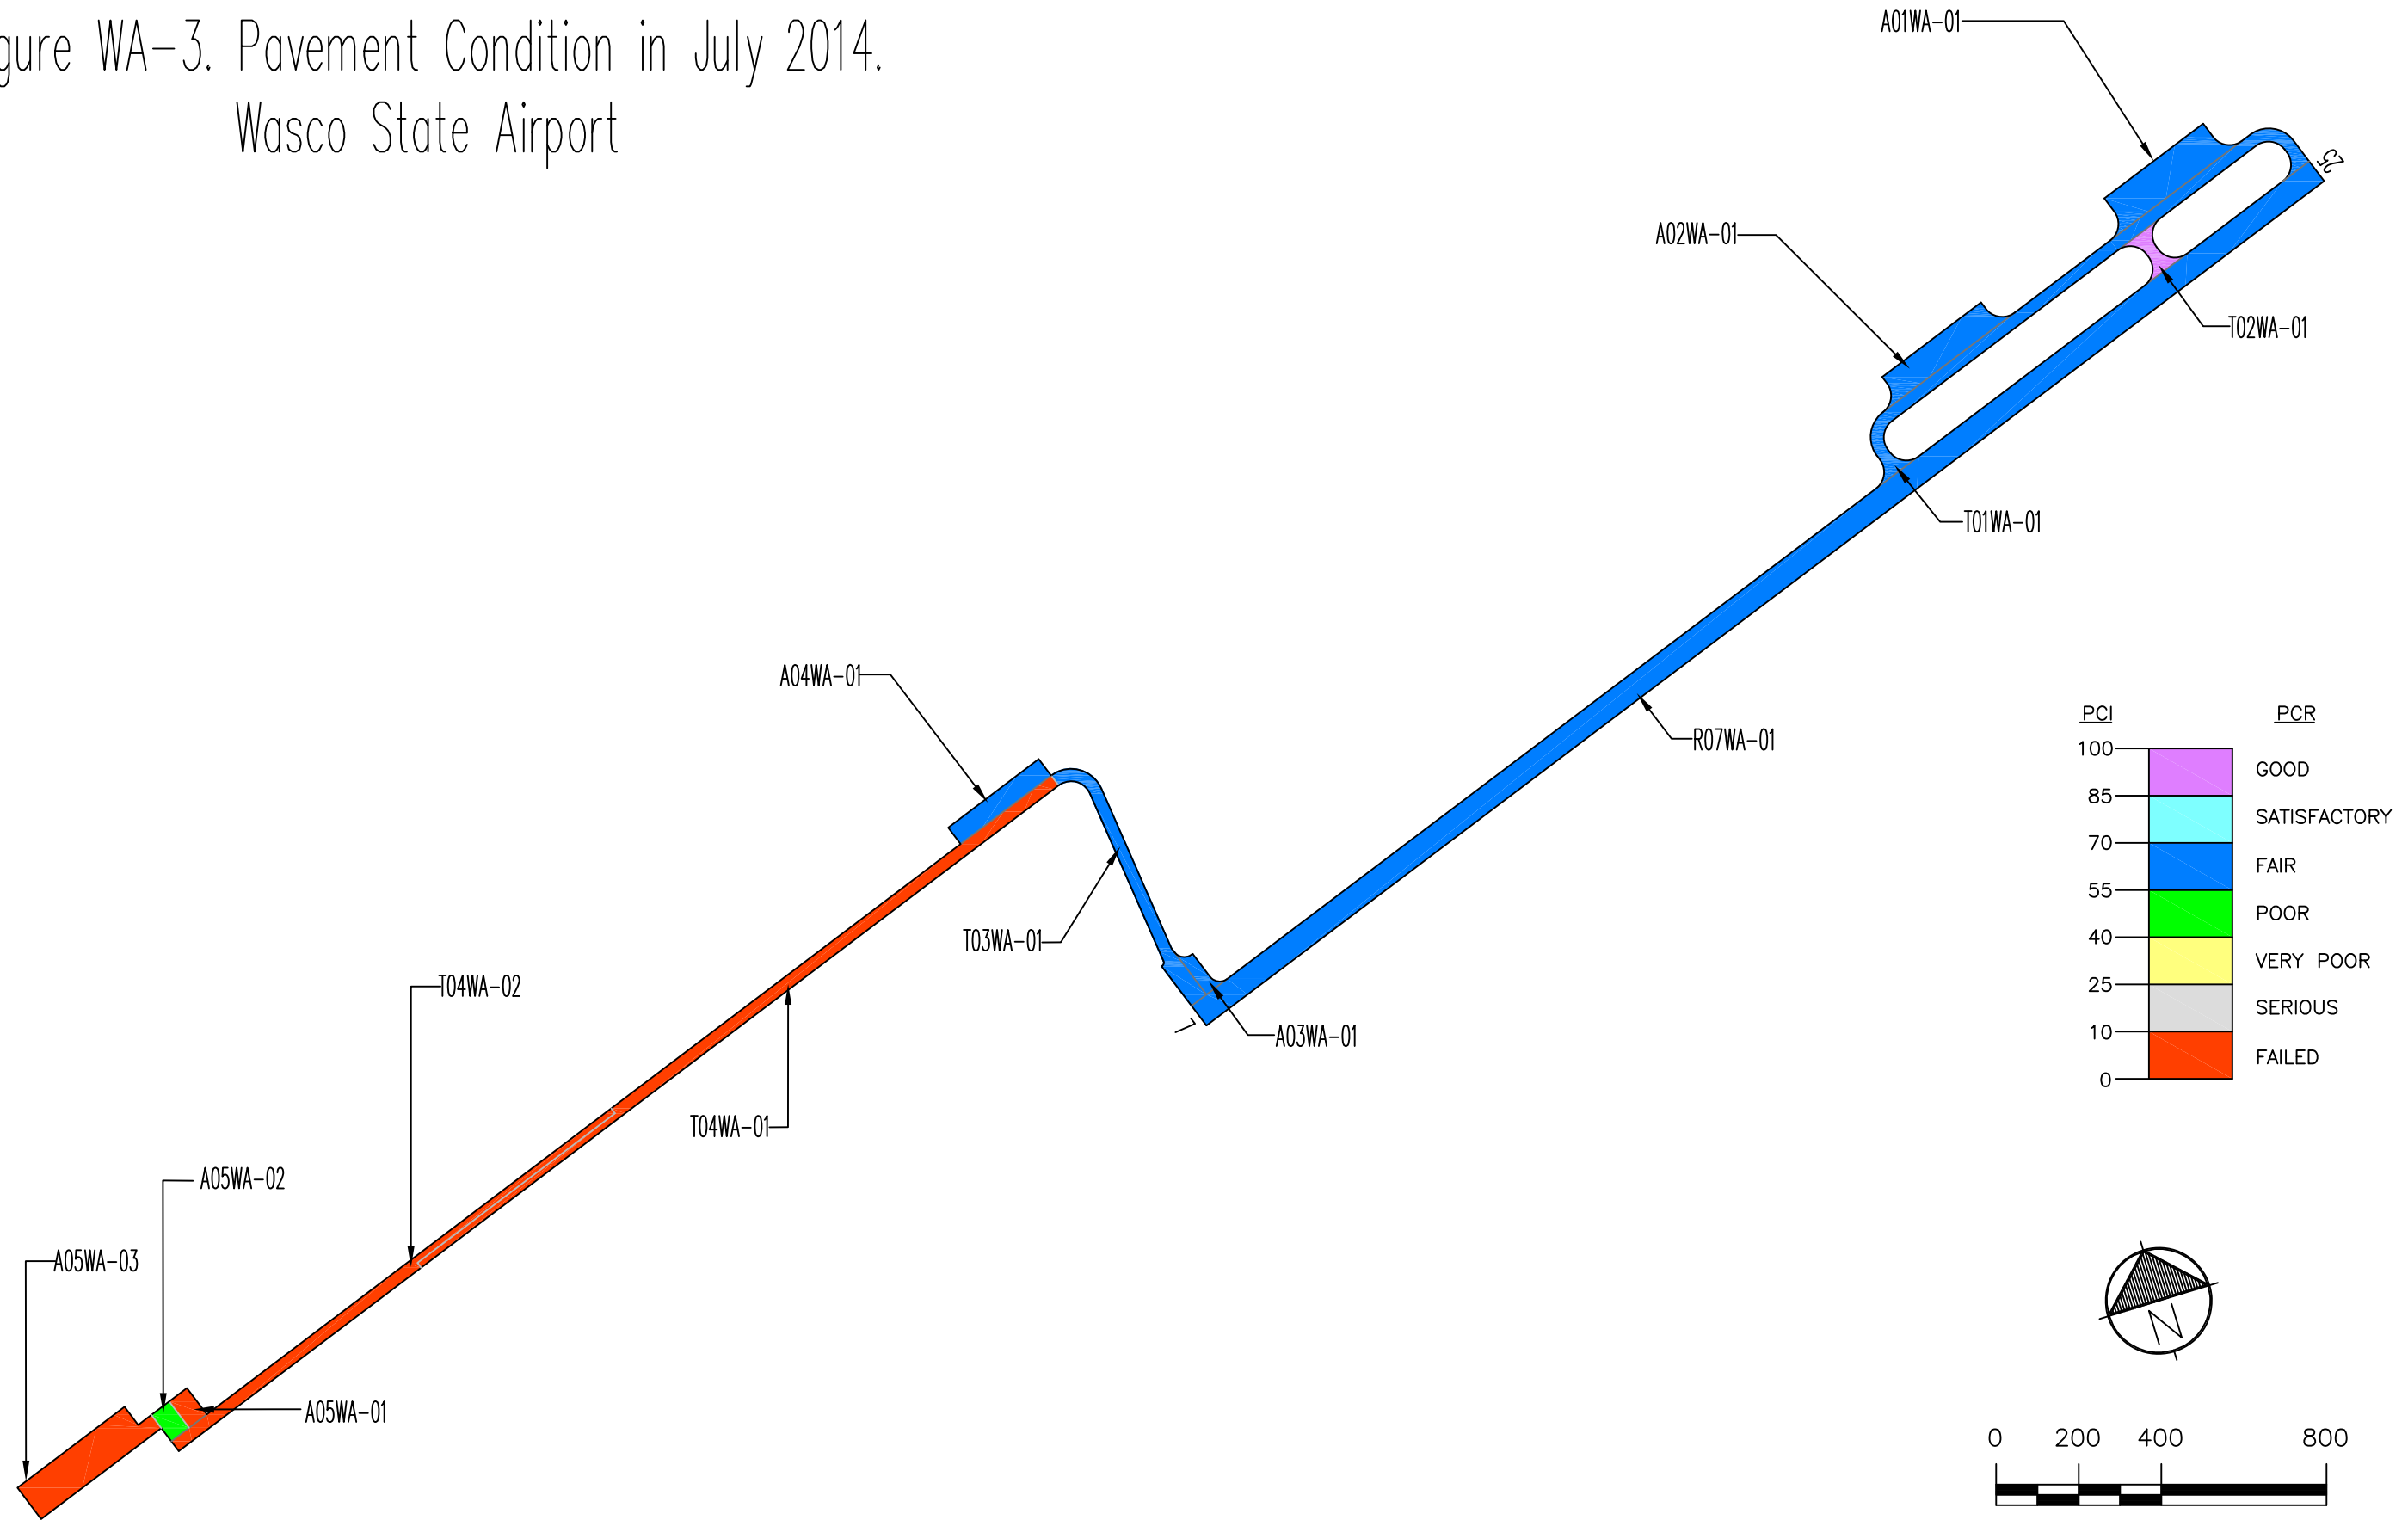
Figure WA-3. Pavement Condition in July 2014.
Wasco State Airport

Section PCIs at Wasco State Airport range from a low of 0 (a PCR of "Failed") to a high of 86 (a PCR of "Good"). The area-weighted average PCI for all airport pavements is 47, corresponding to an overall PCR of "Poor". Figure WA-4 shows how much pavement area is associated with each Pavement Condition Rating category and also shows pavement condition distribution from the inspections conducted in 2006 and 2011.

The primary distresses observed during the inspection were: weathering, block cracking, alligator cracking, longitudinal and transverse cracking, and raveling, with isolated occurrences of patching and depressions.

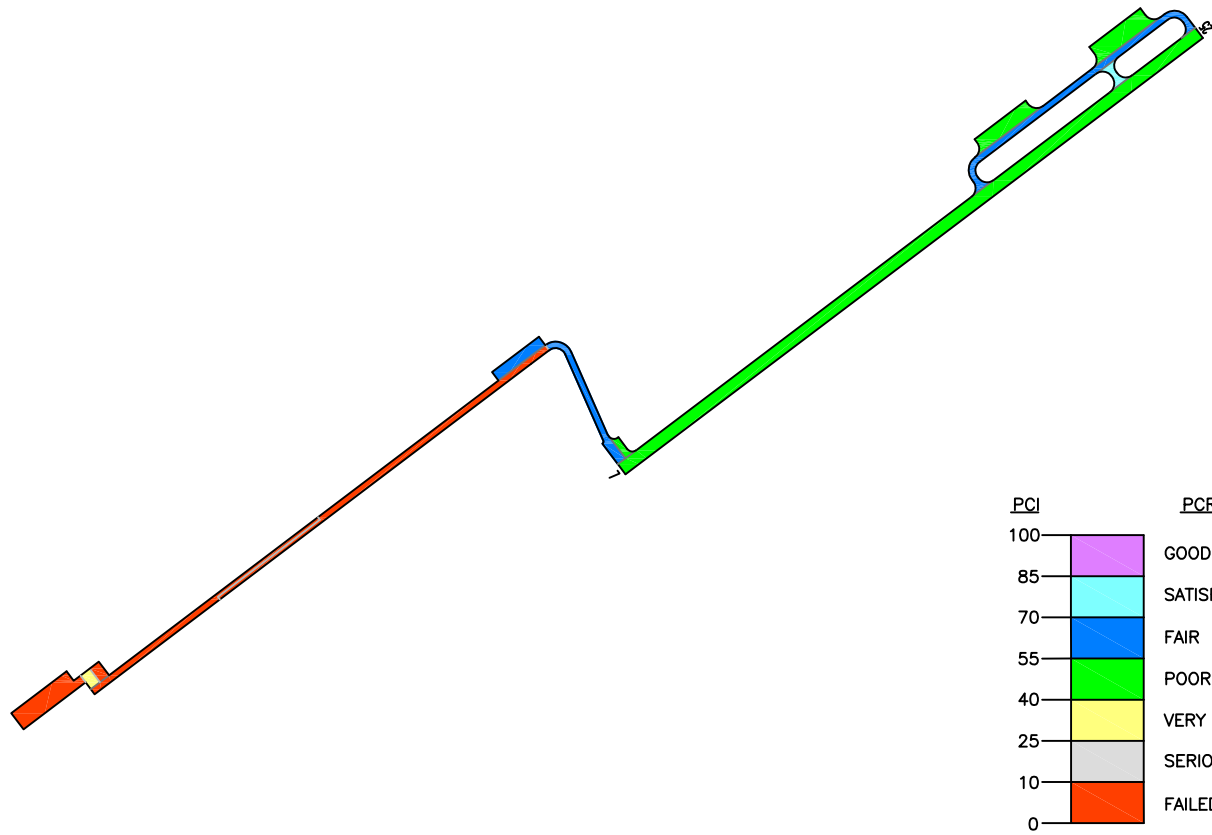
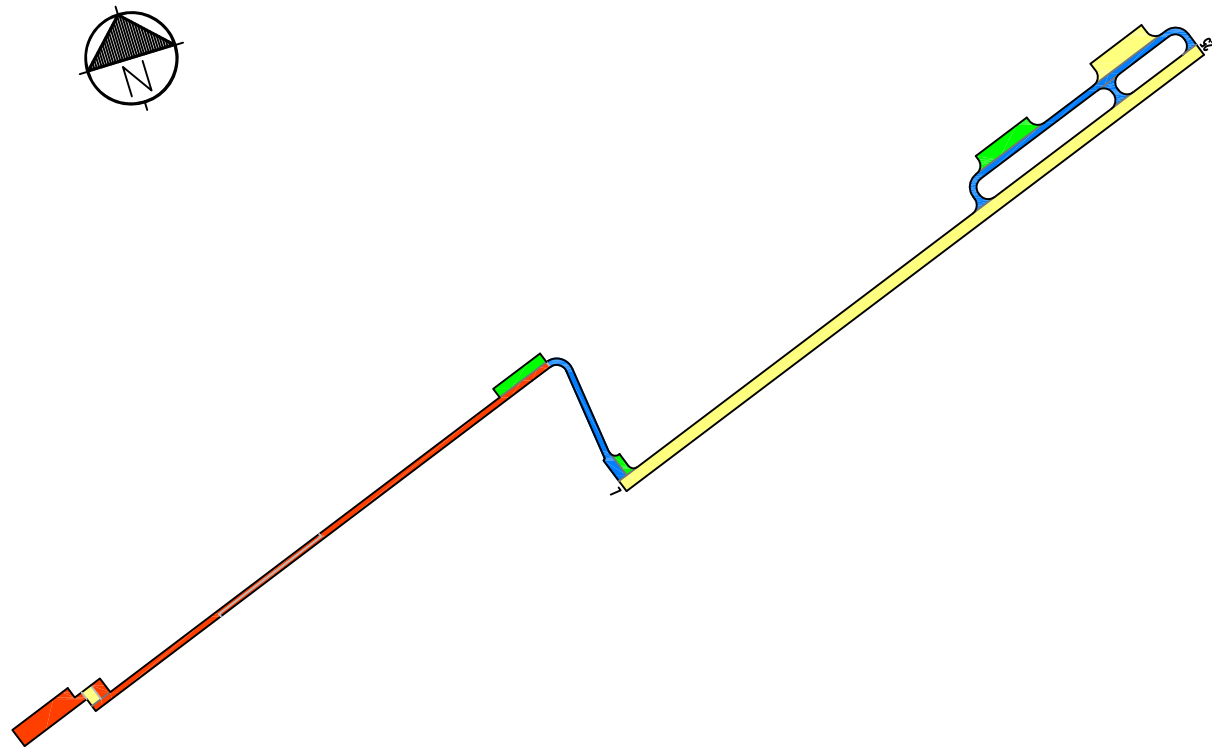
Figure WA-5. Future Pavement Condition.

A graphical representation of the projected PCIs listed in Table 1 is shown in Figure WA-5.
