# Your Airport Report

# LENHARDT AIRPARK

This report describes how your Pavement Maintenance Management Program (PMMP) was developed. Your Program was developed as part of the Oregon Continuous Aviation System Plan sponsored in part by the Oregon Department of Aviation and the Federal Aviation Administration (FAA). The information and data contained in this report ensures you are in compliance with the requirements of FAA Grant Assurance Number 11 which states that any airport requesting federal funds for pavement improvement projects must have implemented a pavement maintenance management program.

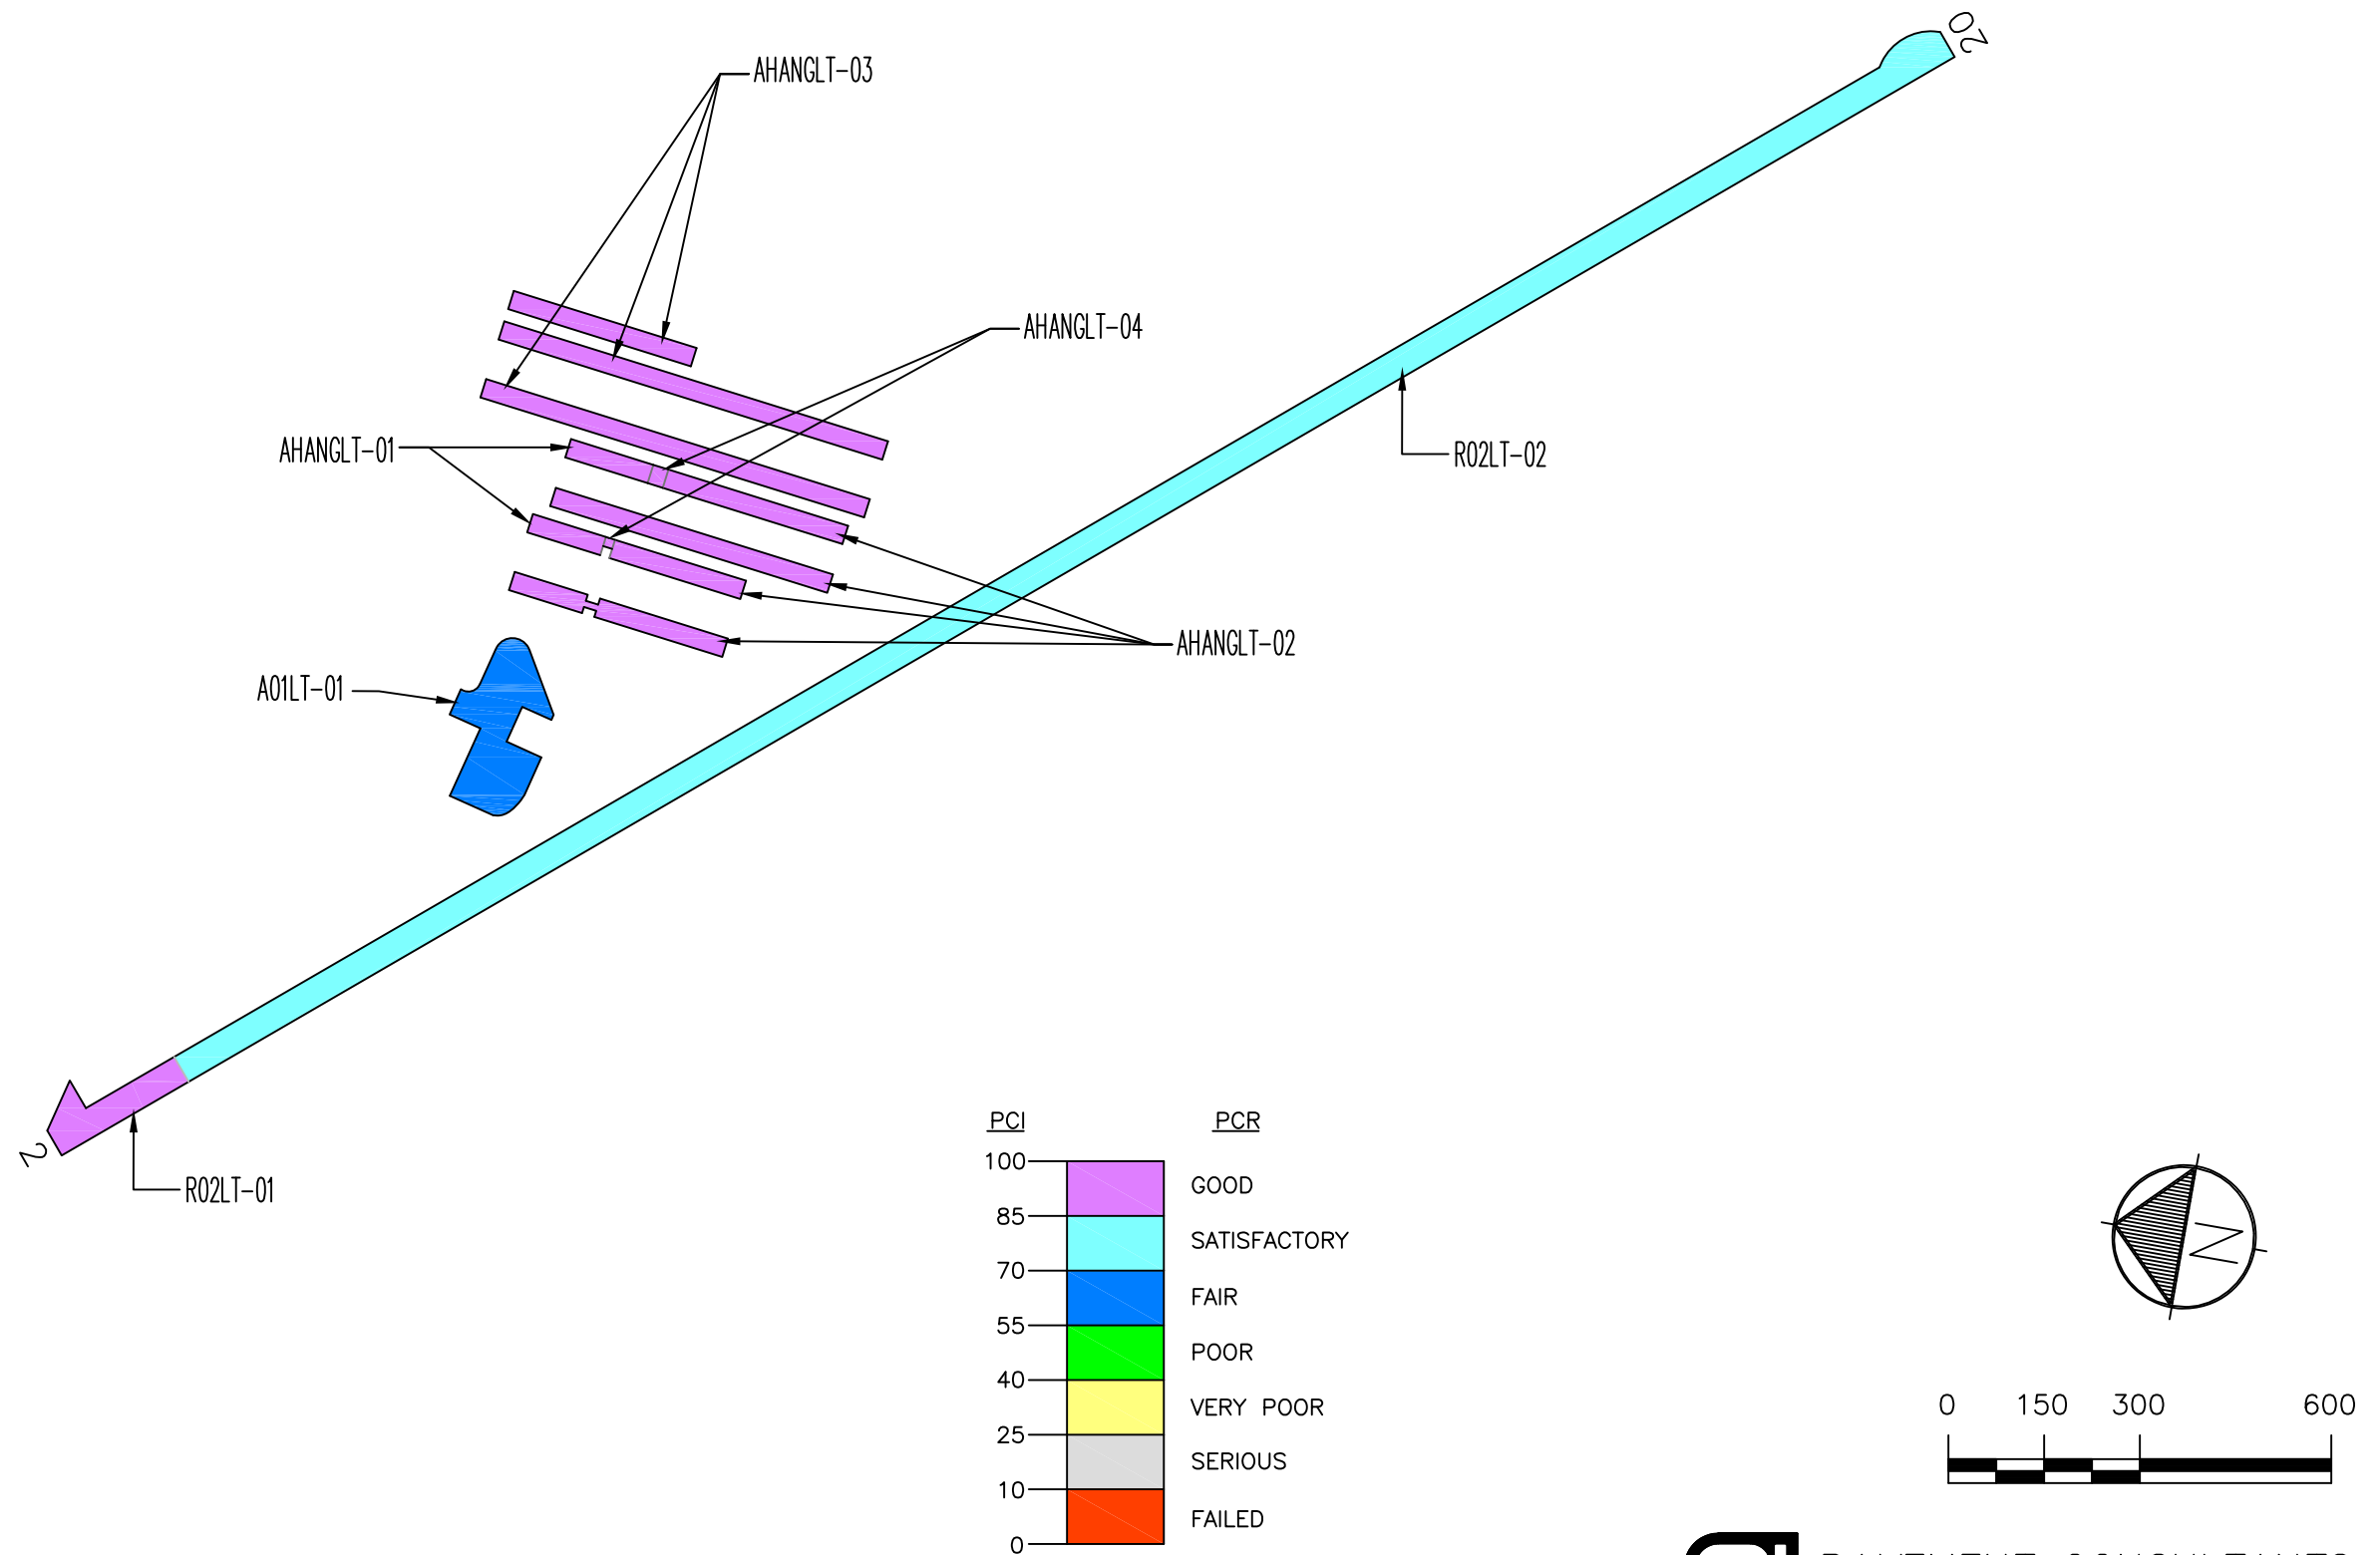
Figure LT-3. Pavement Condition in September 2015.  
Lenhardt Airpark

Section PCIs at Lenhardt Airpark range from a low of 64 (a PCR of “Fair”) to a high of 100 (a PCR of “Good”). The area-weighted average PCI for all airport pavements is 84, corresponding to an overall PCR of “Satisfactory”. Figure LT-4 shows how much pavement area is associated with each Pavement Condition Rating category and also shows pavement condition distribution from the inspections conducted in 2008 and 2012.

The primary distress observed during the inspection was longitudinal and transverse cracking, with isolated occurrences of alligator crack, block cracking, patching and weathering.
