Your Airport Report

NEHALEM BAY STATE AIRPORT

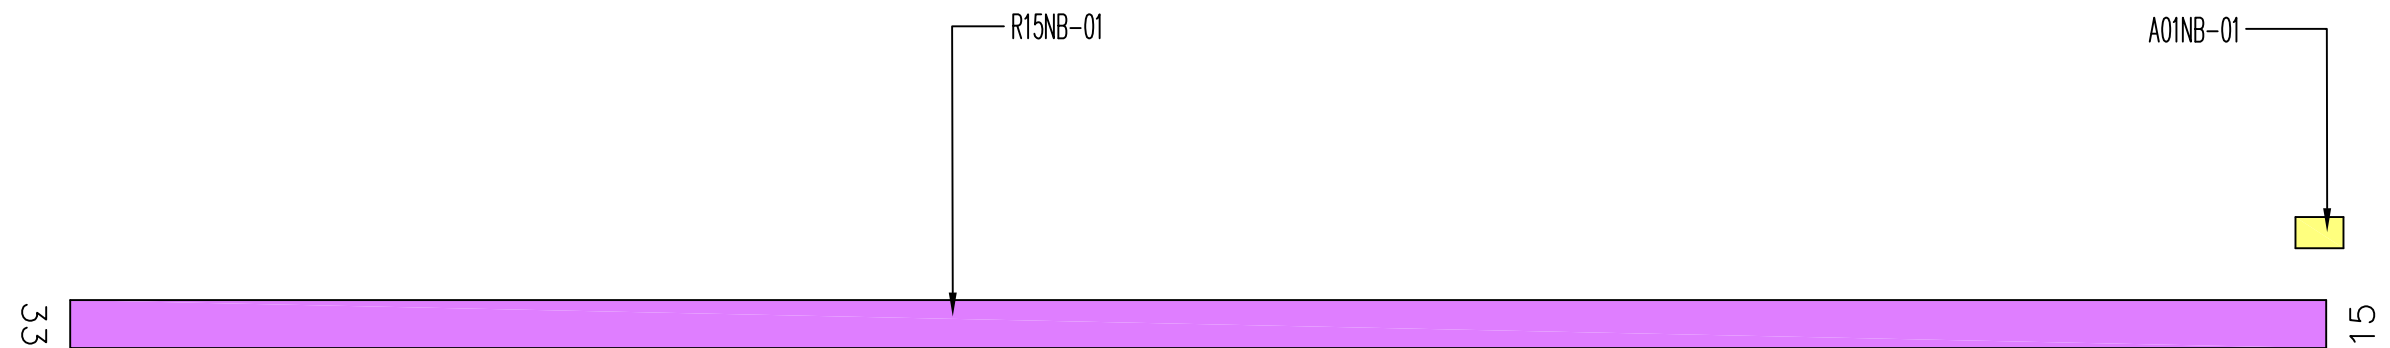
Figure NB-3. Pavement Condition in September 2015.
Nehalem Bay State Airport

The Branch Condition Report in Appendix 1 summarizes current pavement condition by branch while the Section Condition Report in Appendix 2 lists pavement condition by section. The current PCR is shown graphically in Figure NB-3.

Section PCIs at Nehalem Bay State Airport range from a low of 33 (a PCR of "Very Poor") to a high of 91 (a PCR of "Good"). The area-weighted average PCI for all airport pavements is 90, corresponding to an overall PCR of "Good". Figure NB-4 shows how much pavement area is associated with each Pavement Condition Rating category and also shows pavement condition distribution from the inspections conducted in 2008 and 2012.

The primary distress observed during the inspection was longitudinal and transverse cracking, block cracking, depression, and raveling.

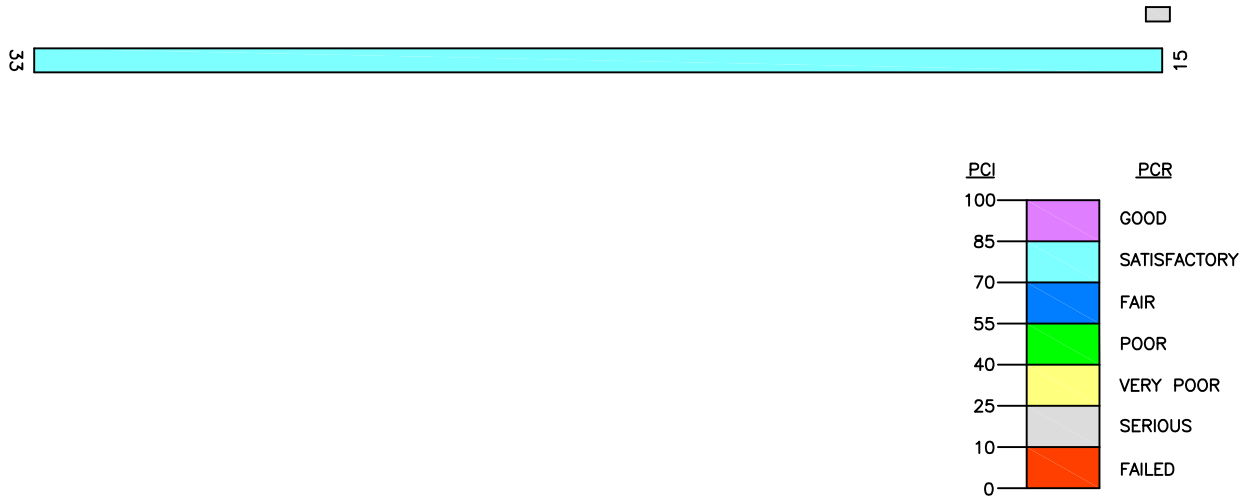
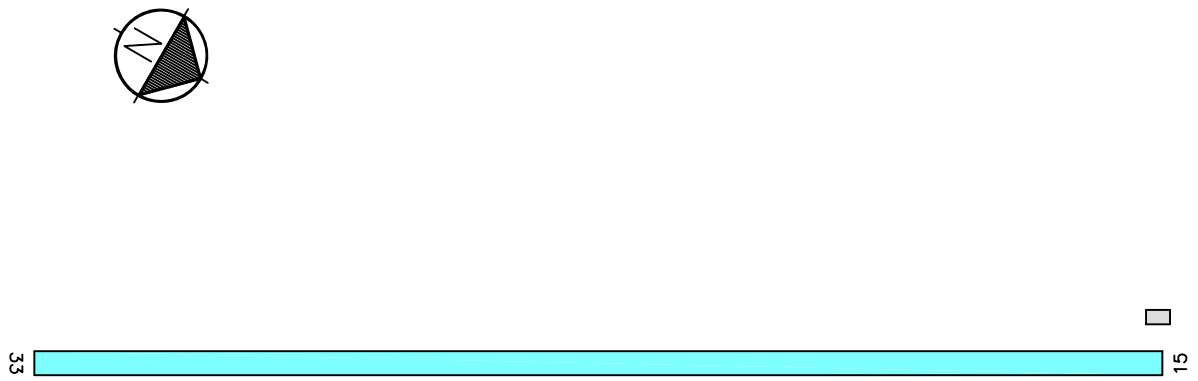
Figure NB-5. Future Pavement Condition.

A graphical representation of the projected PCIs listed in Table 1 is shown in Figure NB-5.
