# Your Airport Report

# PACIFIC CITY STATE AIRPORT

This report describes how your Pavement Maintenance Management Program (PMMP) was developed. Your Program was developed as part of the Oregon Continuous Aviation System Plan sponsored in part by the Oregon Department of Aviation and the Federal Aviation Administration (FAA). The information and data contained in this report ensures you are in compliance with the requirements of FAA Grant Assurance Number 11 which states that any airport requesting federal funds for pavement improvement projects must have implemented a pavement maintenance management program.

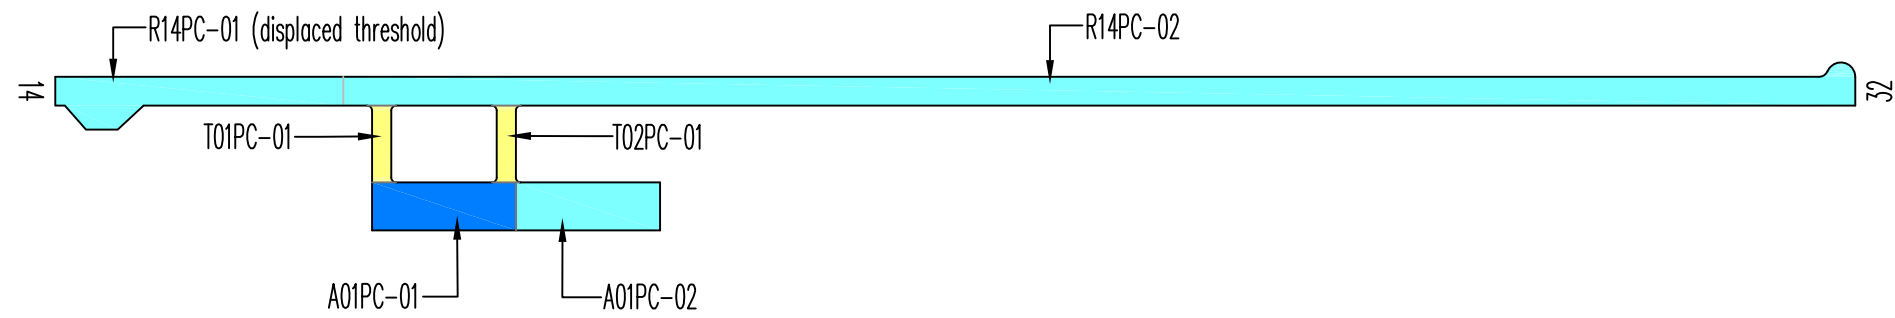
Figure PC-3. Pavement Condition in September 2015.  
Pacific City State Airport

Section PCIs at Pacific City State Airport range from a low of 39 (a PCR of "Very Poor") to a high of 81 (a PCR of "Satisfactory"). The area-weighted average PCI for all airport pavements is 76, corresponding to an overall PCR of "Satisfactory". Figure PC-4 shows how much pavement area is associated with each Pavement Condition Rating category and also shows pavement condition distribution from the inspections conducted in 2008 and 2012.

The primary distresses observed during the inspection were: depressions, longitudinal and transverse cracking, block cracking and alligator cracking, and an isolated occurrence of raveling.

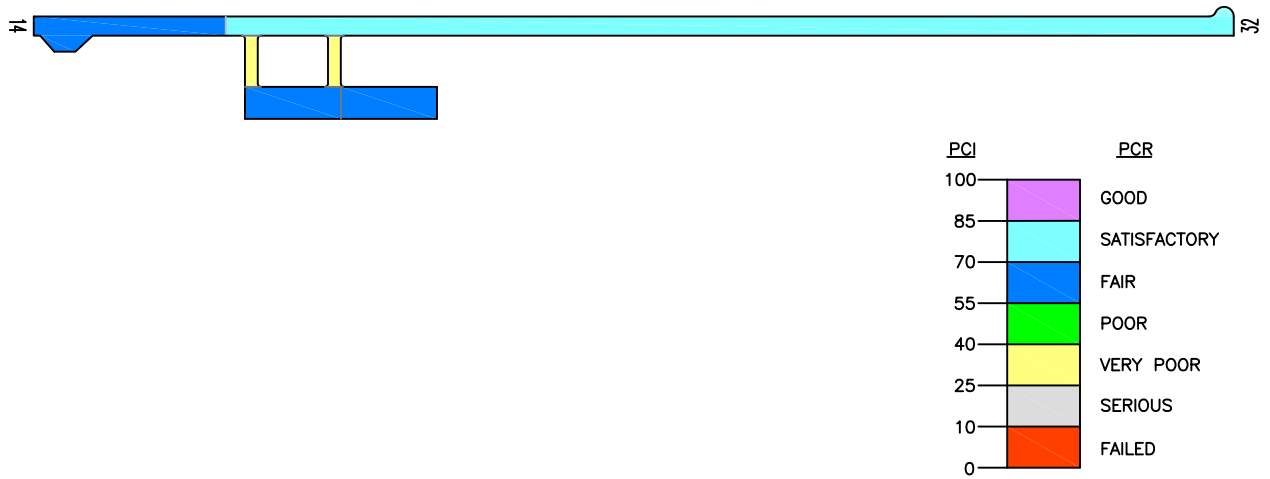
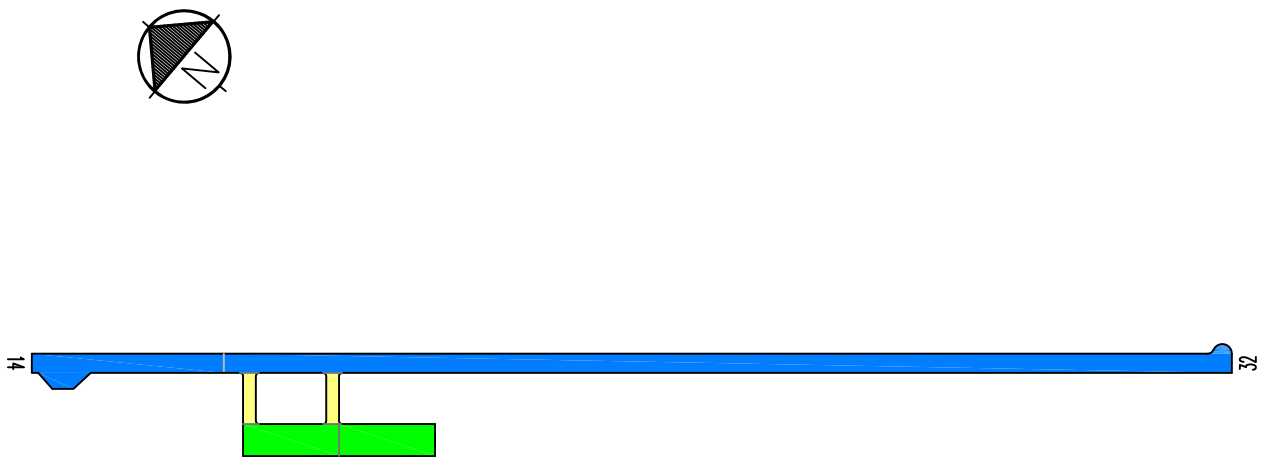
**Figure PC-5. Future Pavement Condition.**

A graphical representation of the projected PCIs listed in Table 1 is shown in Figure PC-5.
