# SALEM McNARY FIELD

This report describes how your Pavement Maintenance Management Program (PMMP) was developed. Your Program was developed as part of the Oregon Continuous Aviation System Plan sponsored in part by the Oregon Department of Aviation and the Federal Aviation Administration (FAA). The information and data contained in this report ensures you are in compliance with the requirements of FAA Grant Assurance Number 11 which states that any airport requesting federal funds for pavement improvement projects must have implemented a pavement maintenance management program.

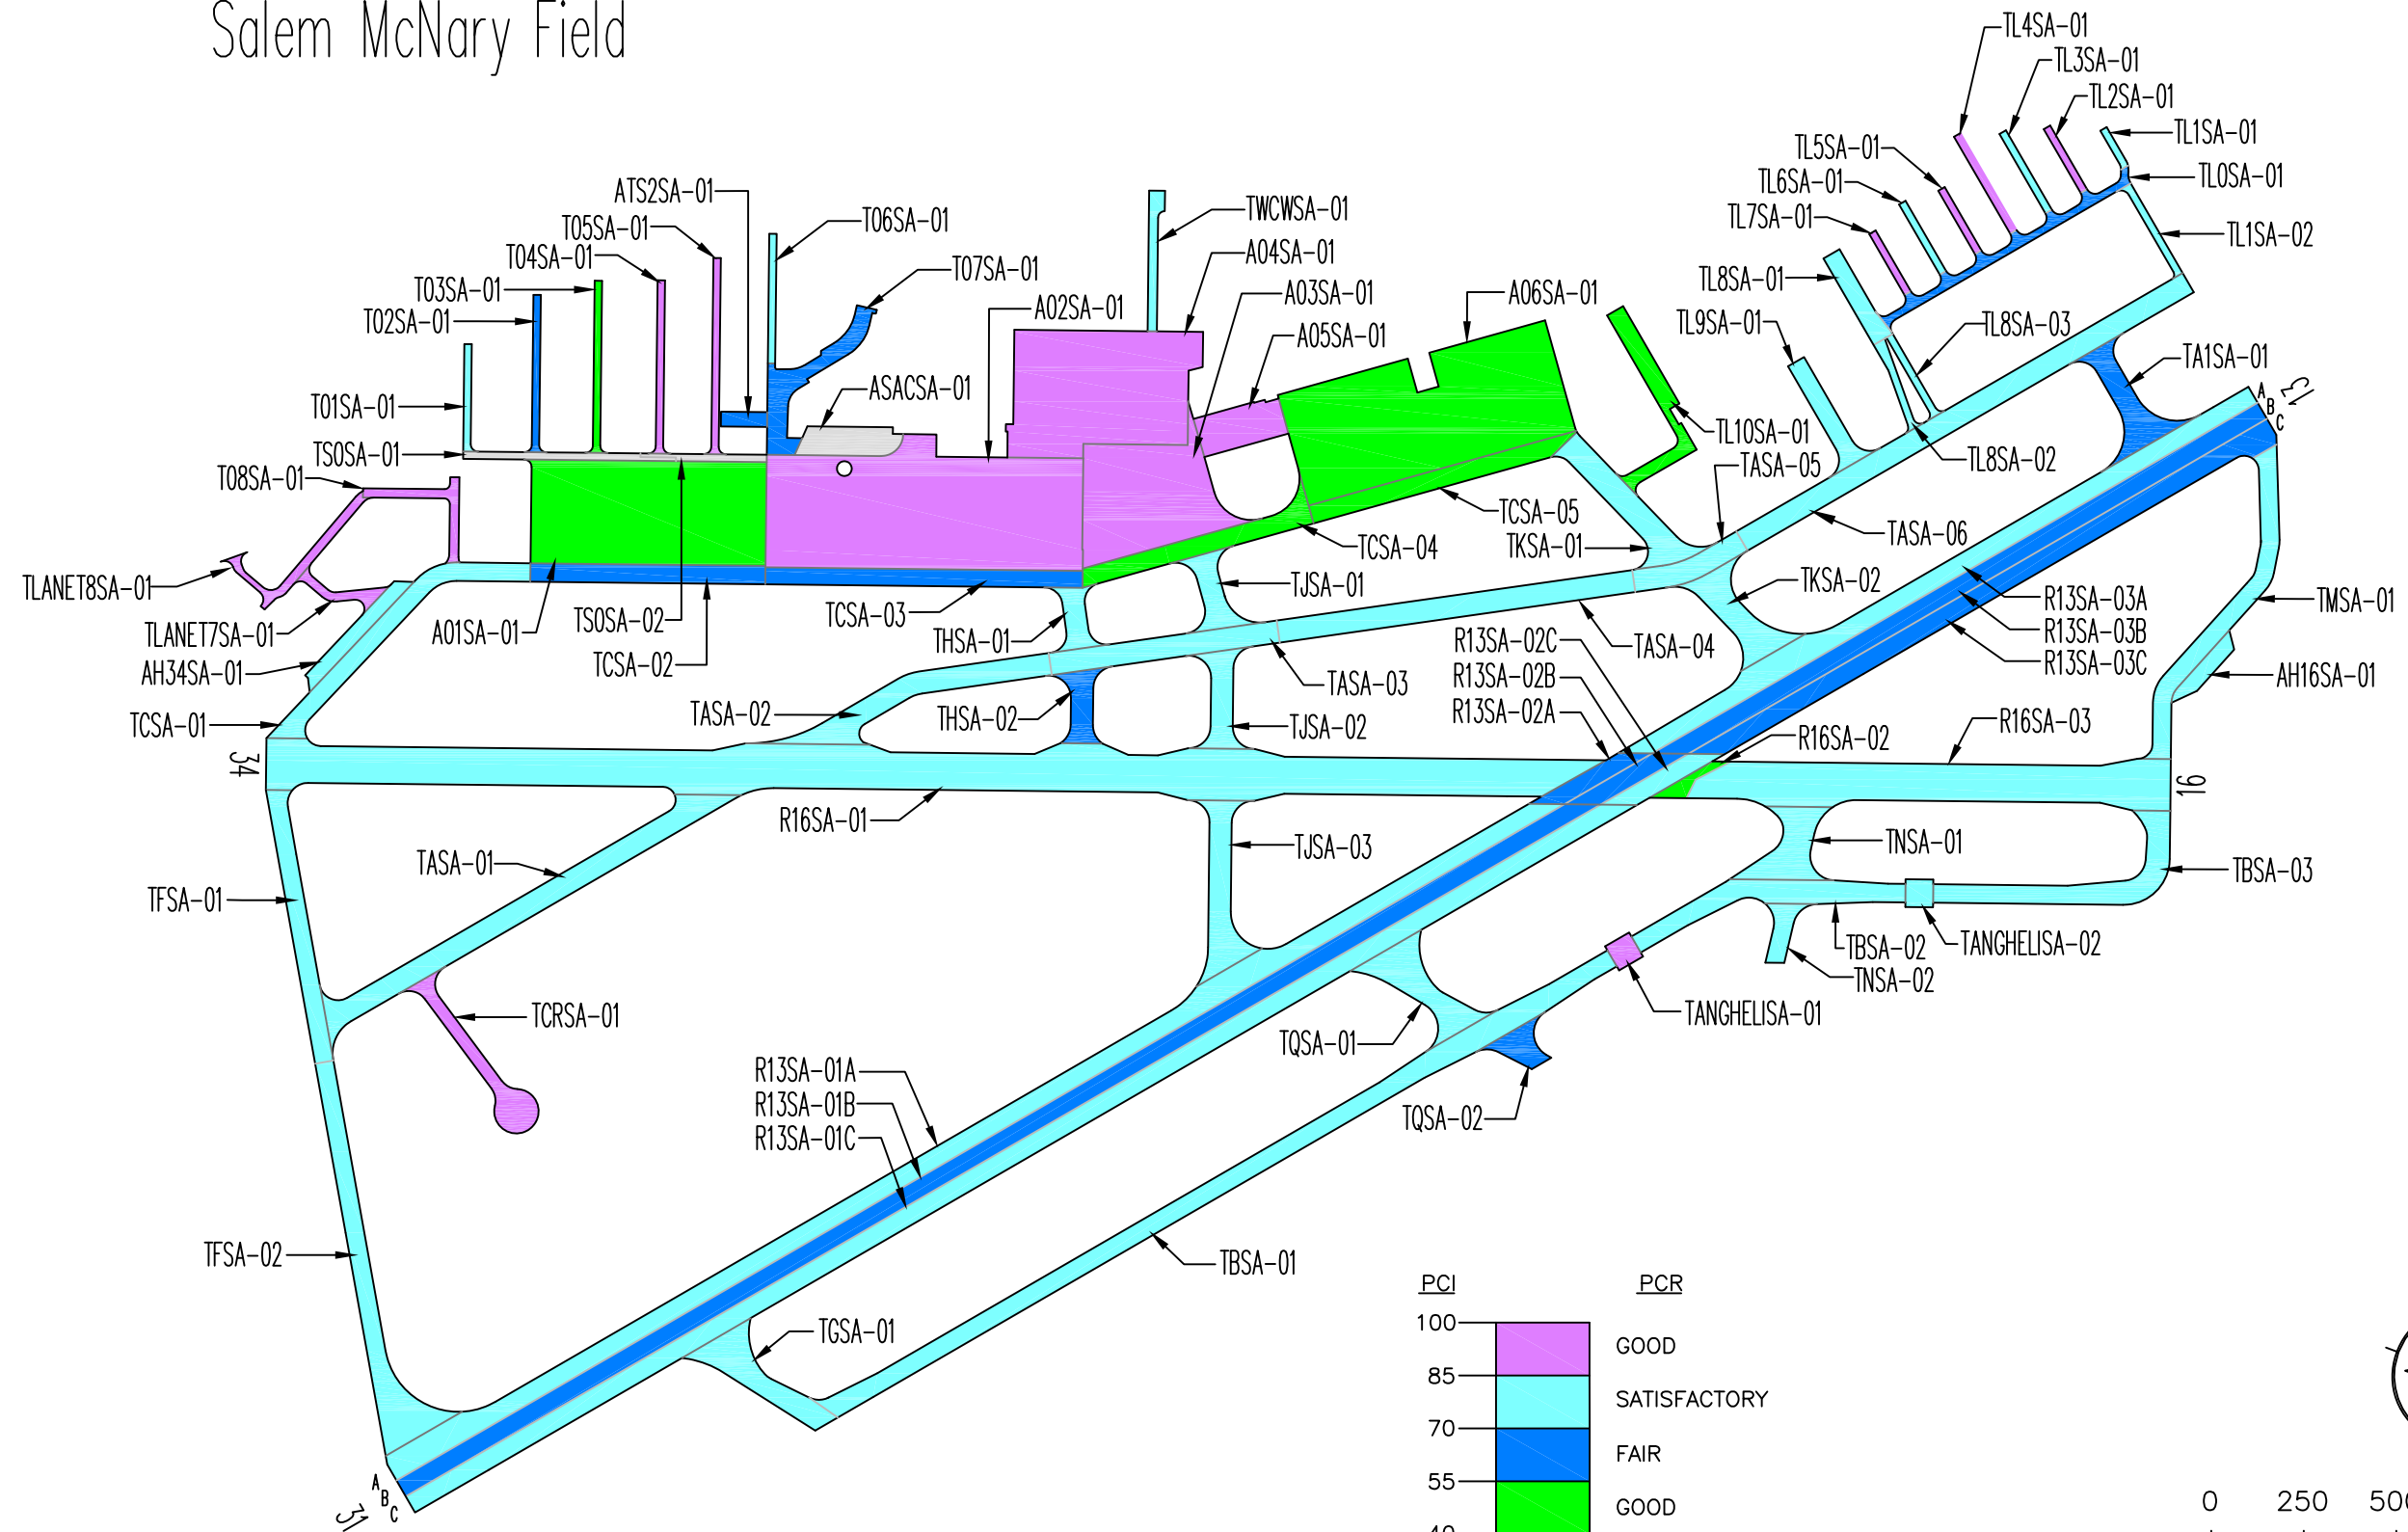
Figure SA-3. Pavement Condition in September 2015.  
Salem McNary Field

Section PCIs at Salem McNary Field range from a low of 12 (a PCR of “Serious”) to a high of 100 (a PCR of “Good”). The area-weighted average PCI for all airport pavements is 73, corresponding to an overall PCR of “Satisfactory”. Figure SA-4 shows how much pavement area is associated with each Pavement Condition Rating category and also shows pavement condition distribution from the inspections conducted in 2008 and 2012.

The primary distresses observed in the asphalt pavements during the inspection were: longitudinal and transverse cracking, weathering, block cracking, alligator cracking, patching, and raveling, with an isolated occurrence of depressions. The primary distresses observed in the concrete pavements were: linear cracking, corner spalls, joint spalls, joint seal damage, and small patches, with isolated occurrences of shattered slabs and shrinkage cracks.

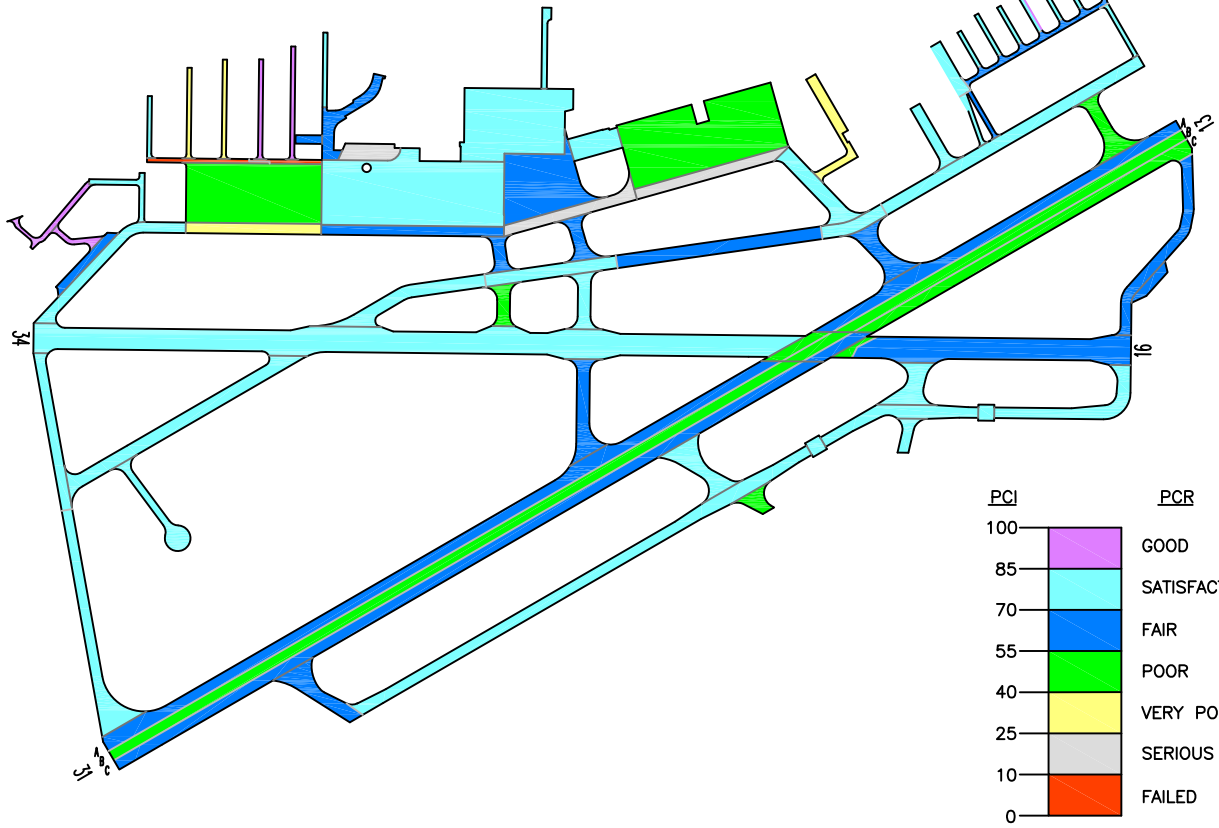
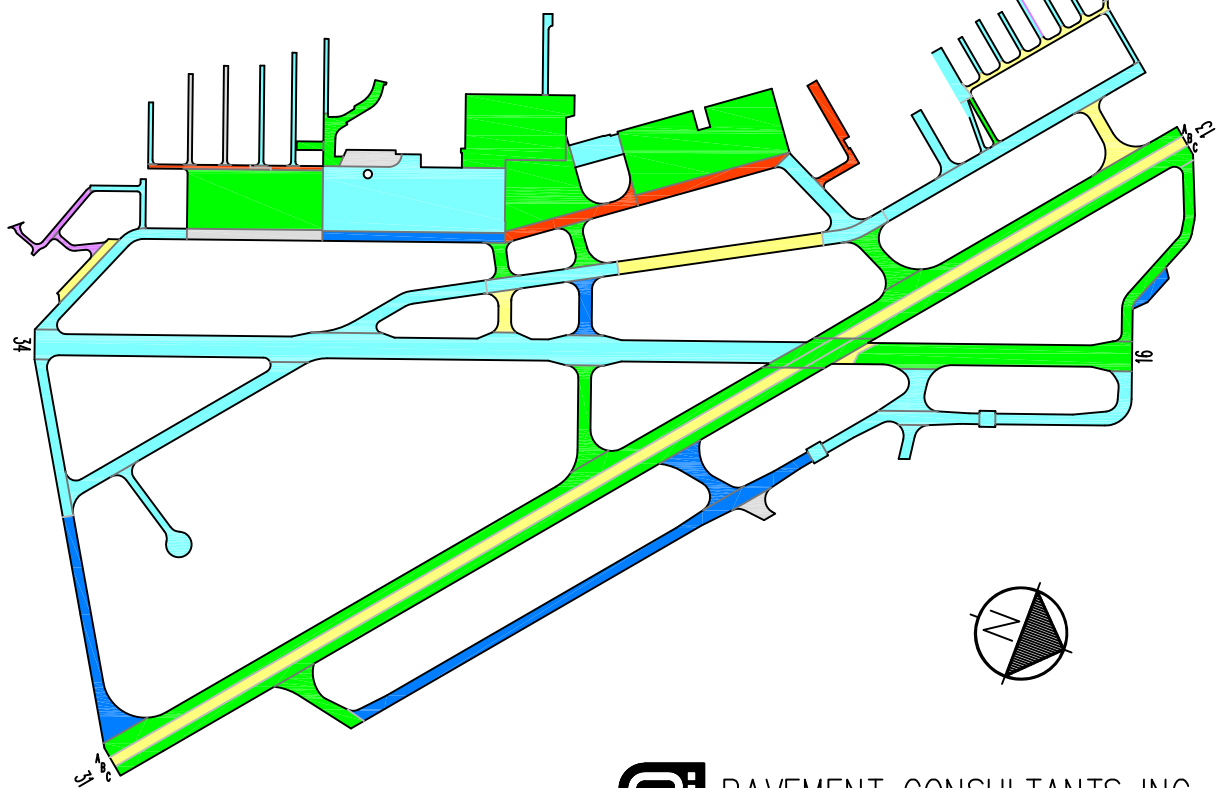
**Figure SA-5. Future Pavement Condition.**

A graphical representation of the projected PCIs listed in Table 1 is shown in Figure SA-5.
