# SCAPPOOSE INDUSTRIAL AIRPARK

This report describes how your Pavement Maintenance Management Program (PMMP) was developed. Your Program was developed as part of the Oregon Continuous Aviation System Plan sponsored in part by the Oregon Department of Aviation and the Federal Aviation Administration (FAA). The information and data contained in this report ensures you are in compliance with the requirements of FAA Grant Assurance Number 11 which states that any airport requesting federal funds for pavement improvement projects must have implemented a pavement maintenance management program.

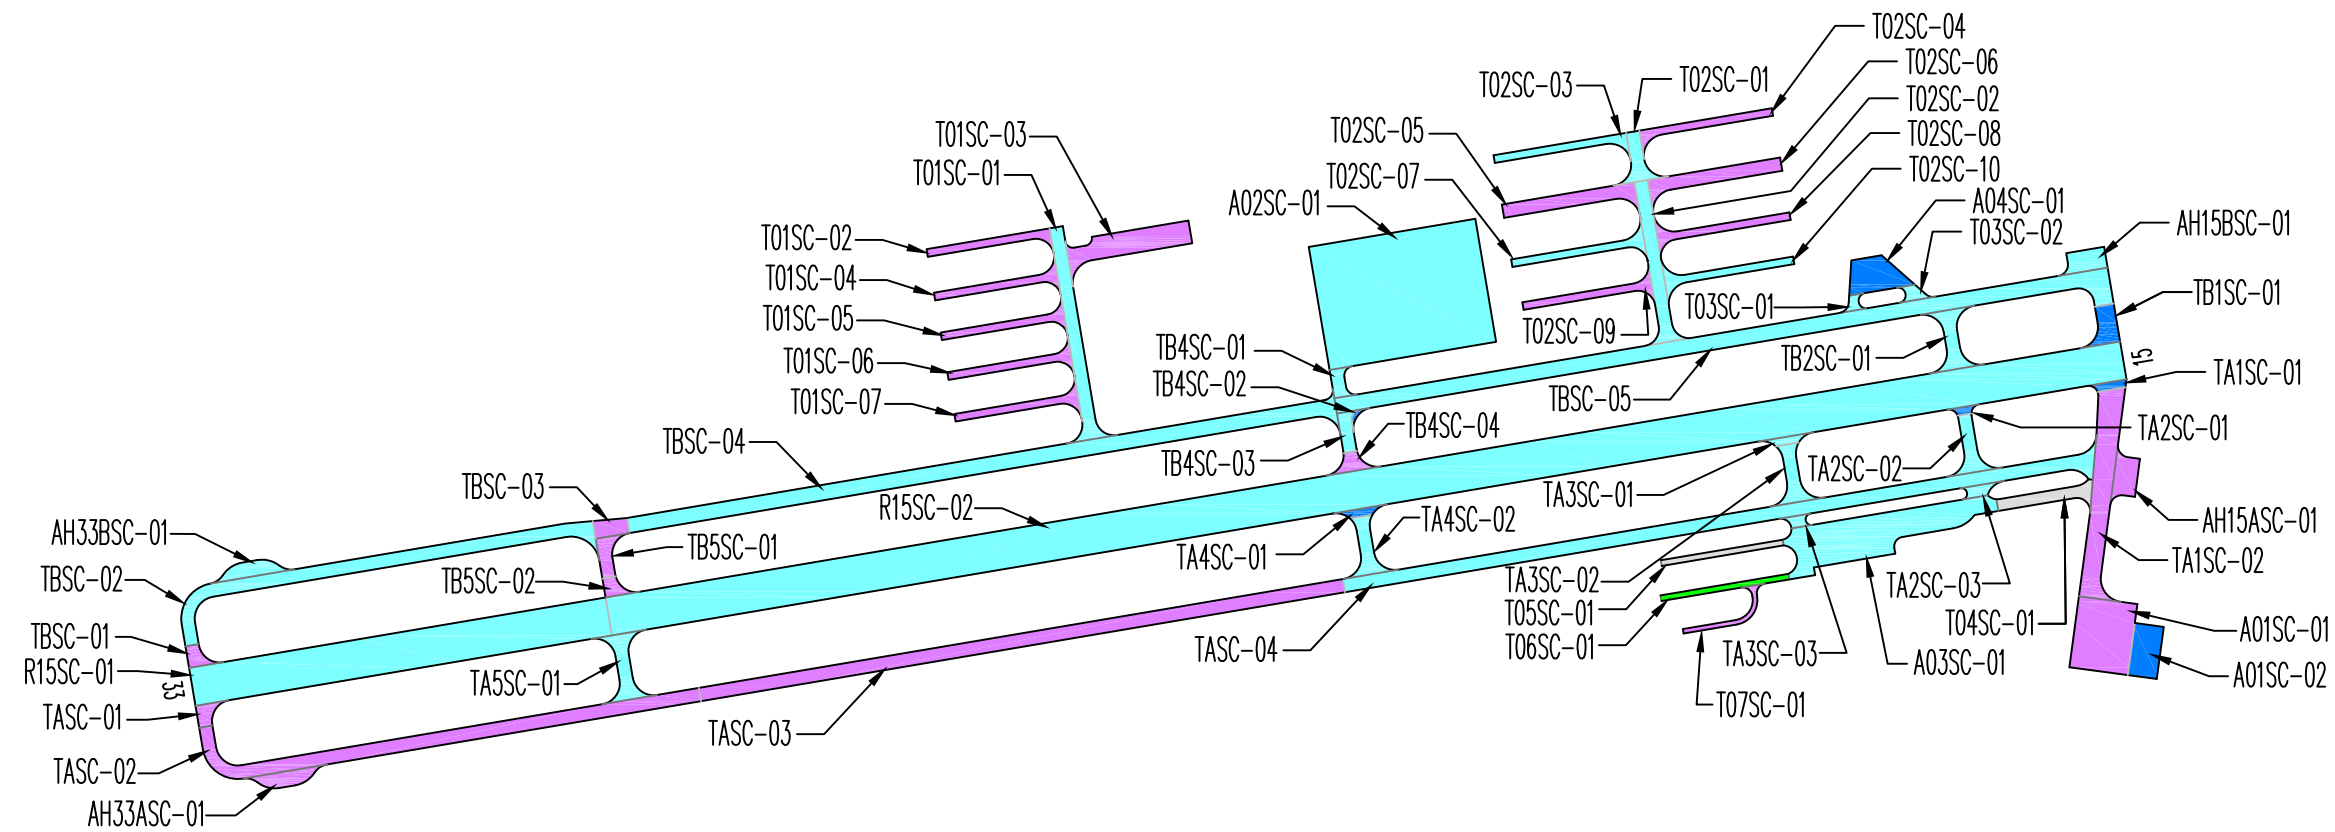
Figure SC-3. Pavement Condition in September 2015.  
Scappoose Industrial Airpark

Section PCIs at Scappoose Industrial Airpark range from a low of 11 (a PCR of “Serious”) to a high of 100 (a PCR of “Good”). The area-weighted average PCI for all airport pavements is 82, corresponding to an overall PCR of “Satisfactory”. Figure SC-4 shows how much pavement area is associated with each Pavement Condition Rating category and also shows pavement condition distribution from the inspections conducted in 2008 and 2012.

The primary distresses observed during the inspection were: longitudinal and transverse cracking, patching, block cracking, raveling and alligator cracking with an isolated occurrence of depressions.
