Your Airport Report

SEASIDE MUNICIPAL AIRPORT

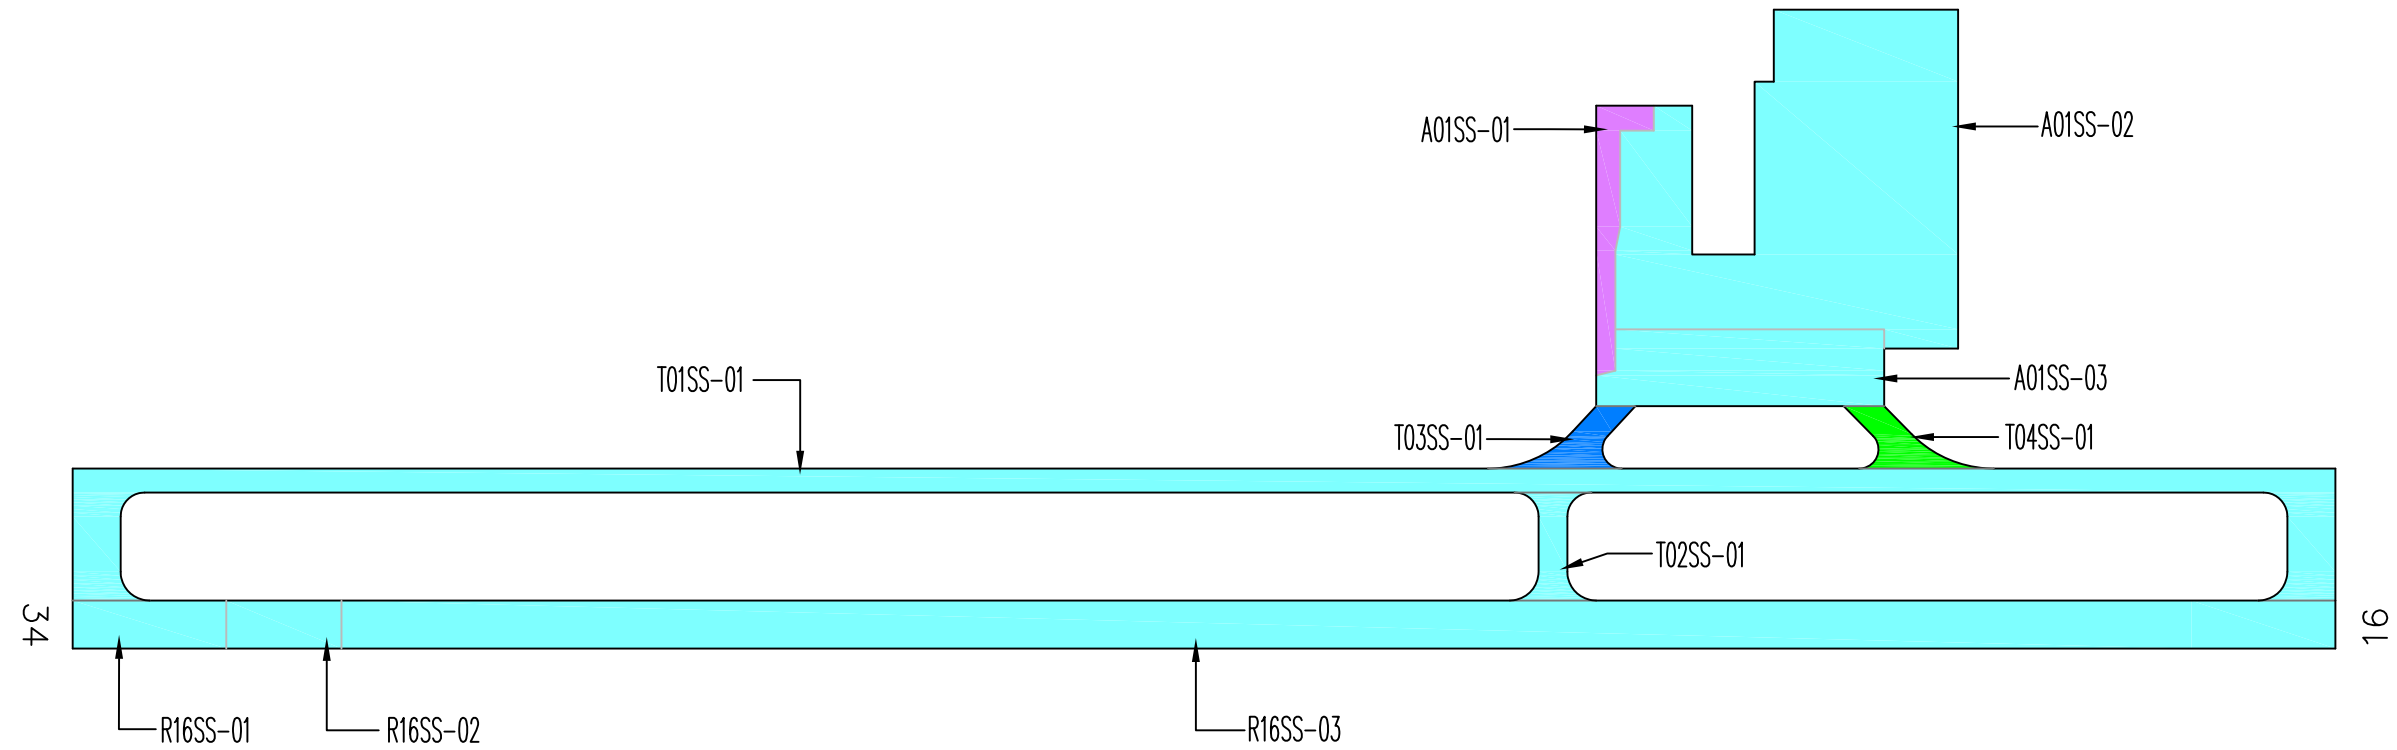
Figure SS-3. Pavement Condition in September 2015.
Seaside Municipal Airport

Section PCIs at Seaside Municipal Airport range from a low of 55 (a PCR of “Poor”) to a high of 100 (a PCR of “Good”). The area-weighted average PCI for all airport pavements is 75, corresponding to an overall PCR of “Satisfactory”. Figure SS-4 shows how much pavement area is associated with each Pavement Condition Rating category and also shows pavement condition distribution from the inspections conducted in 2008 and 2012.

The primary distresses observed during the inspection were: longitudinal and transverse cracking, patching, depressions and an isolated occurrence of block cracking.

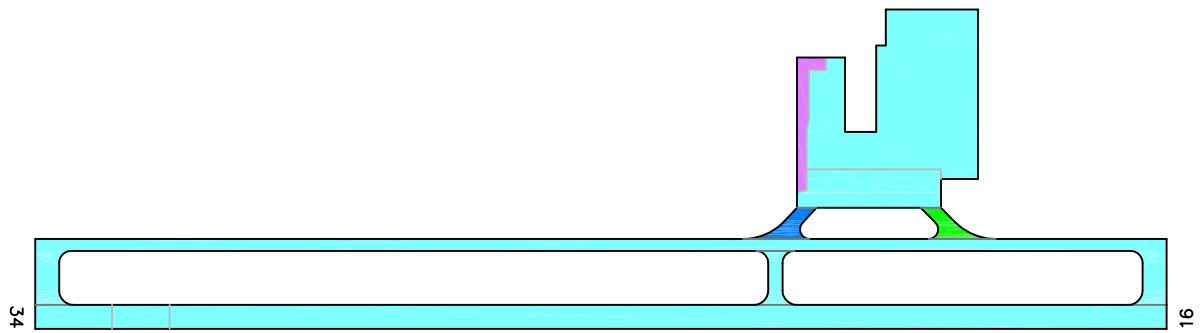
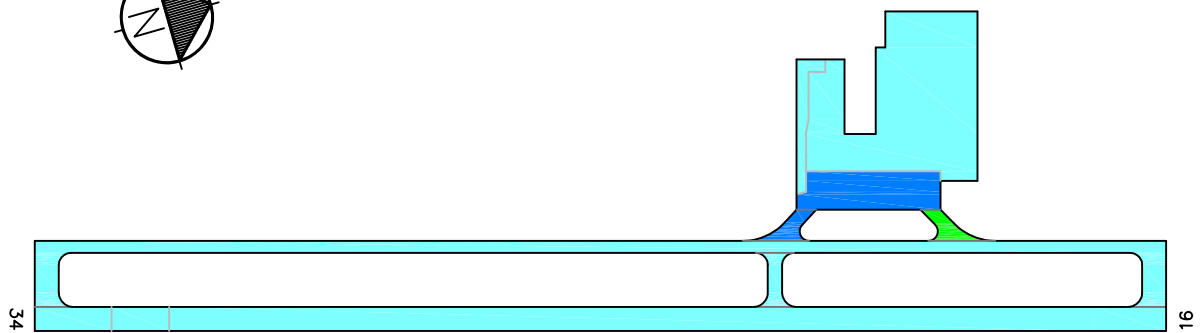
Figure SS-5. Future Pavement Condition.

A graphical representation of the projected PCIs listed in Table 1 is shown in Figure SS-5.
