Your Airport Report

SILETZ BAY STATE AIRPORT

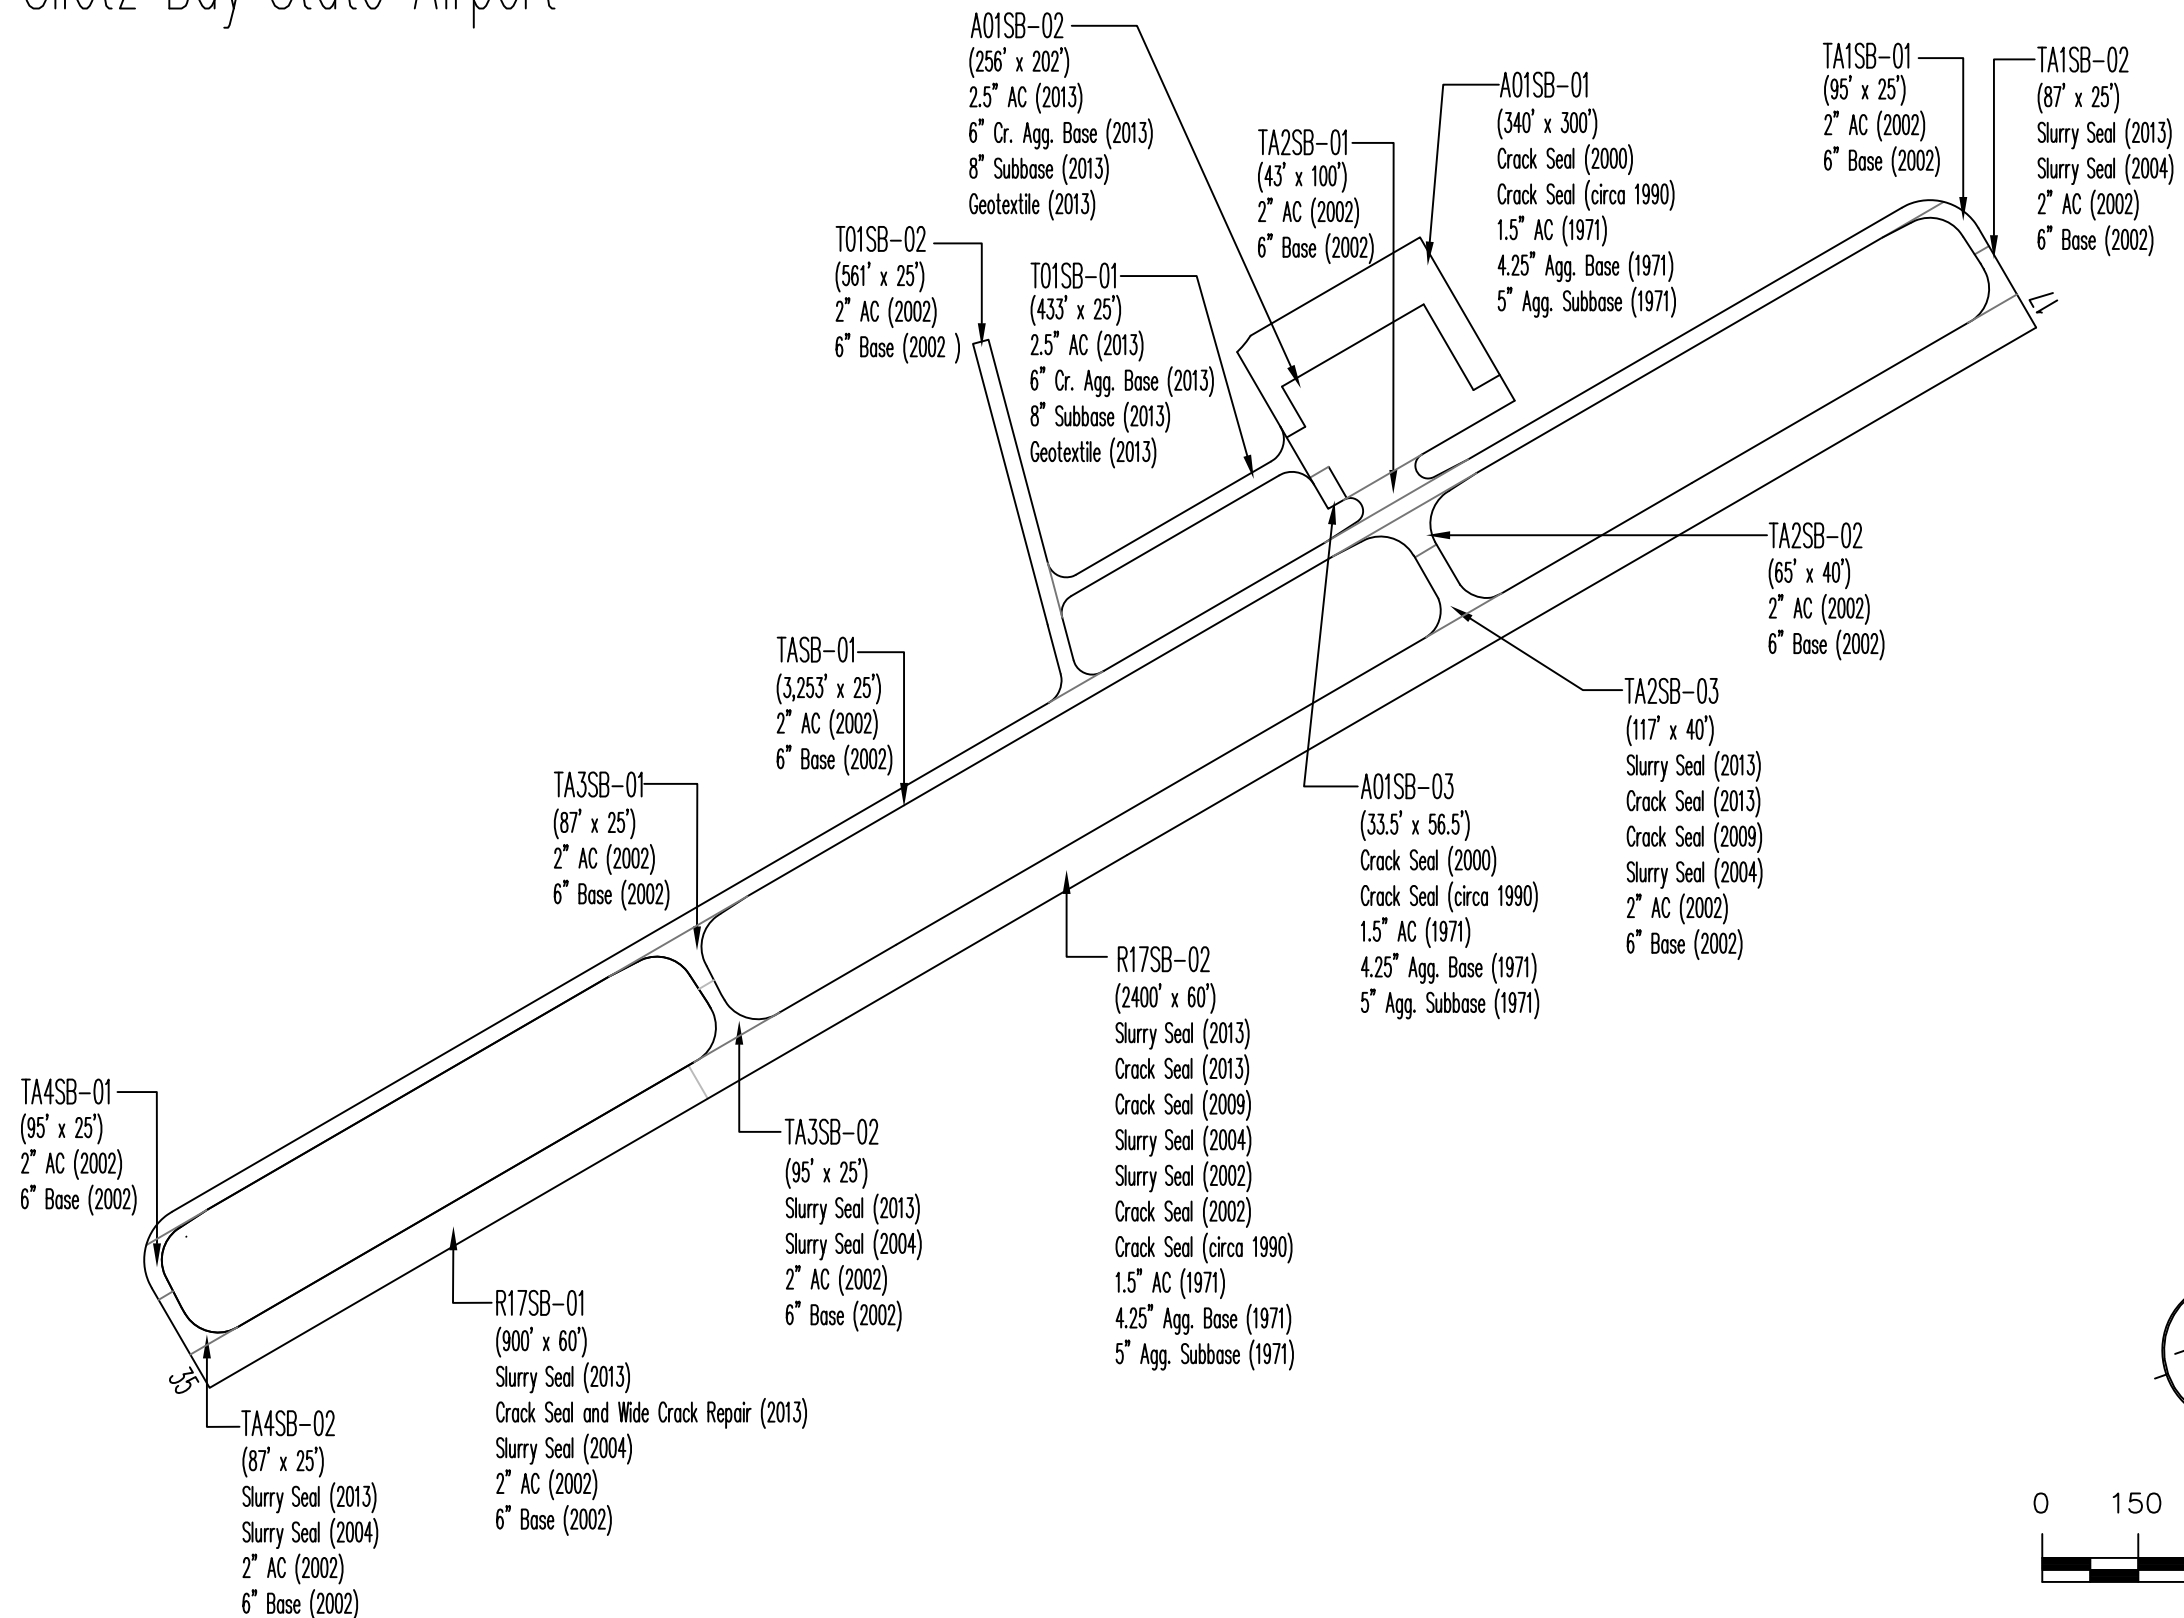
Figure SB-1. Airport Layout, Dimensions and Pavement Cross-Sections.
Siletz Bay State Airport

To determine how your pavements were constructed and their age, a records review was conducted. Figure SB-1 shows the records review results. This figure identifies pavement boundaries, dimensions, pavement layer types, thicknesses and dates of construction. The most recent construction date for each pavement can also be found in the Section Condition Report in Appendix 2. Figure SB-1 and the information contained in Appendices 1, 2 and 4 ensure that your airport complies with the “pavement inventory” requirement of FAA’s PMMP guidelines.

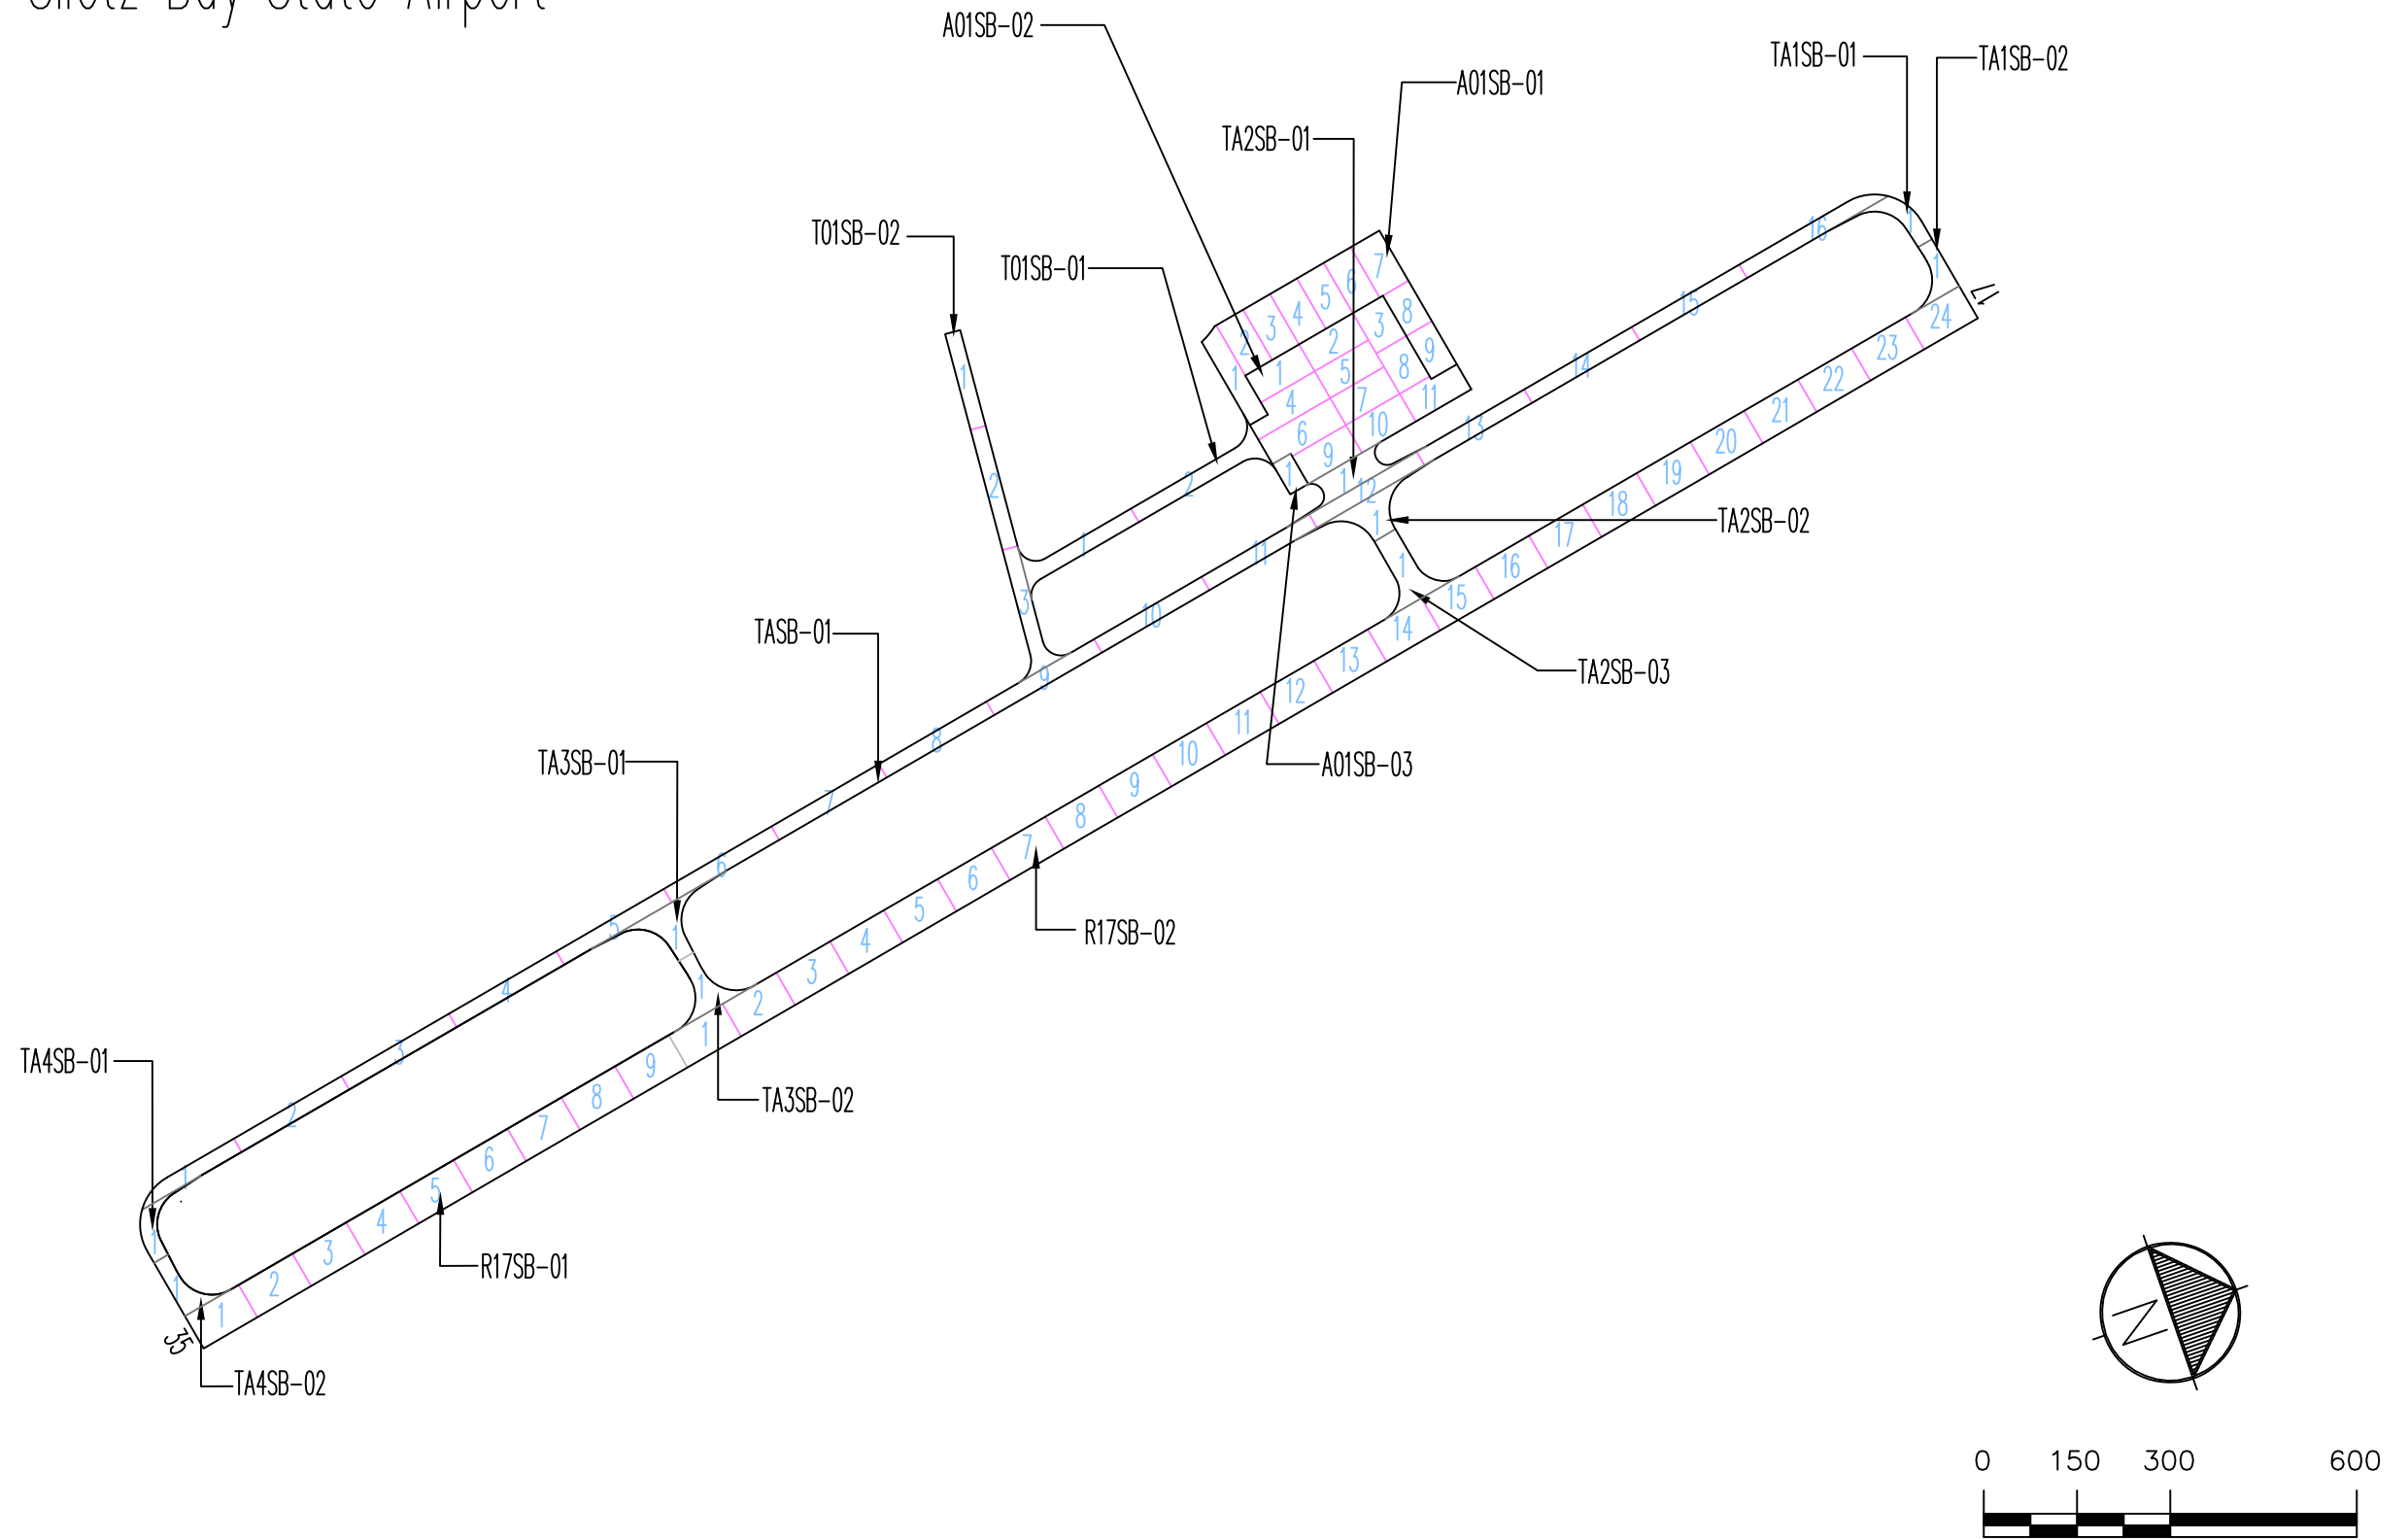
Figure SB-2. Pavement Branch, Section and Sample Unit Layout.
Siletz Bay State Airport

The pavements at your airport were divided into branches, sections and sample units in accordance with the methodology outlined in the current edition of ASTM D5430, *Standard Test Method for Airport Condition Index Surveys*. The branches, sections and sample units established at your airport are shown in Figure SB-2. A Branch Condition Report showing all branches, their associated areas, and their area-weighted average condition is provided in Appendix 1. Additionally, the Appendix 2 Section Condition Report provides information used to define each branch and section in the Micro PAVER database.

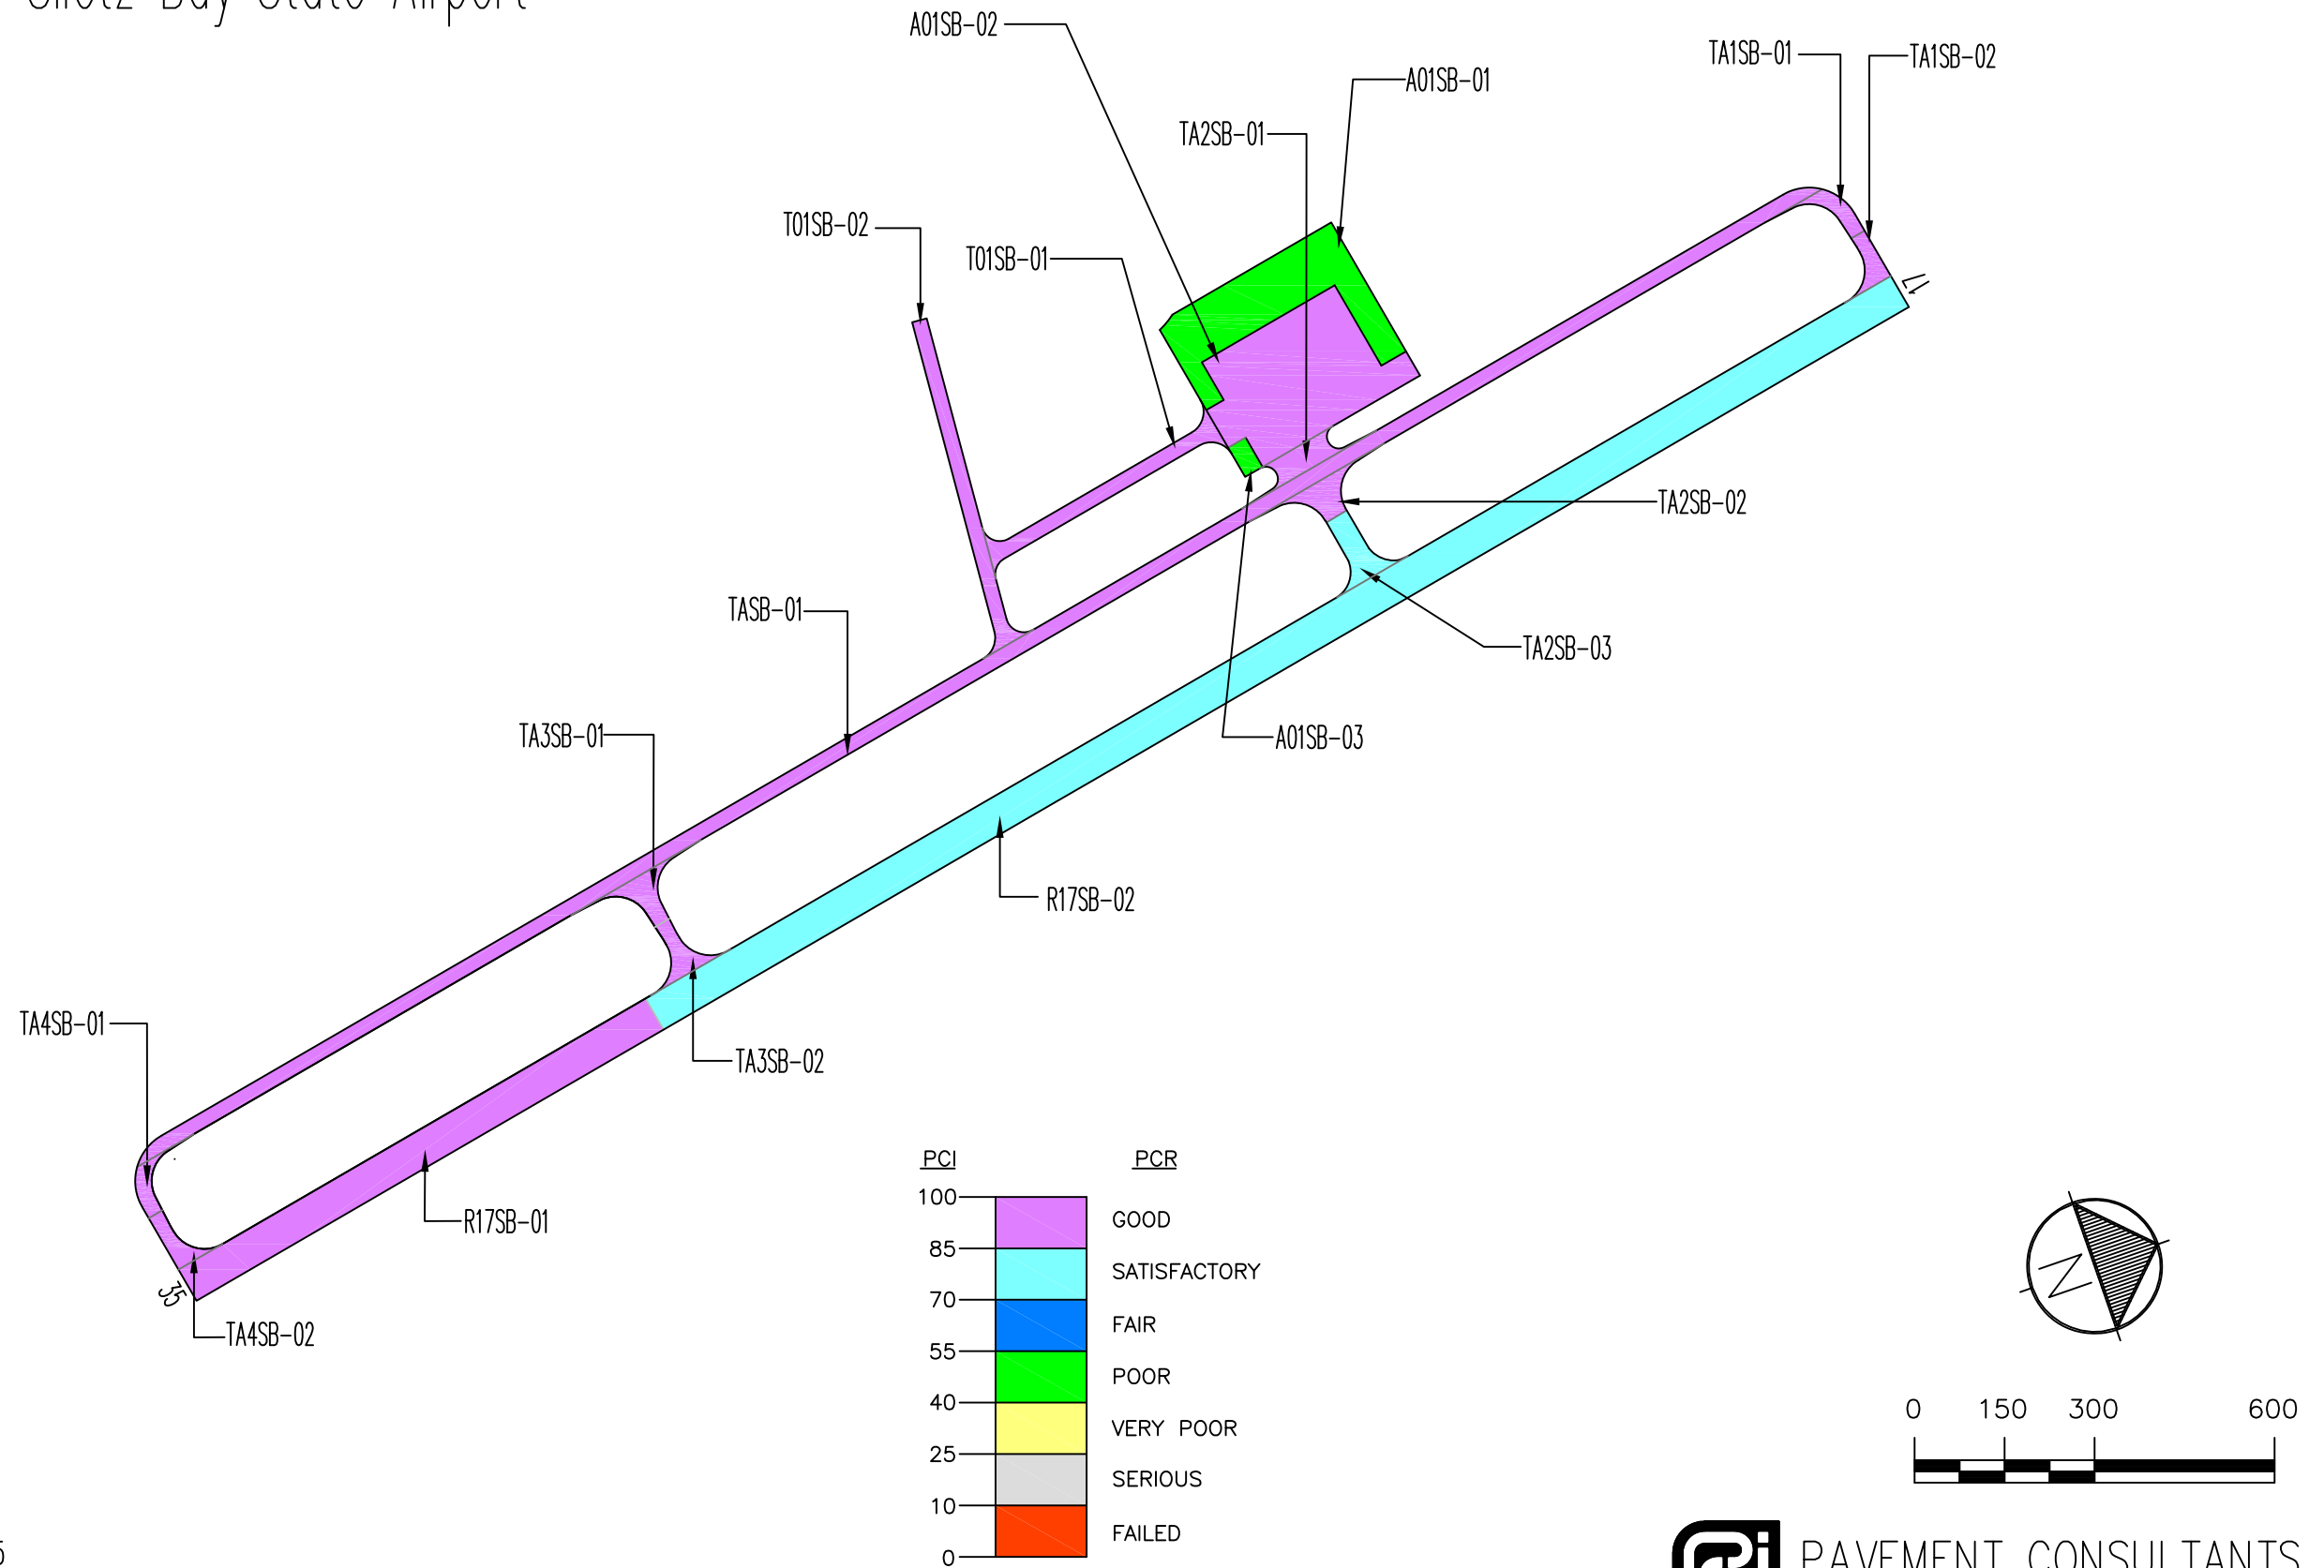
Figure SB-3. Pavement Condition in September 2015.
Siletz Bay State Airport

The Branch Condition Report in Appendix 1 summarizes current pavement condition by branch while the Section Condition Report in Appendix 2 lists pavement condition by section. The current PCR is shown graphically in Figure SB-3.

Section PCIs at Siletz Bay State Airport range from a low of 49 (a PCR of “Poor”) to a high of 100 (a PCR of “Good”). The area-weighted average PCI for all airport pavements is 85, corresponding to an overall PCR of “Satisfactory”. Figure SB-4 shows how much pavement area is associated with each Pavement Condition Rating category and also shows pavement condition distribution from the inspections conducted in 2008 and 2012.

The primary distresses observed during the inspection were: longitudinal and transverse cracking, block cracking and weathering.

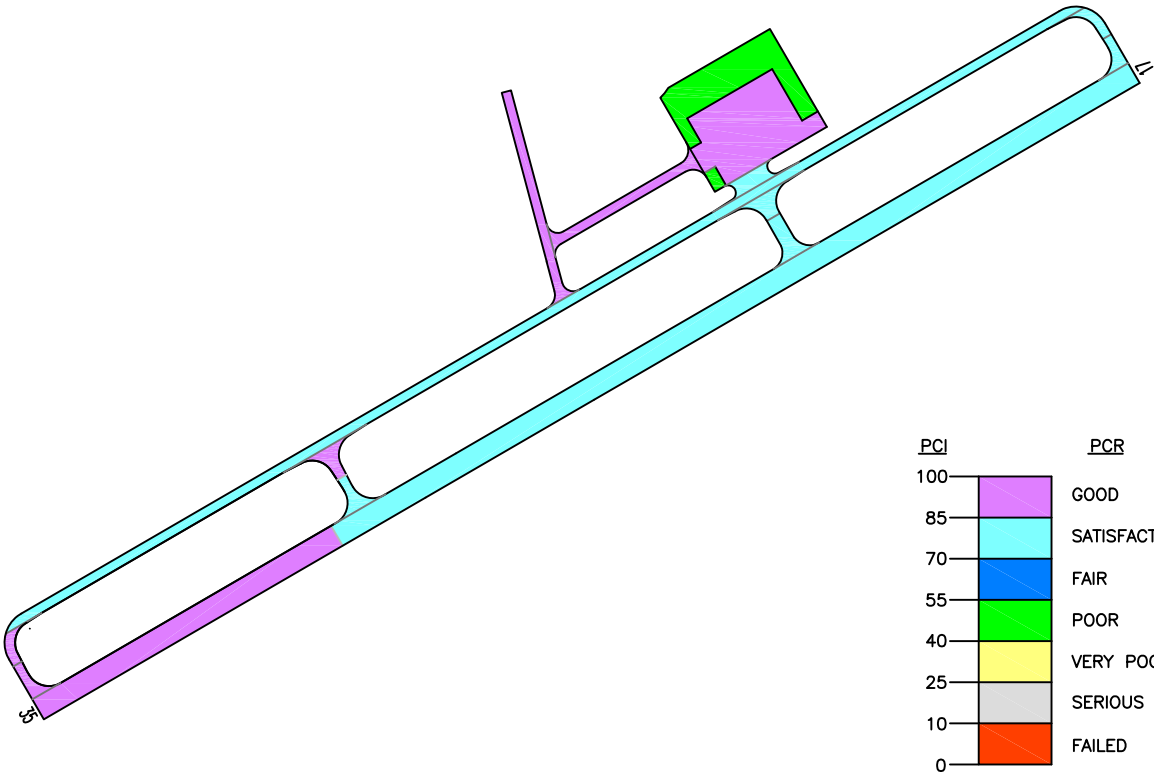
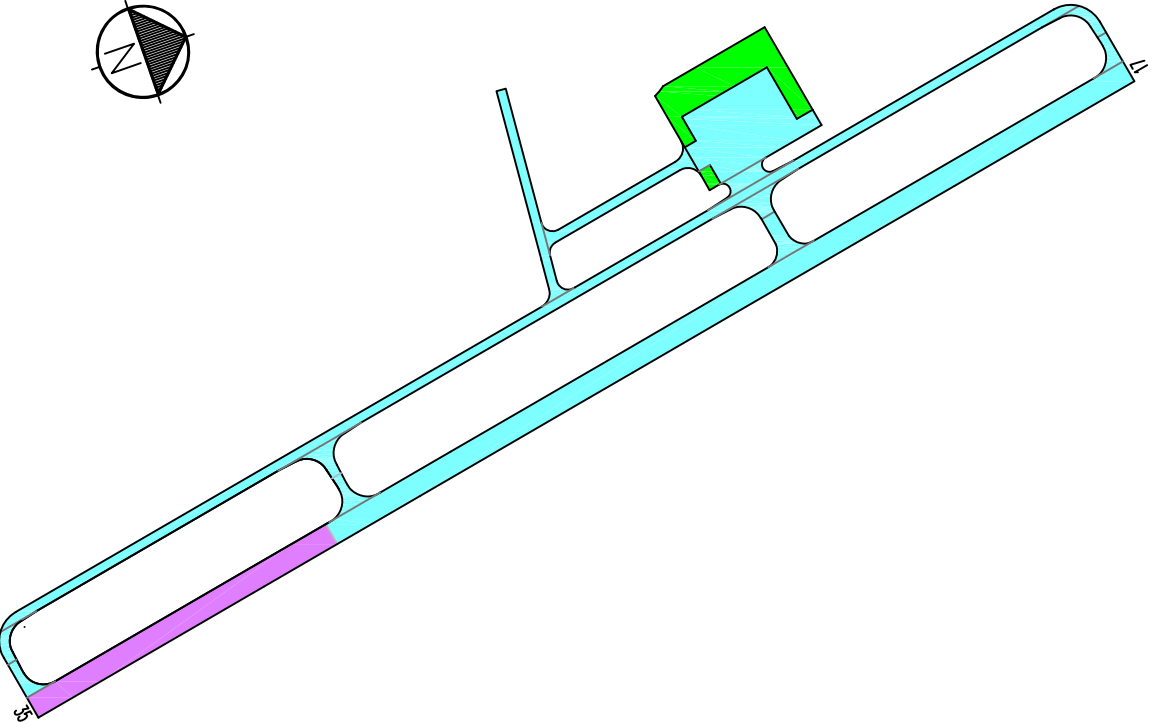
Figure SB-5. Future Pavement Condition.

A graphical representation of the projected PCIs listed in Table 1 is shown in Figure SB-5.
