Your Airport Report

SPORTSMAN AIRPARK

This report describes how your Pavement Maintenance Management Program (PMMP) was developed. Your Program was developed as part of the Oregon Continuous Aviation System Plan sponsored in part by the Oregon Department of Aviation and the Federal Aviation Administration (FAA). The information and data contained in this report ensures you are in compliance with the requirements of FAA Grant Assurance Number 11 which states that any airport requesting federal funds for pavement improvement projects must have implemented a pavement maintenance management program.

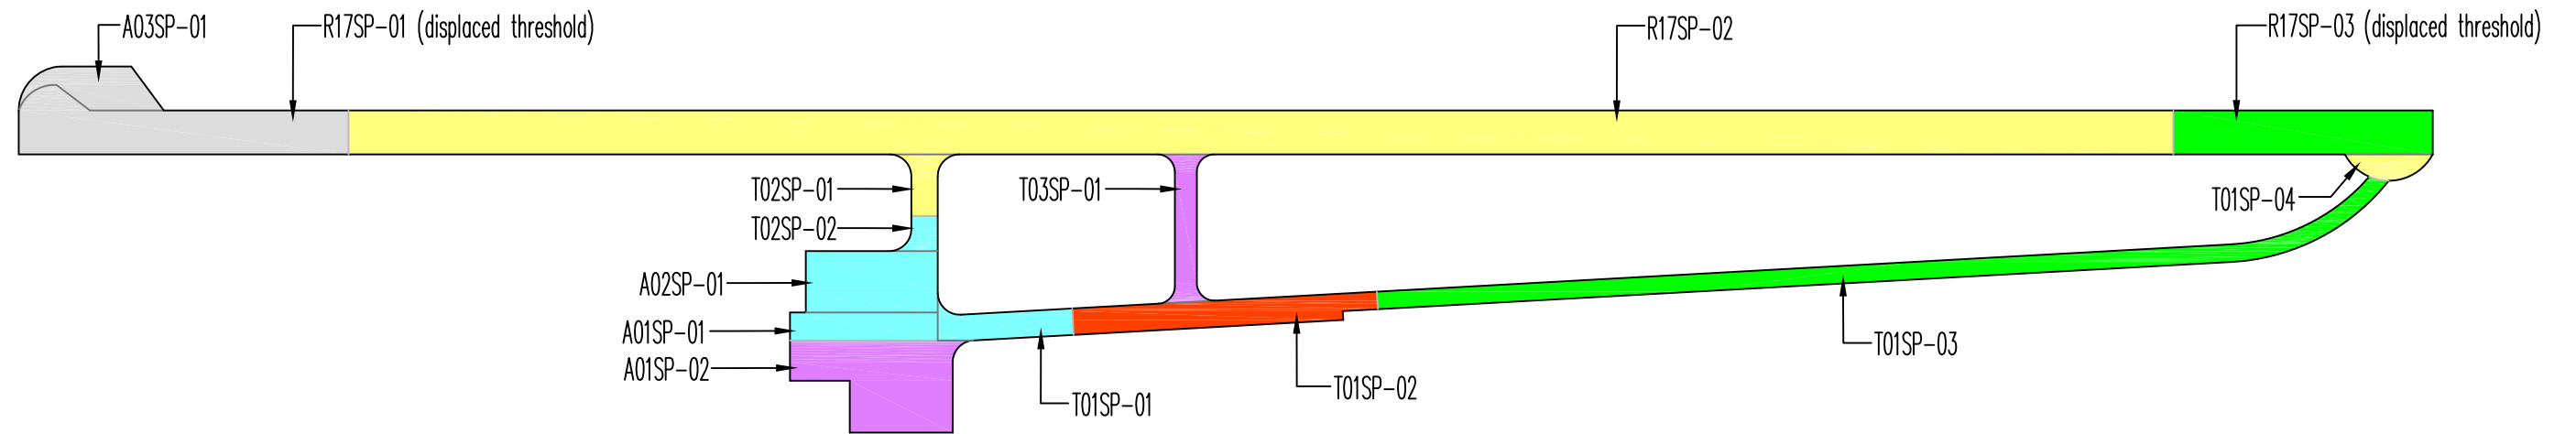
Figure SP-3. Pavement Condition in September 2015.
Sportsman Airpark

The Branch Condition Report in Appendix 1 summarizes current pavement condition by branch while the Section Condition Report in Appendix 2 lists pavement condition by section. The current PCR is shown graphically in Figure SP-3.

Section PCIs at Sportsman Airpark range from a low of 8 (a PCR of “Failed”) to a high of 90 (a PCR of “Good”). The area-weighted average PCI for all airport pavements is 42, corresponding to an overall PCR of “Poor”. Figure SP-4 shows how much pavement area is associated with each Pavement Condition Rating category and also shows pavement condition distribution from the inspections conducted in 2008 and 2012.

The primary distresses observed during the inspection were: weathering, longitudinal and transverse cracking, raveling, alligator cracking, block cracking, patching, and depressions.
