Your Airport Report

TOLEDO STATE AIRPORT

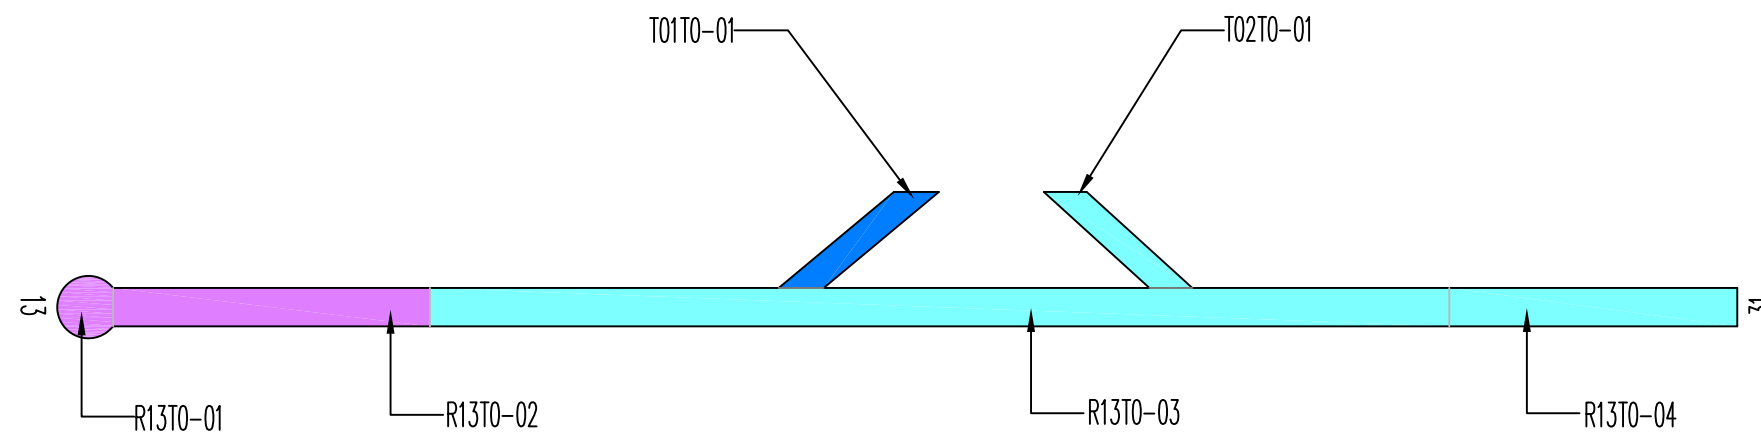
Figure T0-3. Pavement Condition in September 2015.
Toledo State Airport

Section PCIs at Toledo State Airport range from a low of 68 (a PCR of “Fair”) to a high of 91 (a PCR of “Good”). The area-weighted average PCI for all airport pavements is 84, corresponding to an overall PCR of “Satisfactory”. Figure TO-4 shows how much pavement area is associated with each Pavement Condition Rating category and also shows pavement condition distribution from the inspections conducted in 2008 and 2012.

The primary distresses observed during the inspection were: longitudinal and transverse cracking and depressions.
