# Your Airport Report

# VALLEY VIEW AIRPORT

This report describes how your Pavement Maintenance Management Program (PMMP) was developed. Your Program was developed as part of the Oregon Continuous Aviation System Plan sponsored in part by the Oregon Department of Aviation and the Federal Aviation Administration (FAA). The information and data contained in this report ensures you are in compliance with the requirements of FAA Grant Assurance Number 11 which states that any airport requesting federal funds for pavement improvement projects must have implemented a pavement maintenance management program.

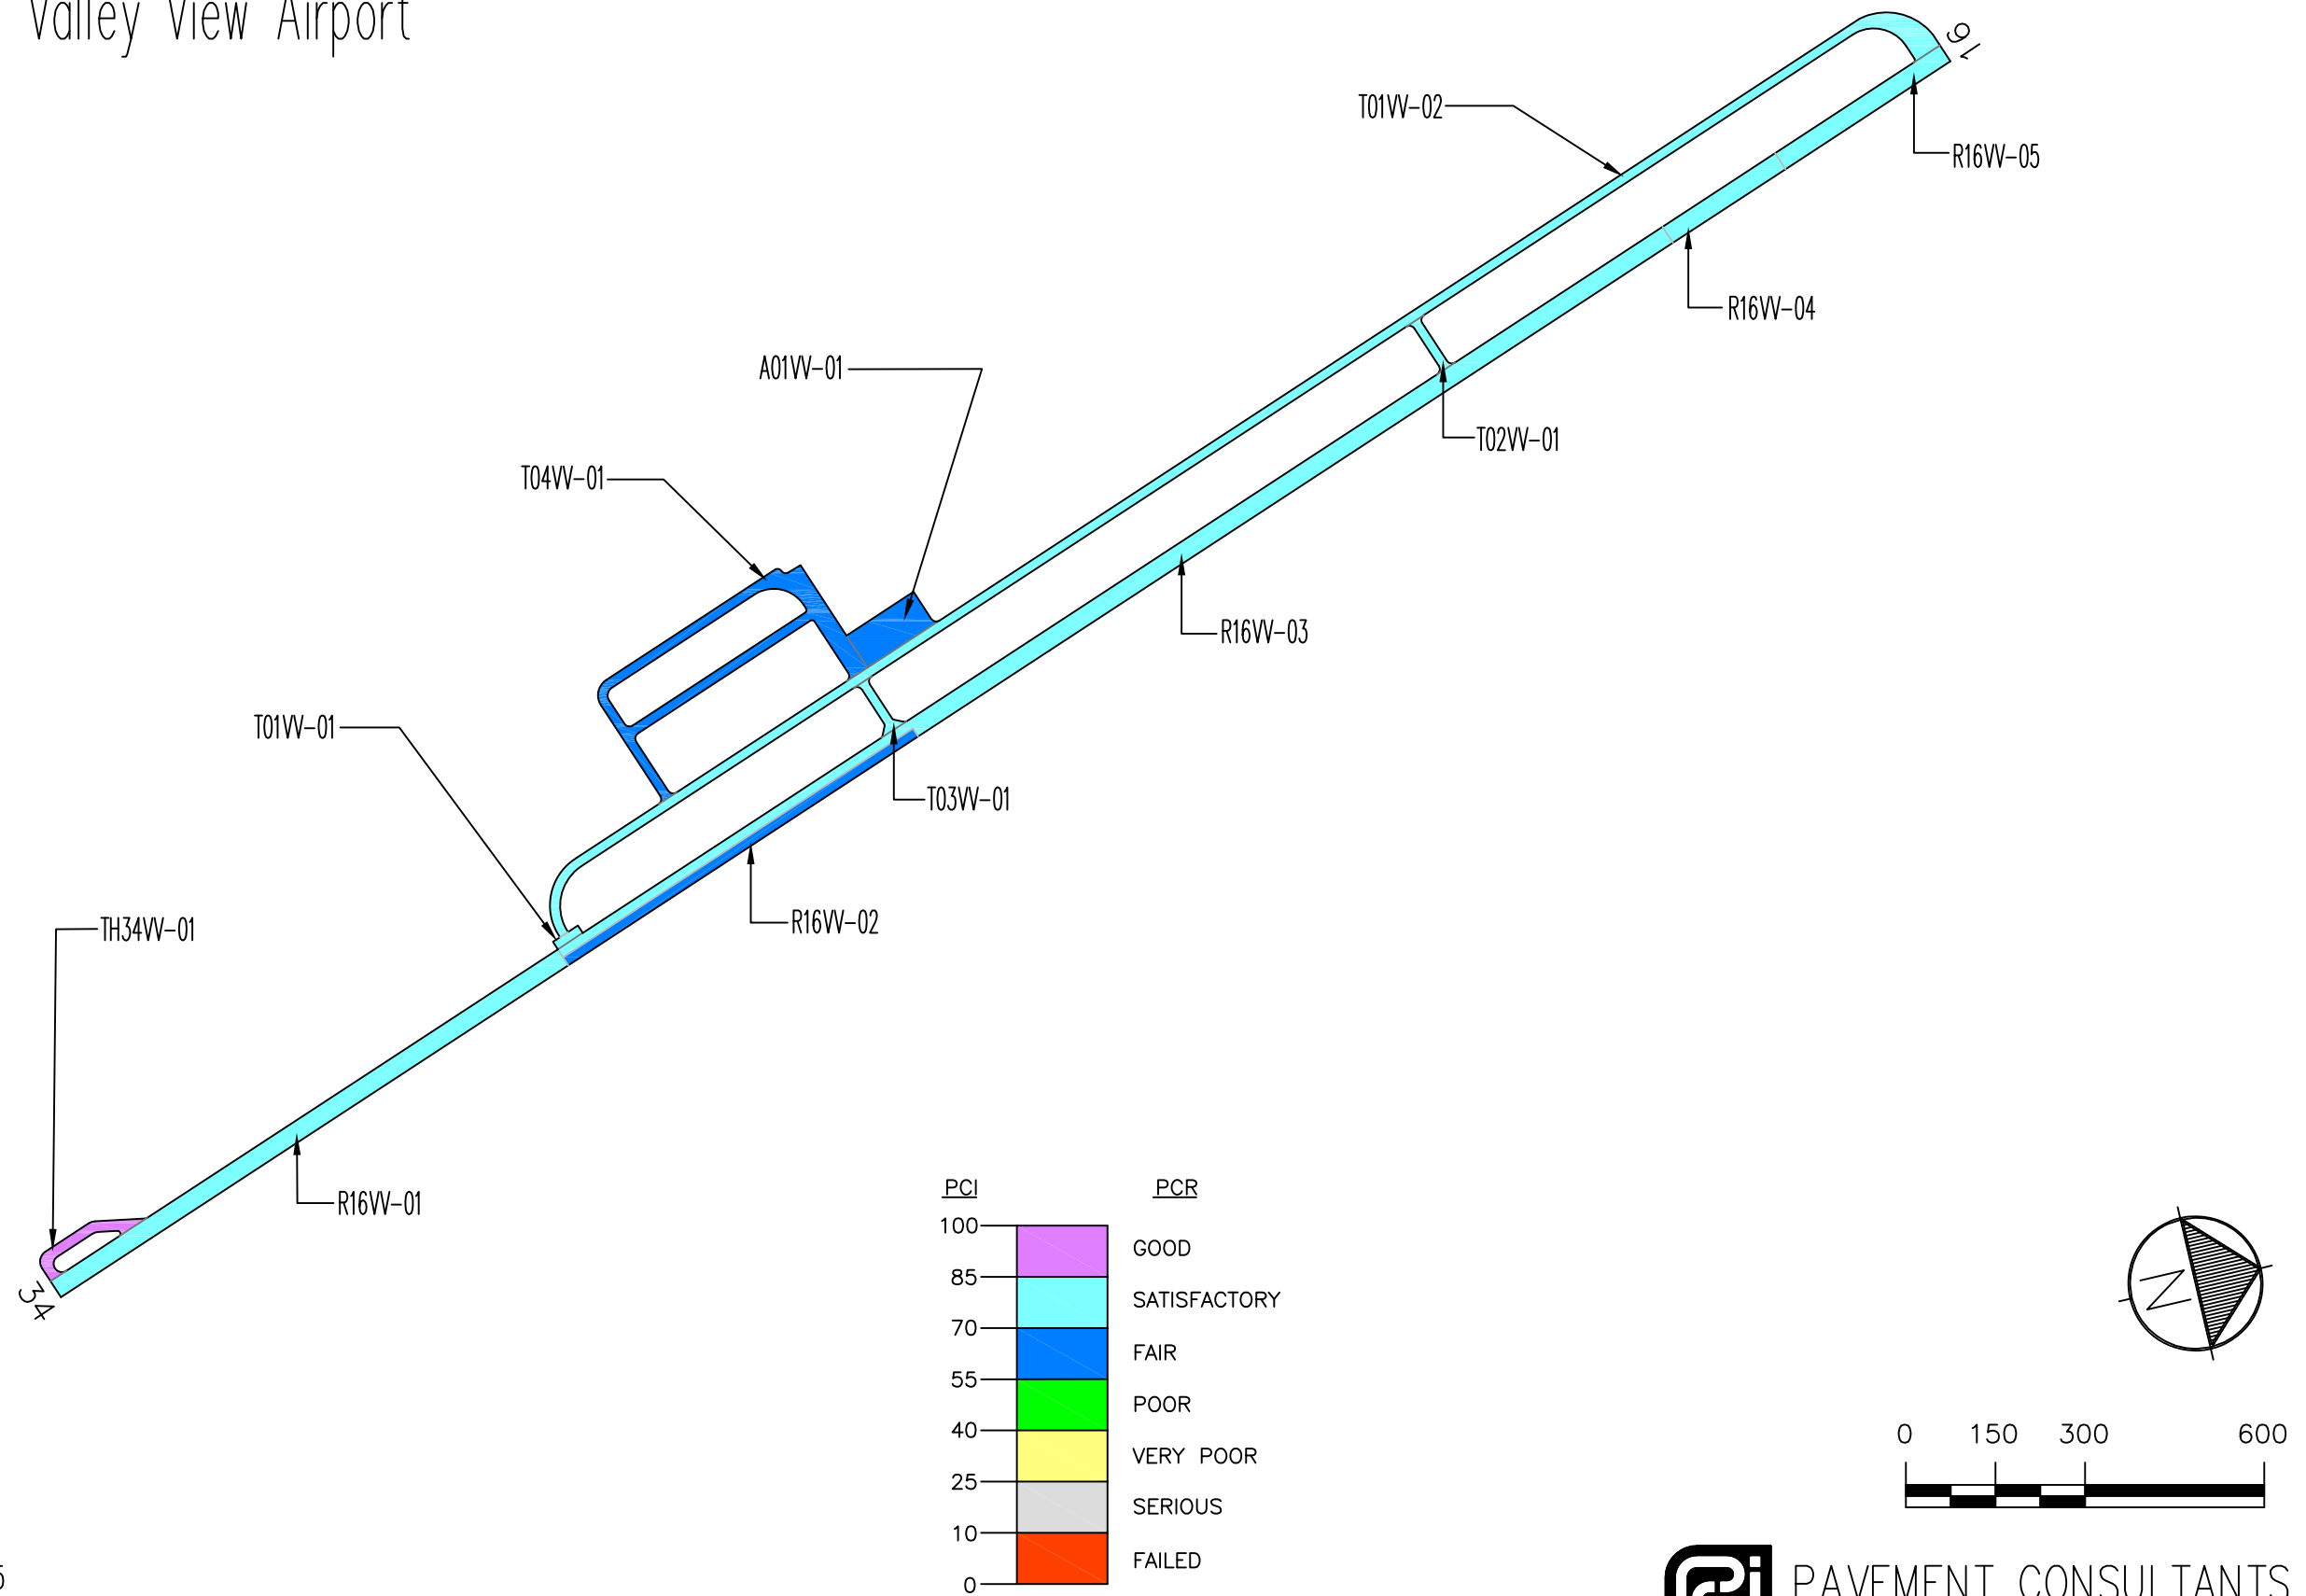
Figure VV-3. Pavement Condition in September 2015.  
Valley View Airport

Section PCIs at Valley View Airport range from a low of 57 (a PCR of “Fair”) to a high of 91 (a PCR of “Good”). The area-weighted average PCI for all airport pavements is 74, corresponding to an overall PCR of “Satisfactory”. Figure VV-4 shows how much pavement area is associated with each Pavement Condition Rating category and also shows pavement condition distribution from the inspections conducted in 2008 and 2012.

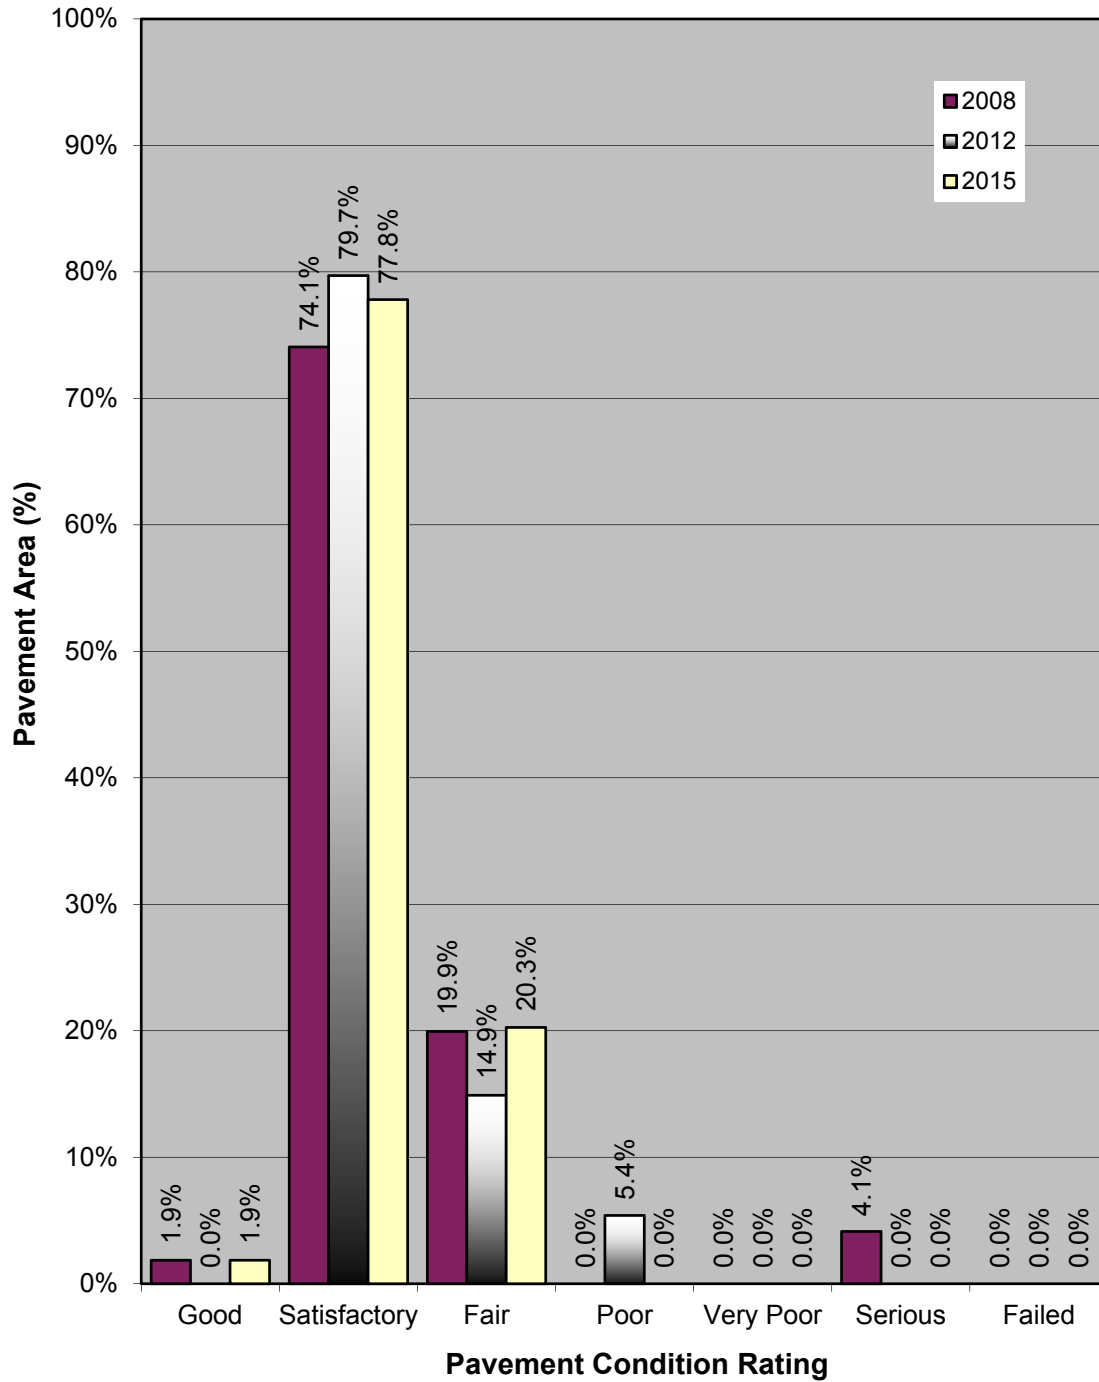
**Figure VV-4. Pavement Condition Distribution  
Valley View Airport**

The primary distresses observed during the inspection were: longitudinal and transverse cracking, patching, block cracking, and alligator cracking, with isolated occurrences of corrugations and weathering.

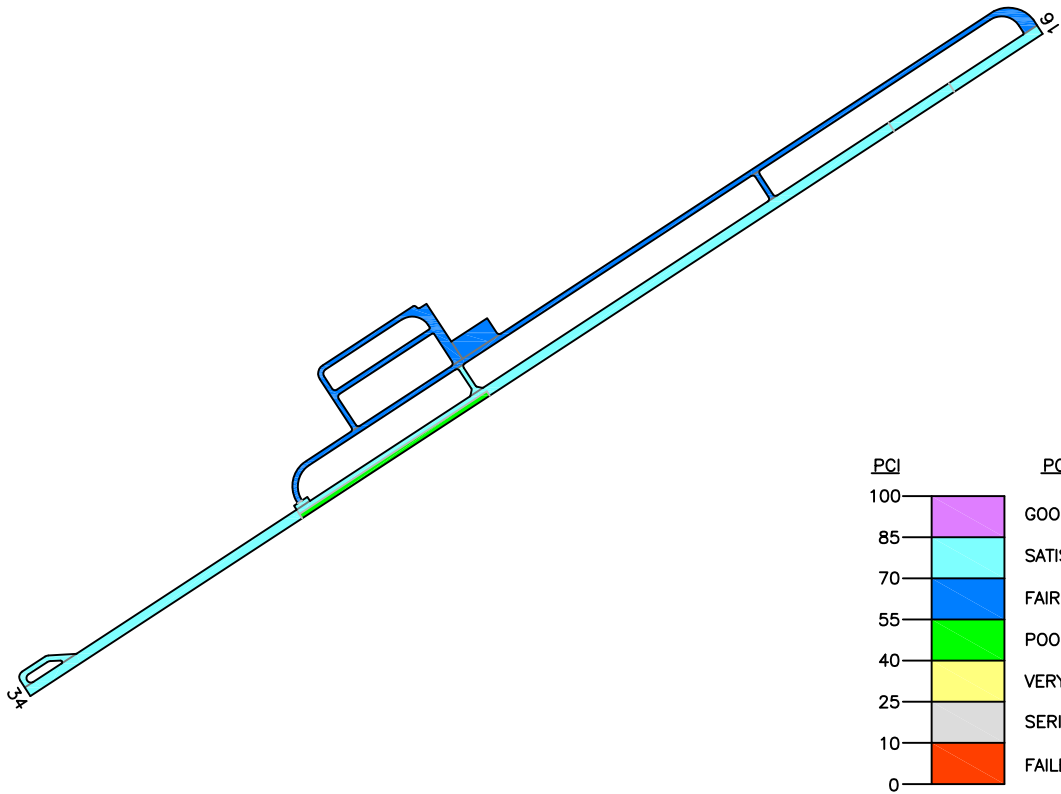
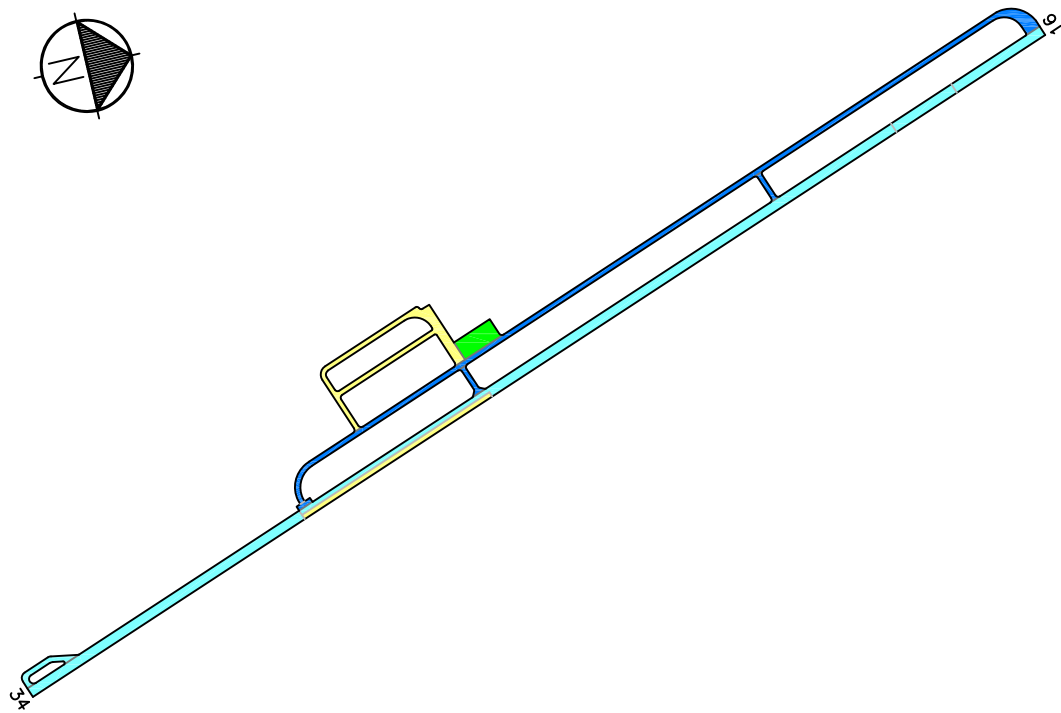
**Figure VV-5. Future Pavement Condition.**

A graphical representation of the projected PCIs listed in Table 1 is shown in Figure VV-5.
