ASHLAND MUNICIPAL AIRPORT – SUMNER PARKER FIELD

This report describes how your Pavement Maintenance Management Program (PMMP) was developed. Your Program was developed as part of the Oregon Continuous Aviation System Plan sponsored in part by the Oregon Department of Aviation and the Federal Aviation Administration (FAA). The information and data contained in this report ensures you are in compliance with the requirements of FAA Grant Assurance Number 11 which states that any airport requesting federal funds for pavement improvement projects must have implemented a pavement maintenance management program.

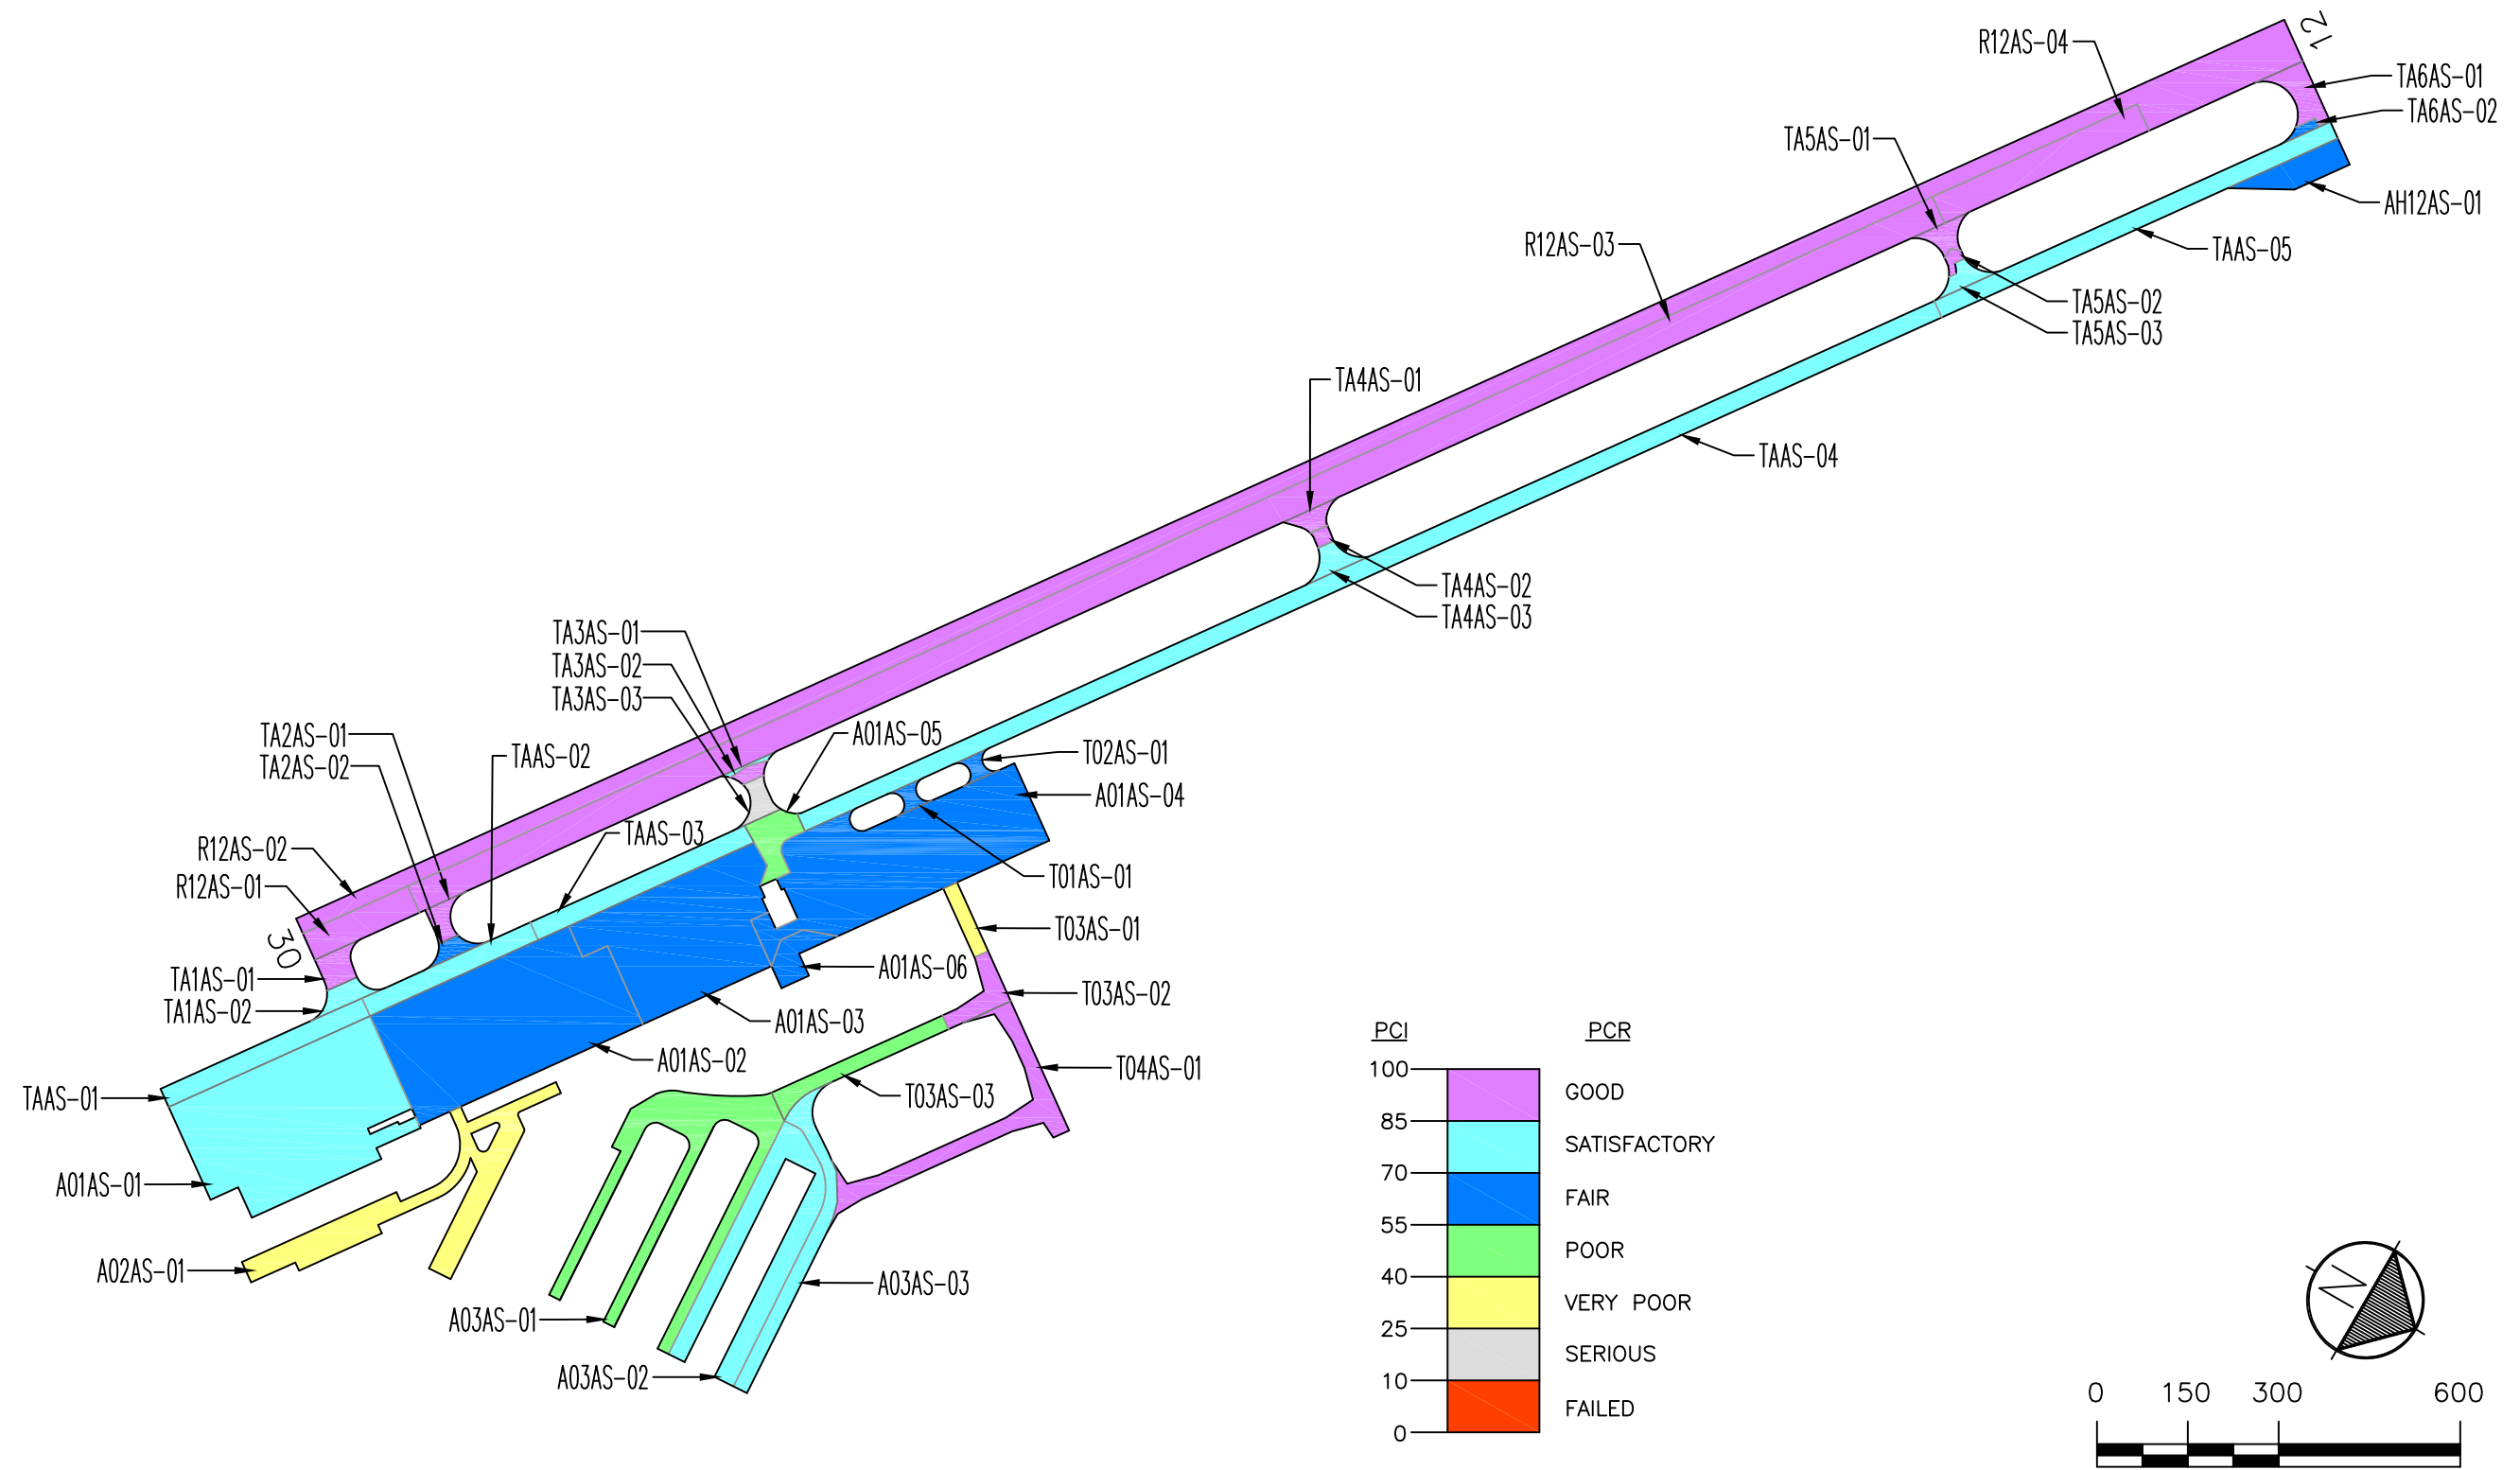
Figure AS-3. Pavement Condition in July 2016.
Ashland Municipal Airport (Sumner Parker Field)

Section PCIs at Ashland Municipal Airport range from a low of 14 (a PCR of “Serious”) to a high of 100 (a PCR of “Good”). The area-weighted average PCI for all airport pavements is 77, corresponding to an overall PCR of “Satisfactory”. Figure AS-4 shows how much pavement area is associated with each Pavement Condition Rating category and also shows pavement condition distribution from the inspections conducted in 2009 and 2013.

The primary distresses observed during the inspection were: longitudinal and transverse cracking, patching, weathering, alligator cracking, depressions, block cracking and raveling.

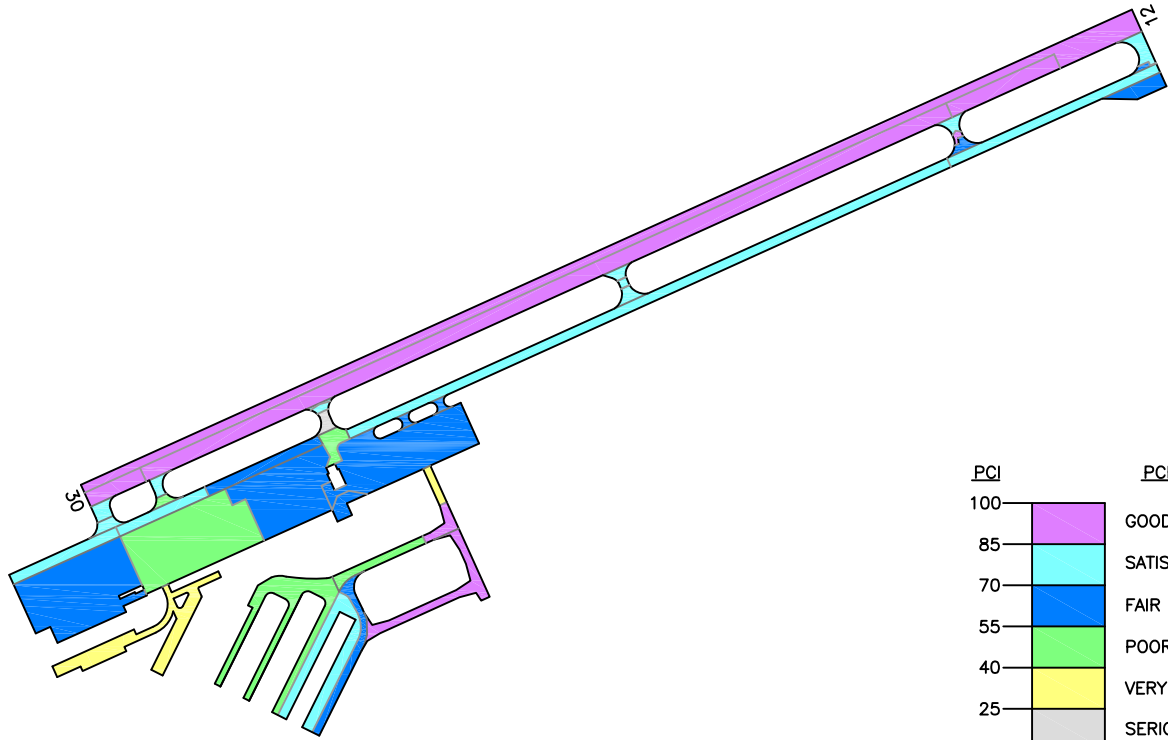
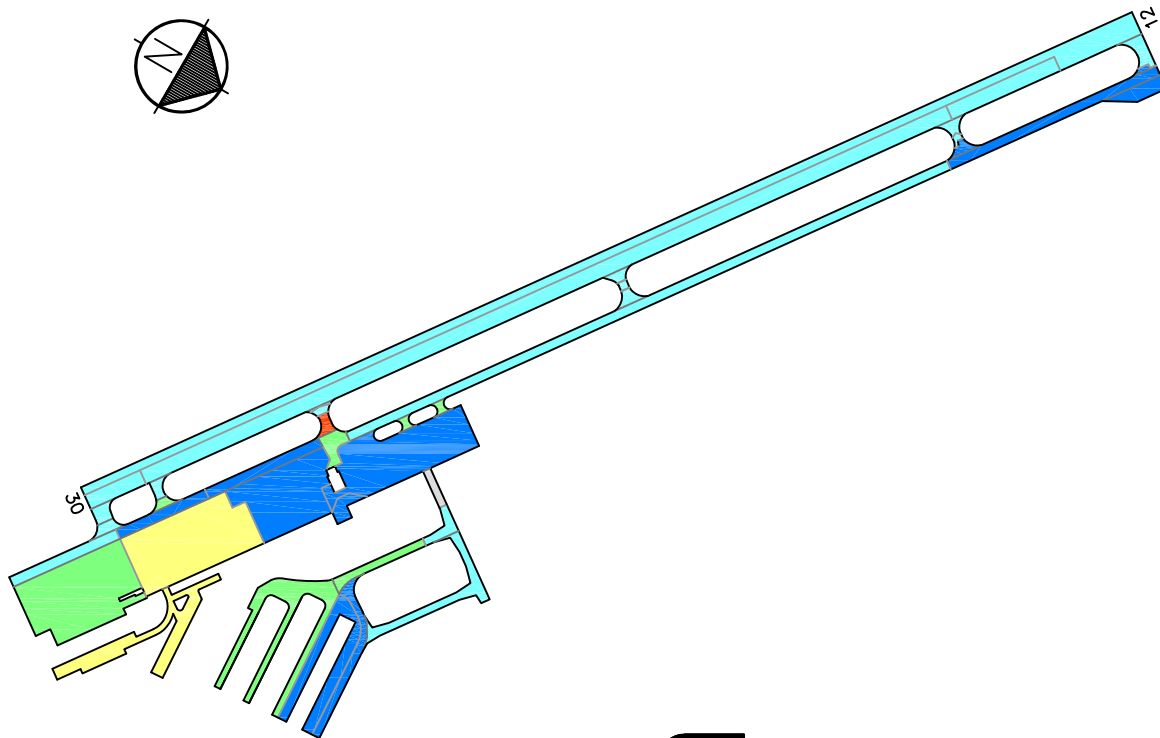
Figure AS-5. Future Pavement Condition.

A graphical representation of the projected PCIs listed in Table 1 is shown in Figure AS-5.
