BANDON STATE AIRPORT

Figure BN-1. Airport Layout, Dimensions and Pavement Cross-Sections.
Bandon State Airport

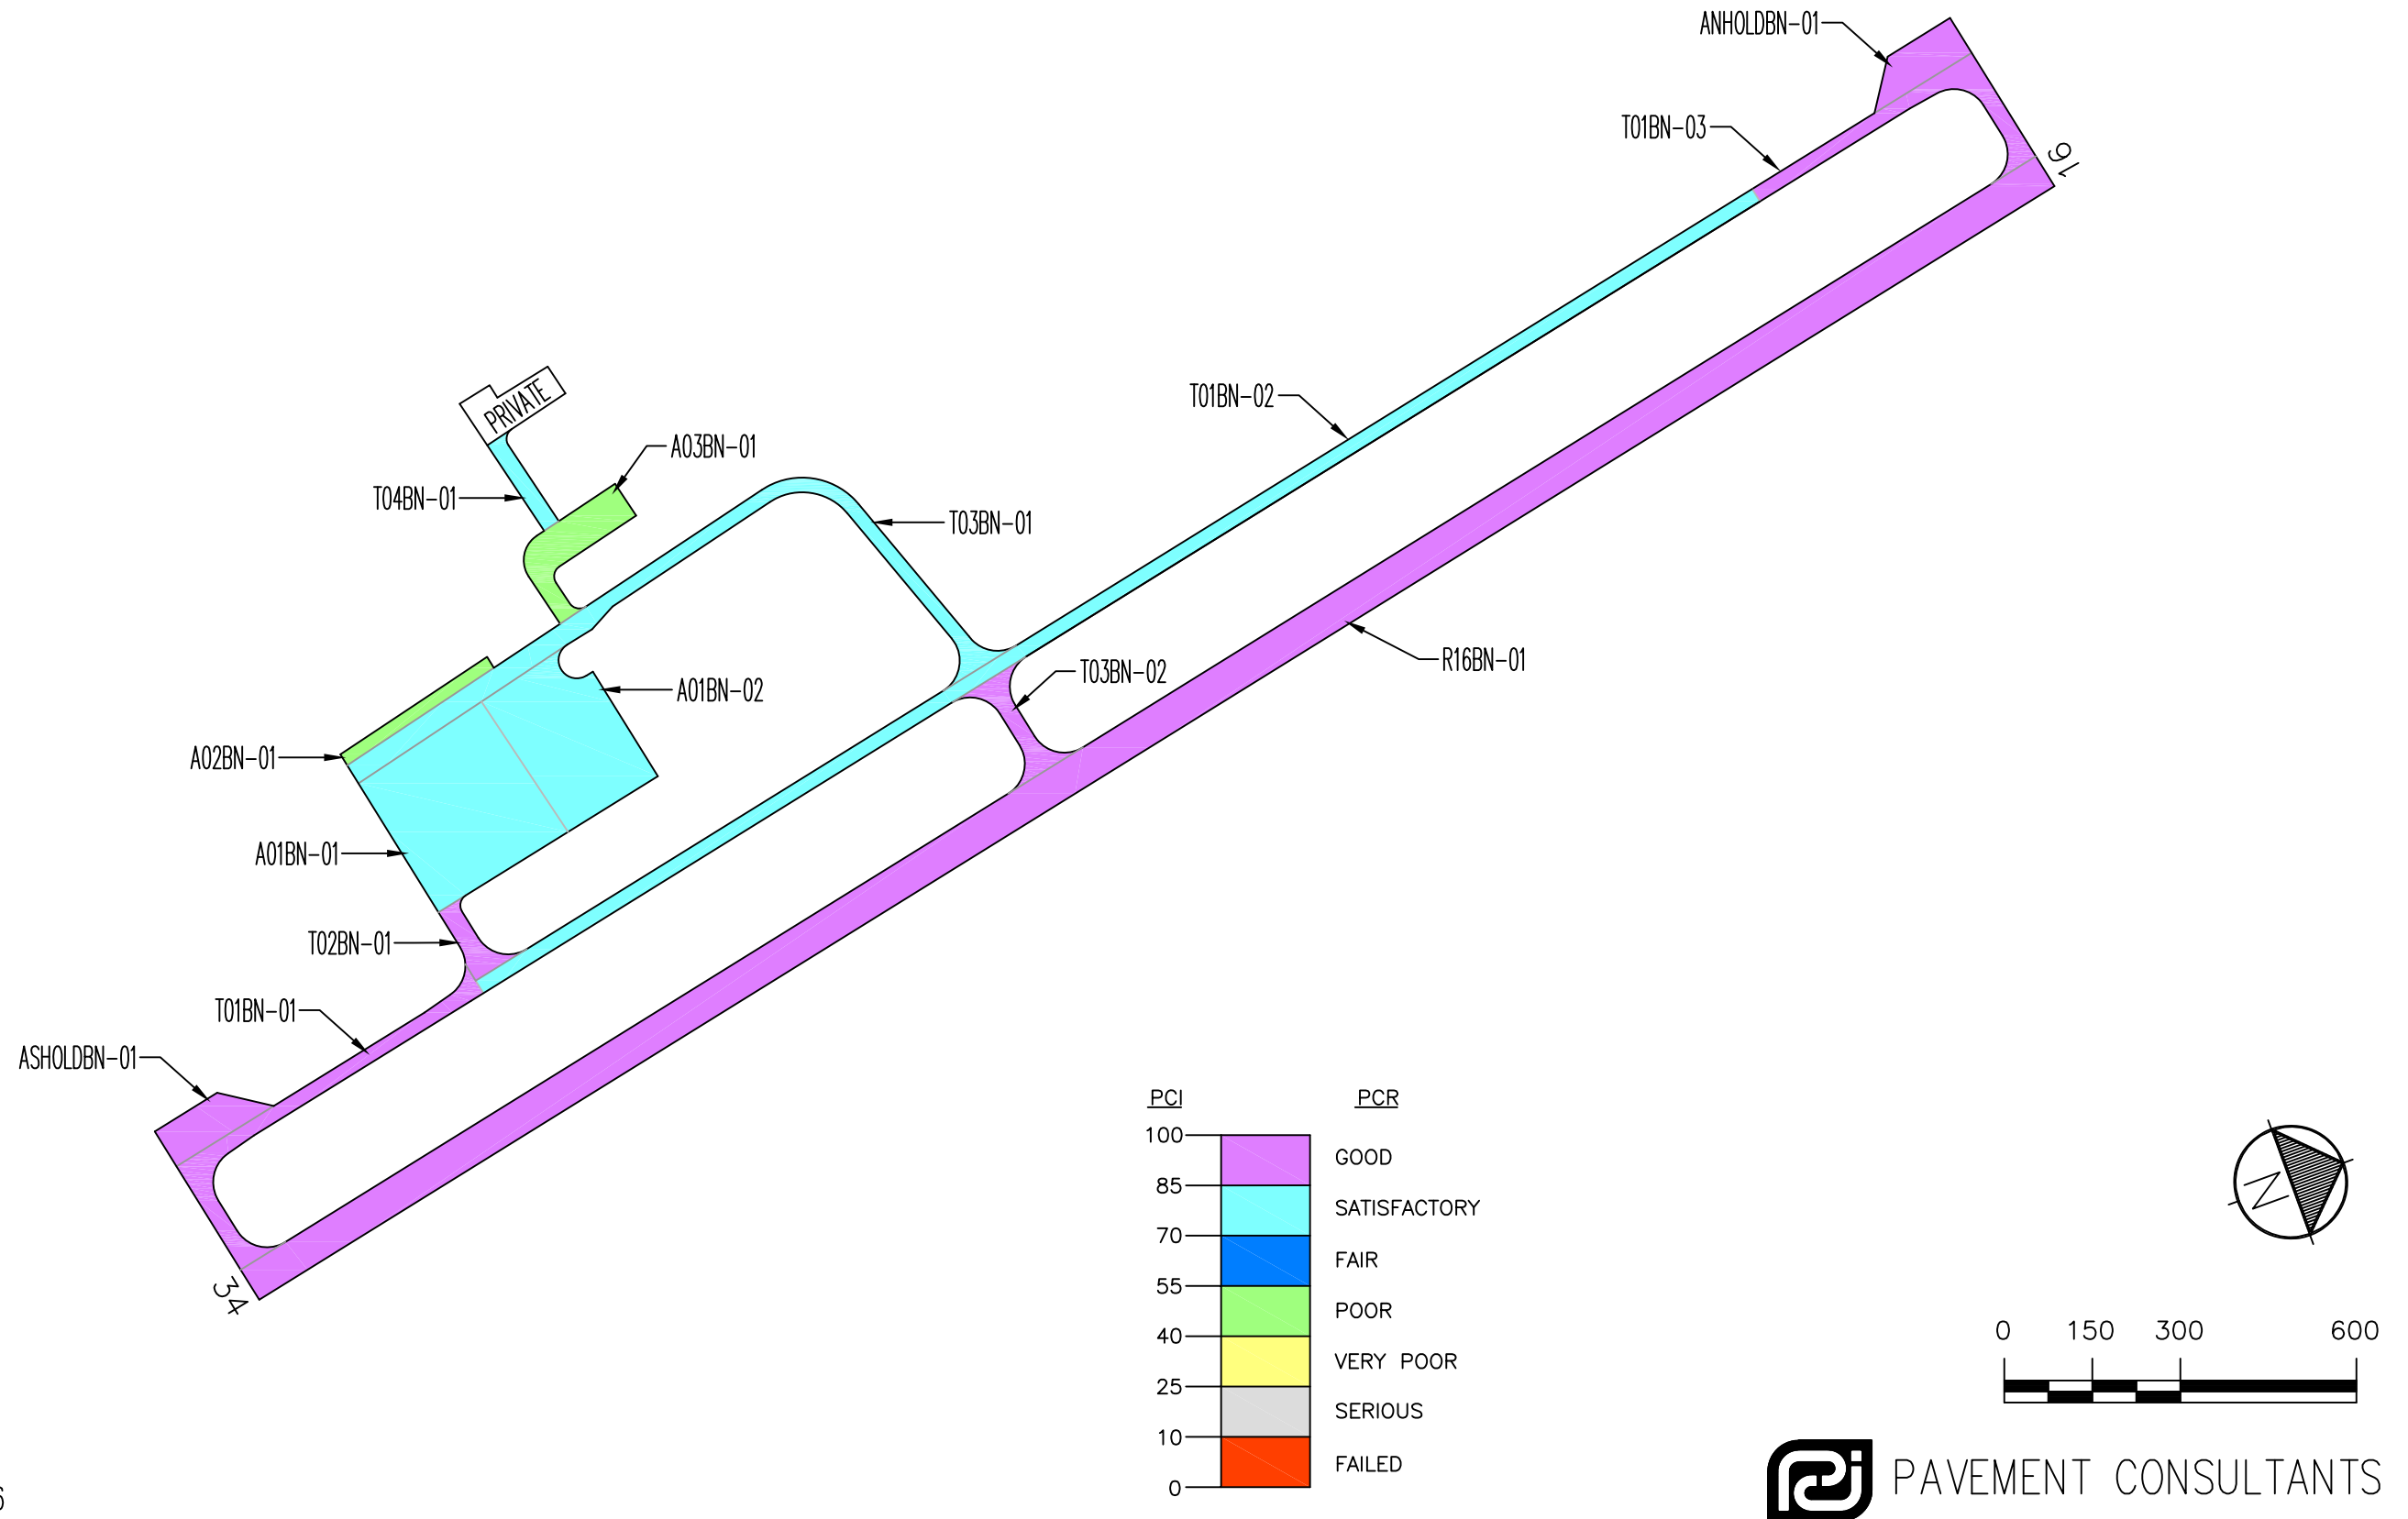
Figure BN-3. Pavement Condition in July 2016.
Bandon State Airport

The Branch Condition Report in Appendix 1 summarizes current pavement condition by branch while the Section Condition Report in Appendix 2 lists pavement condition by section. The current Pavement Condition Rating (PCR) is shown graphically in Figure BN-3.

Section PCIs at Bandon State Airport range from a low of 49 (a PCR of “Poor”) to a high of 100 (a PCR of “Good”). The area-weighted average PCI for all airport pavements is 89, corresponding to an overall PCR of “Good”. Figure BN-4 shows how much pavement area is associated with each Pavement Condition Rating category and also shows pavement condition distribution from the inspections conducted in 2009 and 2013.

The primary distresses observed during the inspection were: longitudinal and transverse cracking, patching, alligator cracking, weathering, and an isolated occurrence of raveling.

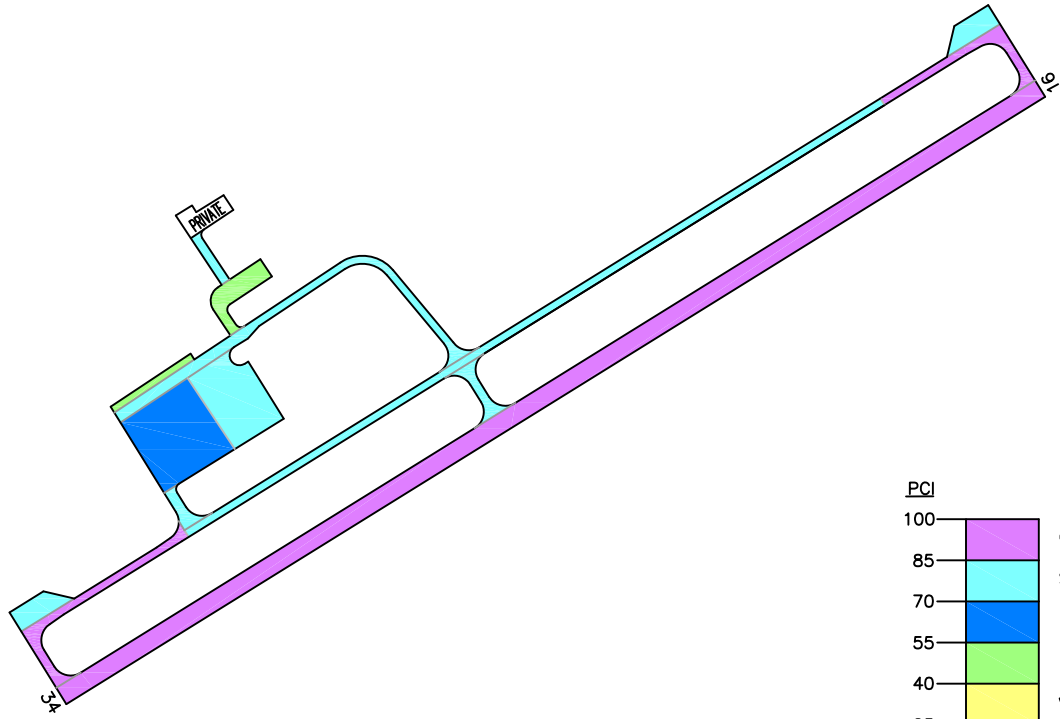
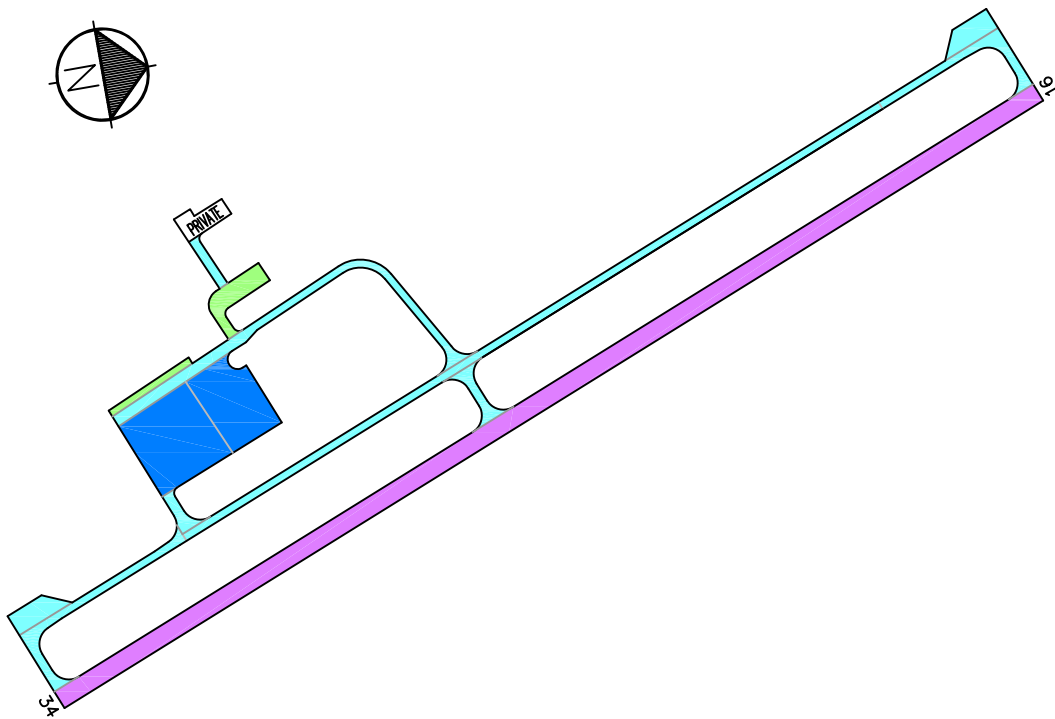
Figure BN-5. Future Pavement Condition.

A graphical representation of the projected PCIs listed in Table 1 is shown in Figure BN-5.
