BROOKINGS AIRPORT

Figure BR-1. Airport Layout, Dimensions and Pavement Cross-Sections.
Brookings Airport

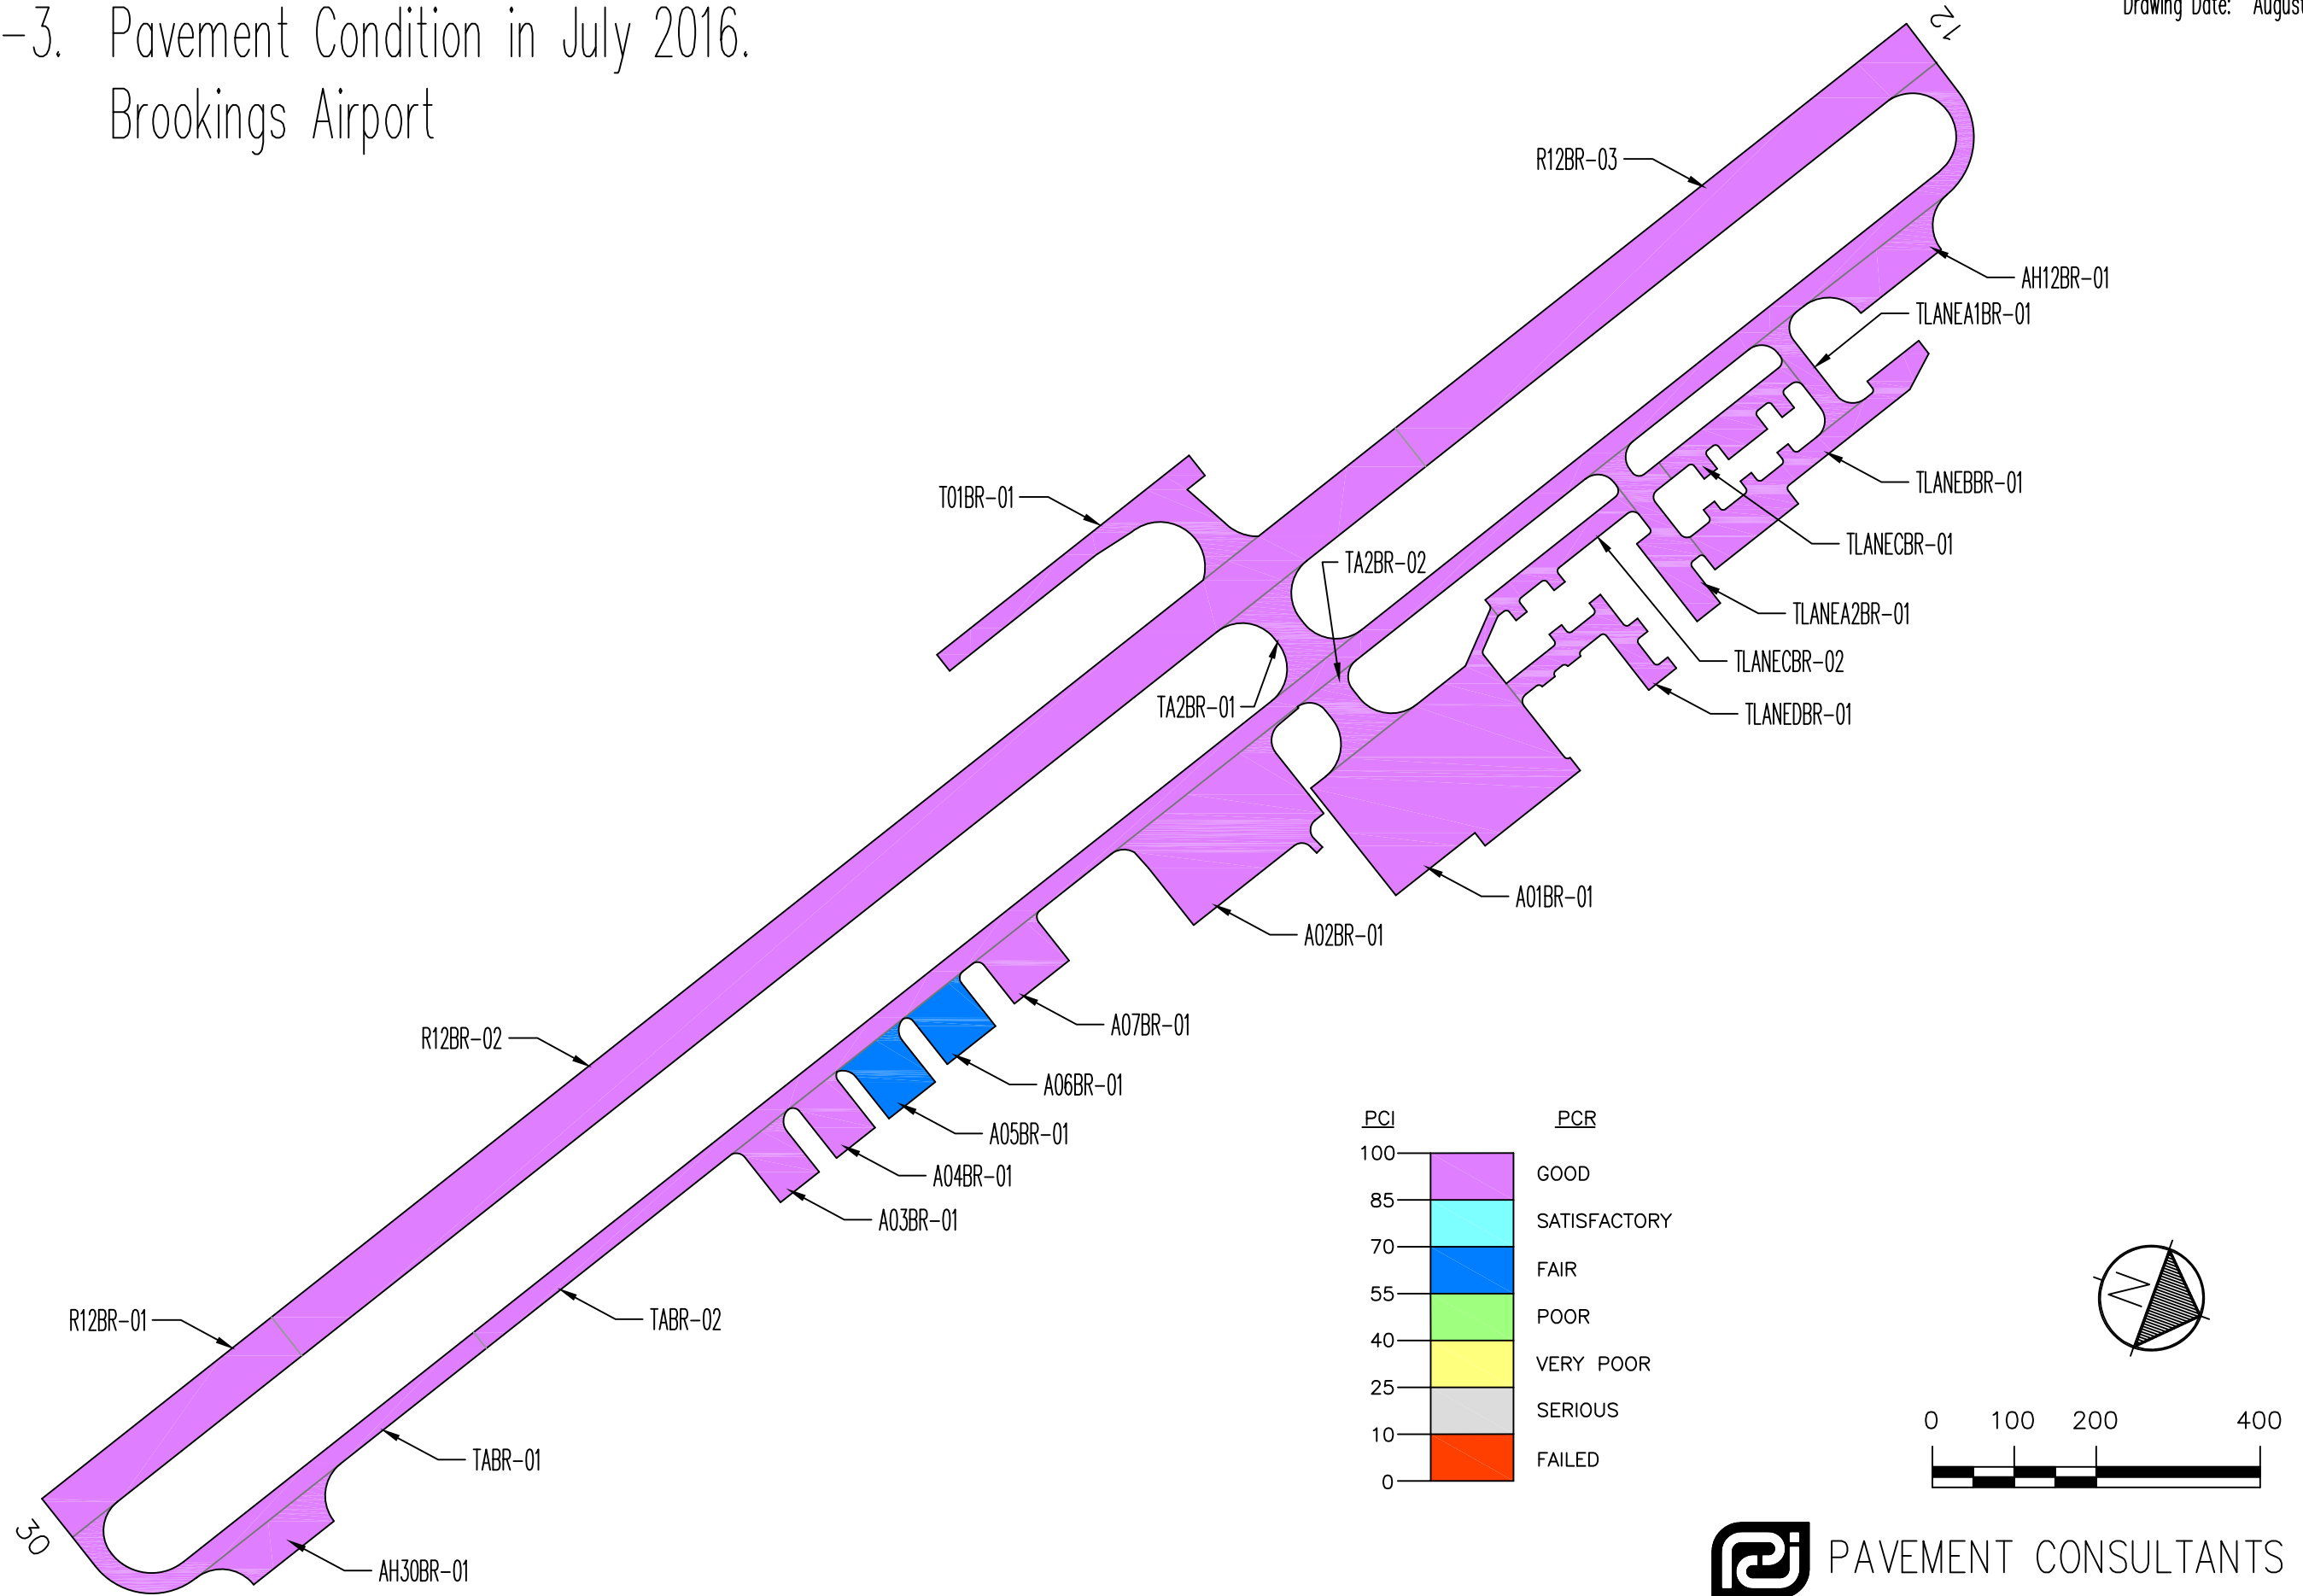
Figure BR-3. Pavement Condition in July 2016.
Brookings Airport

Section PCIs at Brookings Airport range from a low of 63 (a PCR of “Fair”) to a high of 100 (a PCR of “Good”). The area-weighted average PCI for all airport pavements is 94, corresponding to an overall PCR of “Good”. Figure BR-4 shows how much pavement area is associated with each Pavement Condition Rating category and also shows pavement condition distribution from the inspections conducted in 2009 and 2013.

The primary distresses observed during the inspection were: longitudinal and transverse cracking, and weathering, with isolated occurrences of block cracking, patching and swell.

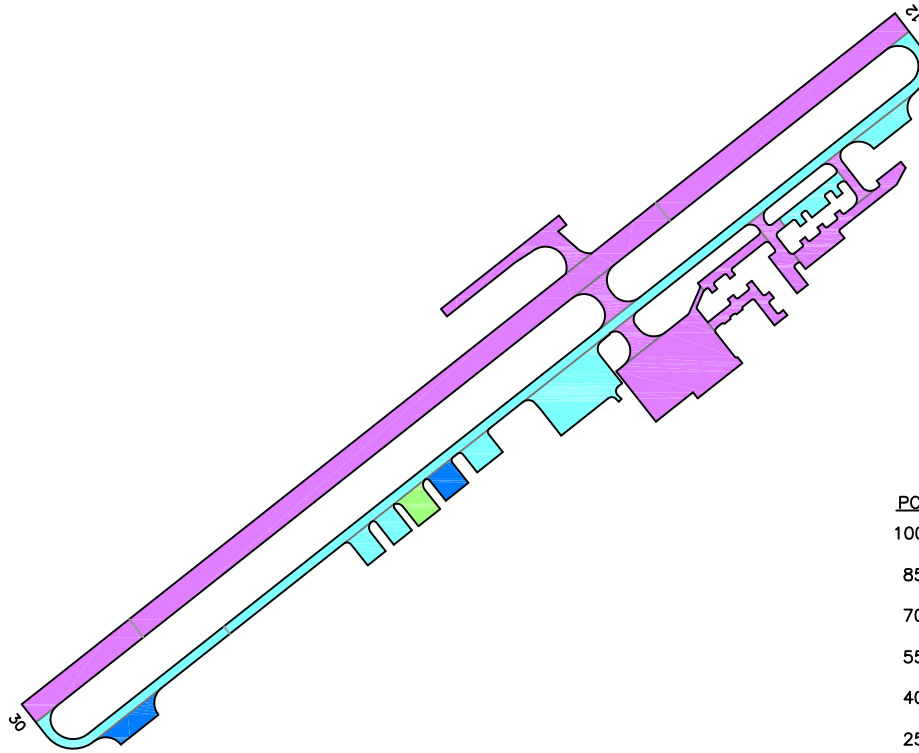
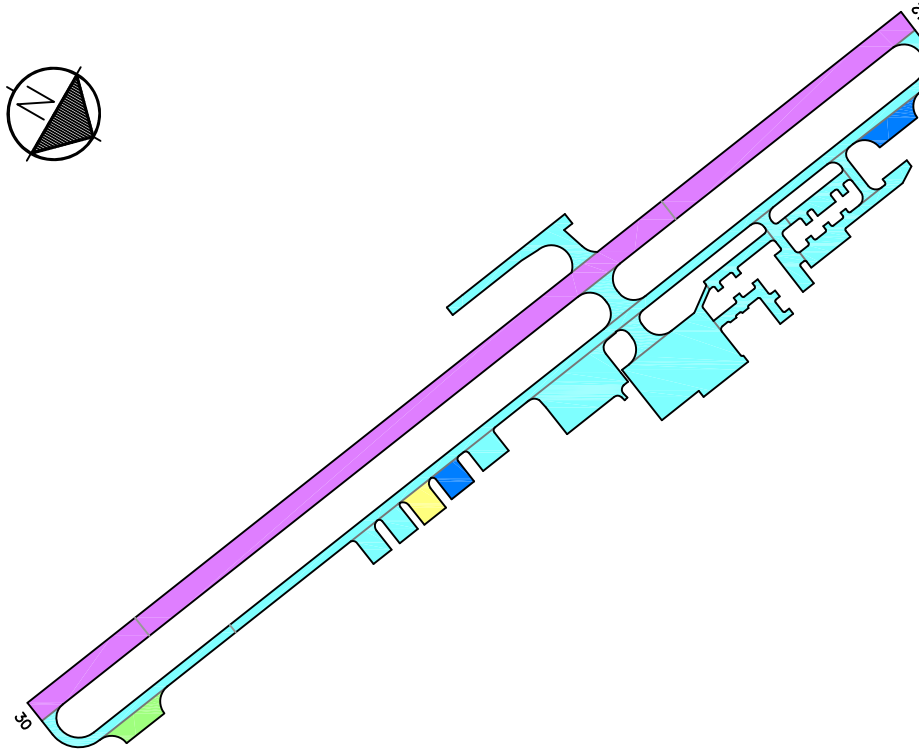
Figure BR-5. Future Pavement Condition.

A graphical representation of the projected PCIs listed in Table 1 is shown in Figure BR-5.
