CAPE BLANCO STATE AIRPORT

Figure CB-1. Airport Layout, Dimensions and Pavement Cross-Sections.
Cape Blanco State Airport

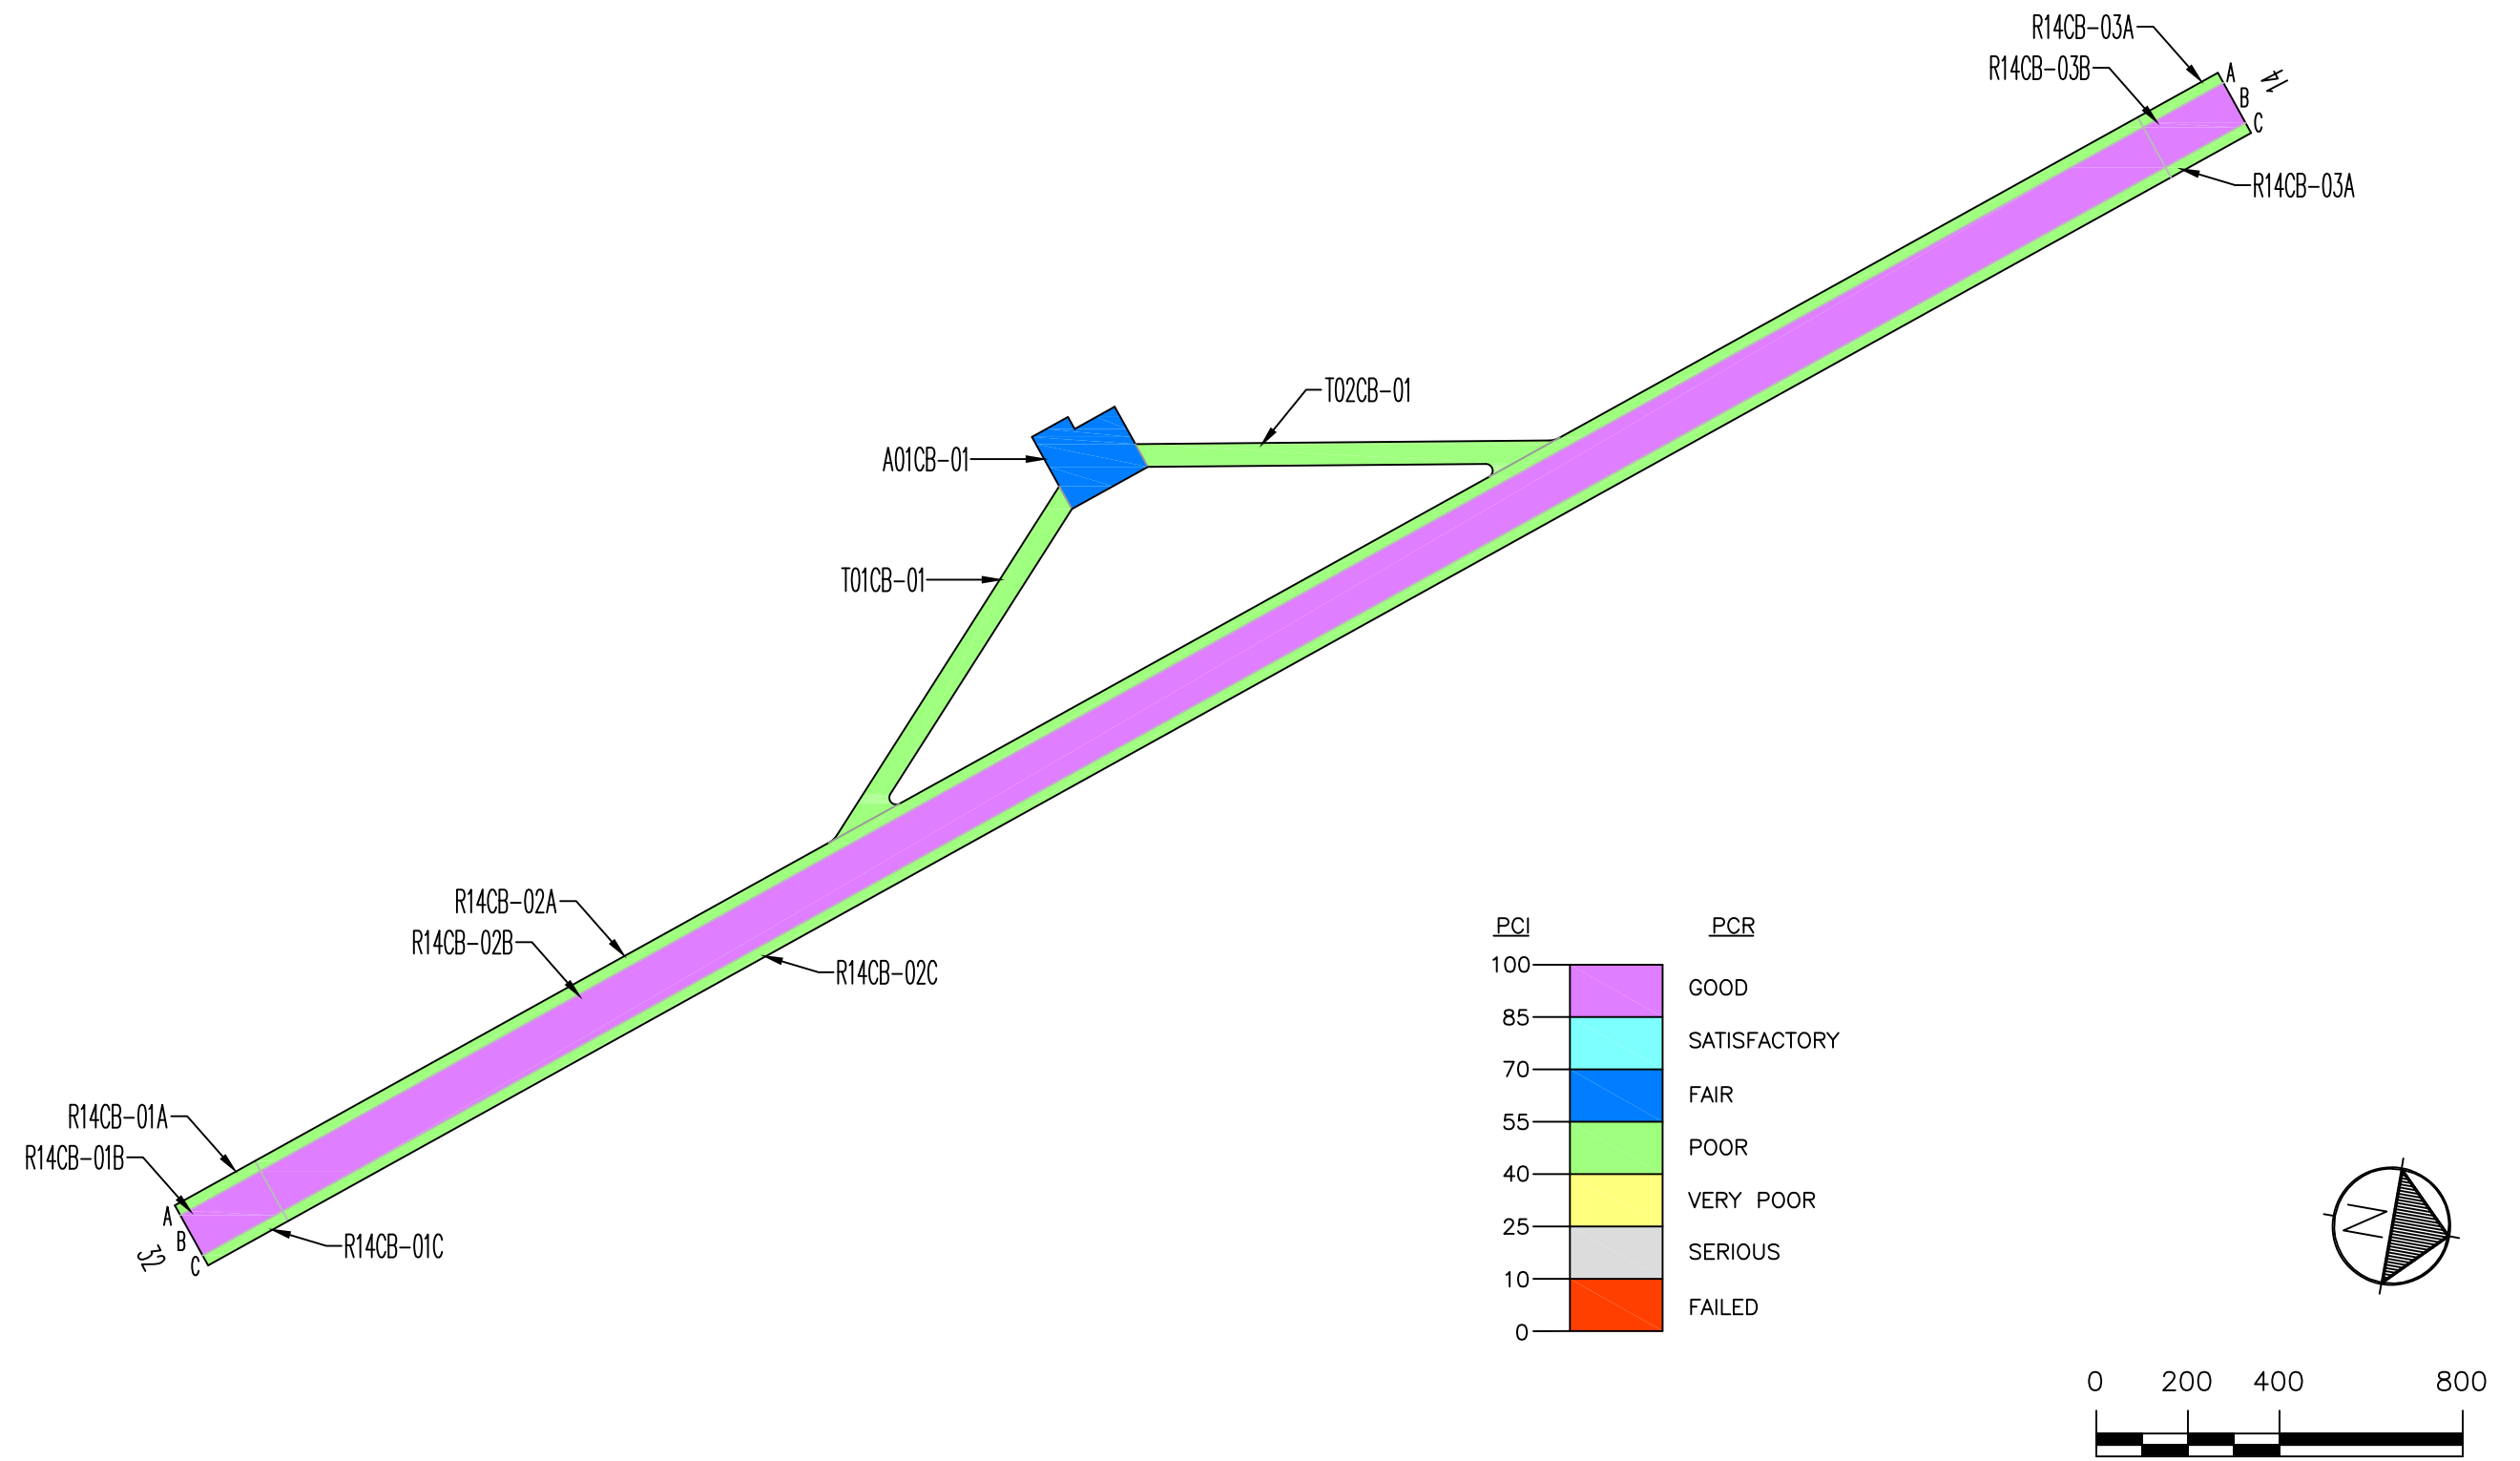
Figure CB-3. Pavement Condition in July 2016.
Cape Blanco State Airport

Section PCIs at Cape Blanco State Airport range from a low of 54 (a PCR of “Poor”) to a high of 90 (a PCR of “Good”). The area-weighted average PCI for all airport pavements is 75, corresponding to an overall PCR of “Satisfactory”. Figure CB-4 shows how much pavement area is associated with each Pavement Condition Rating category and also shows pavement condition distribution from the inspections conducted in 2009 and 2013.

The primary distresses observed during the inspection were: block cracking, weathering, raveling, and longitudinal and transverse cracking.

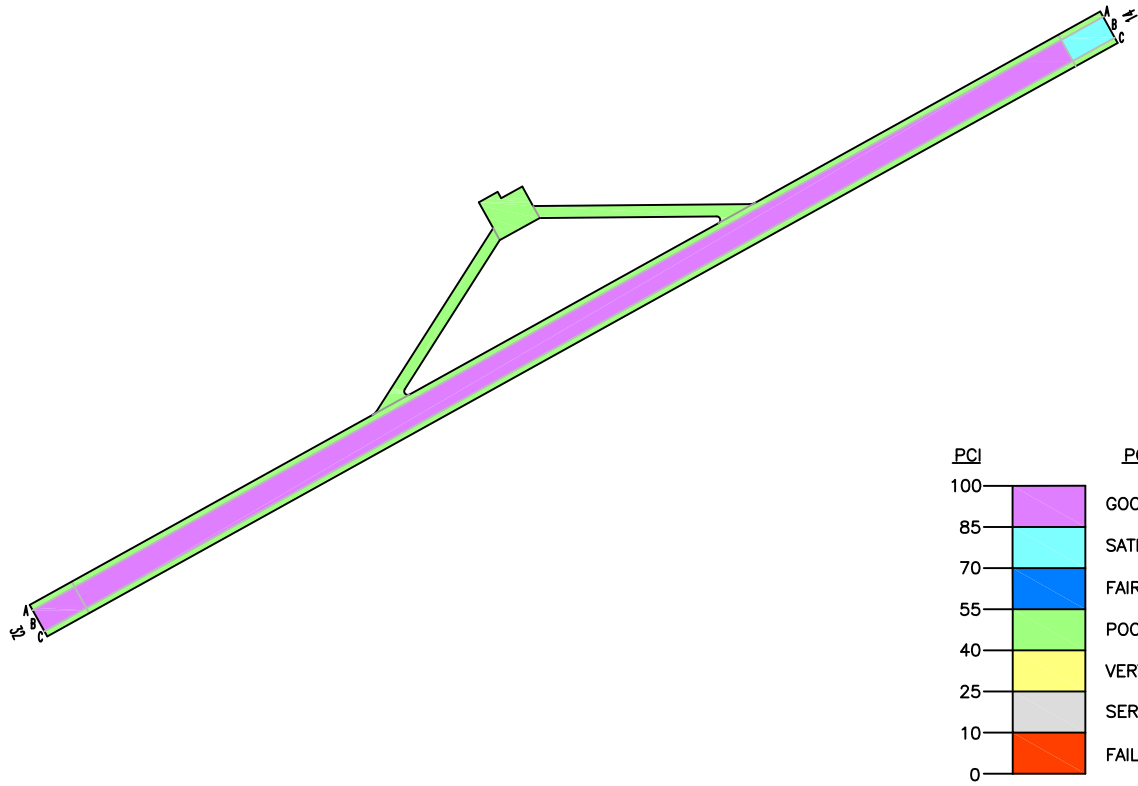
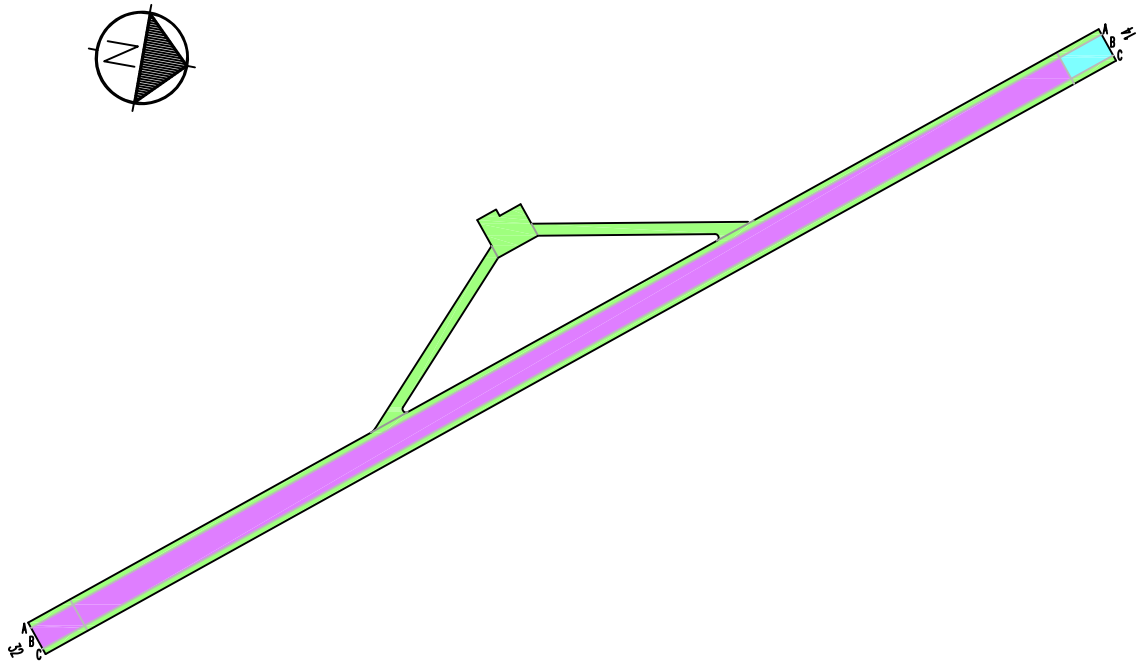
Figure CB-5. Future Pavement Condition.

A graphical representation of the projected PCIs listed in Table 1 is shown in Figure CB-5.
