CHILOQUIN STATE AIRPORT

Figure CH-1. Airport Layout, Dimensions and Pavement Cross-Sections.
Chiloquin State Airport

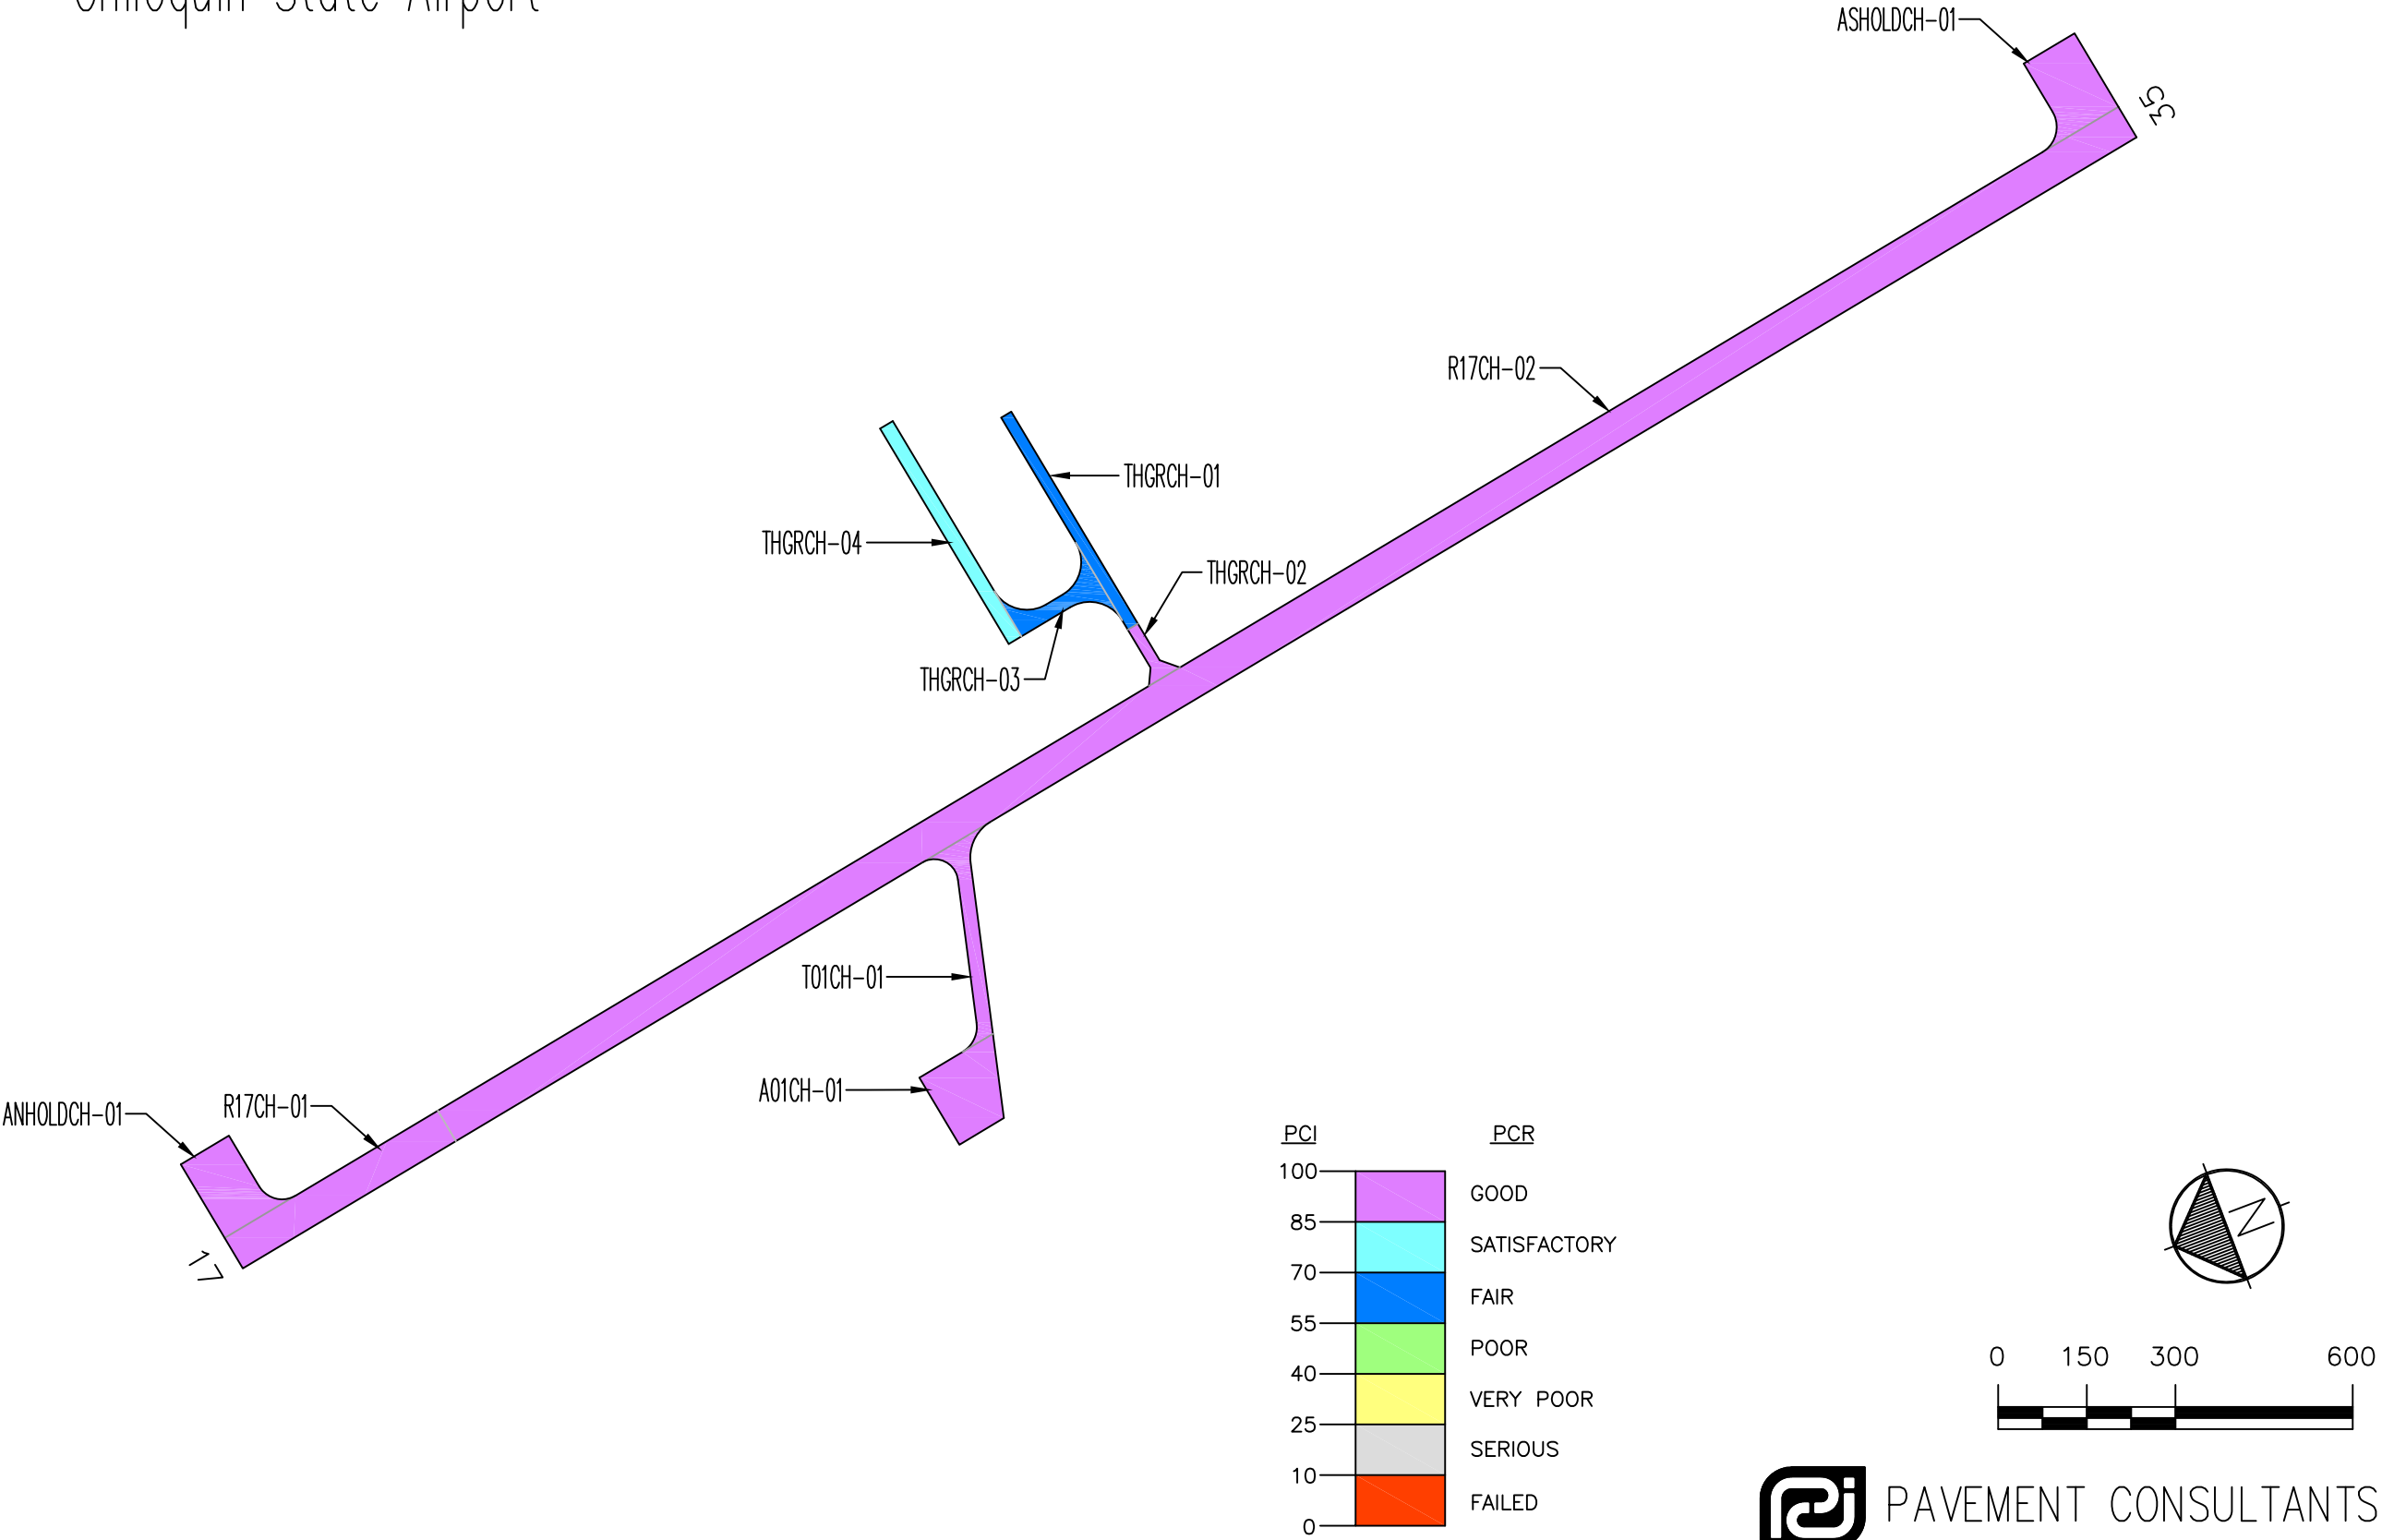
Figure CH-3. Pavement Condition in August 2016.
Chiloquin State Airport

Section PCIs at Chiloquin State Airport range from a low of 59 (a PCR of “Fair”) to a high of 100 (a PCR of “Good”). The area-weighted average PCI for all airport pavements is 94, corresponding to an overall PCR of “Good”. Figure CH-4 shows how much pavement area is associated with each Pavement Condition Rating category and also shows pavement condition distribution from the inspections conducted in 2009 and 2013.

The primary distresses observed during the inspection were: longitudinal and transverse cracking, weathering, and an isolated occurrence of depression.

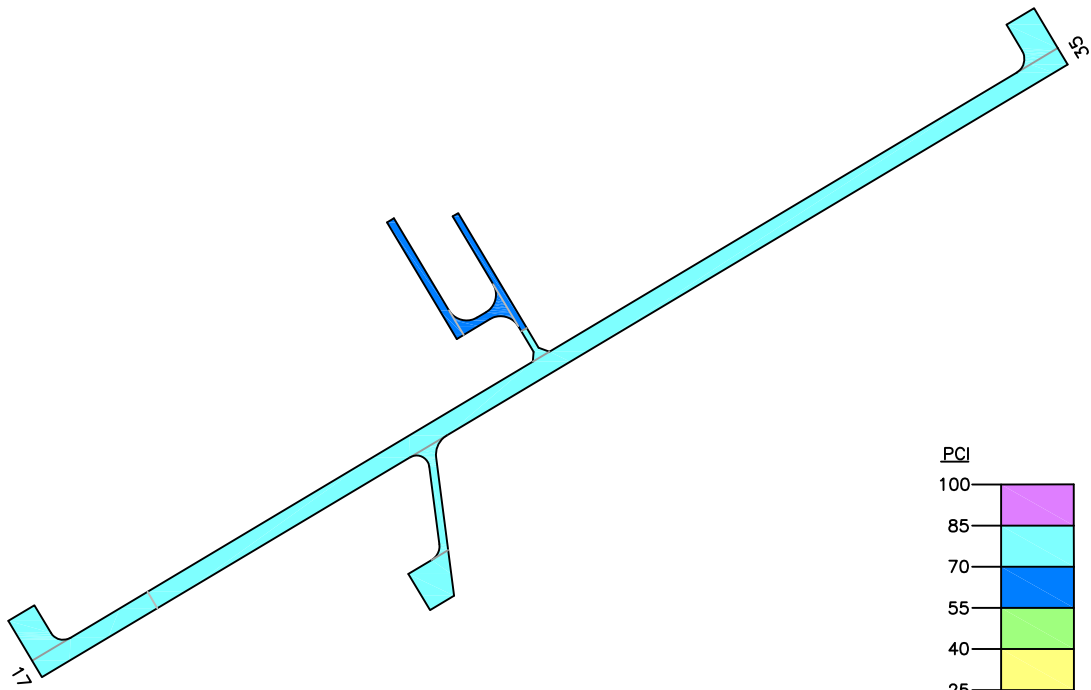
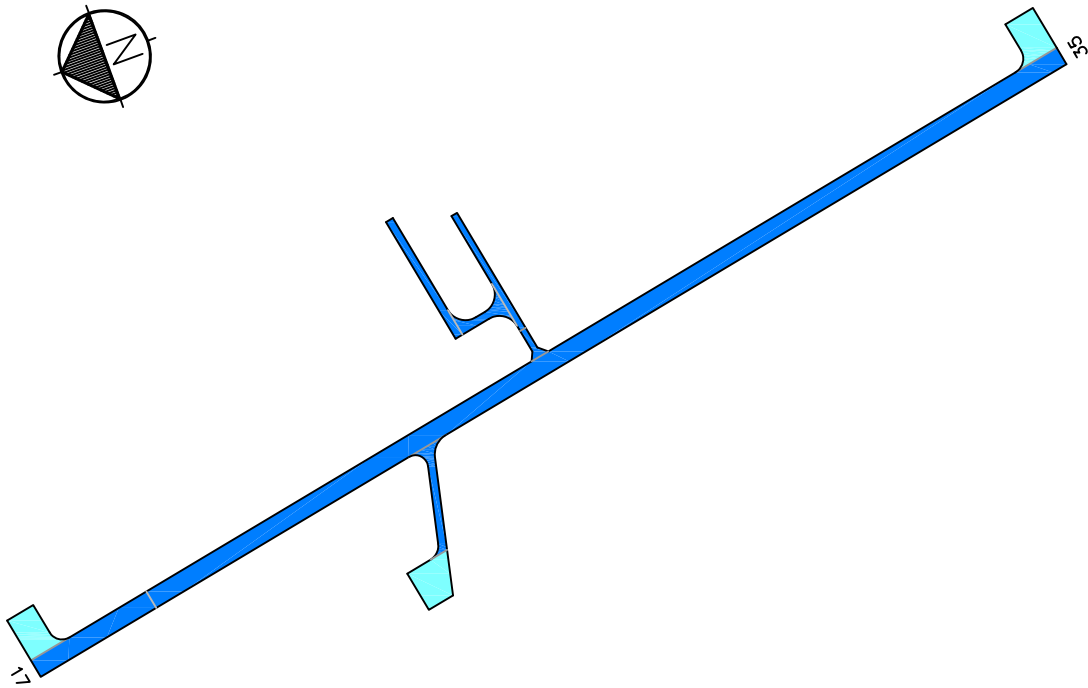
Figure CH-5. Future Pavement Condition.

Branch	Section	Inspections			Forecast	
		2009	2013	2016	2021	2026
A01CH	1	70	100	100	85	75
ANHOLDCH	1	---	---	93	80	72
ASHOLDCH	1	---	---	89	78	71
R17CH	1	26	100	96	82	68
R17CH	2	44	100	97	83	69
T01CH	1	72	100	95	75	64
THGRCH	1	82	74	59	58	58
THGRCH	2	56	100	100	77	65
THGRCH	3	85	70	68	61	58
THGRCH	4	96	88	80	67	60

A graphical representation of the projected PCIs listed in Table 1 is shown in Figure CH-5.
