# CHRISTMAS VALLEY AIRPORT

## DATA COLLECTION

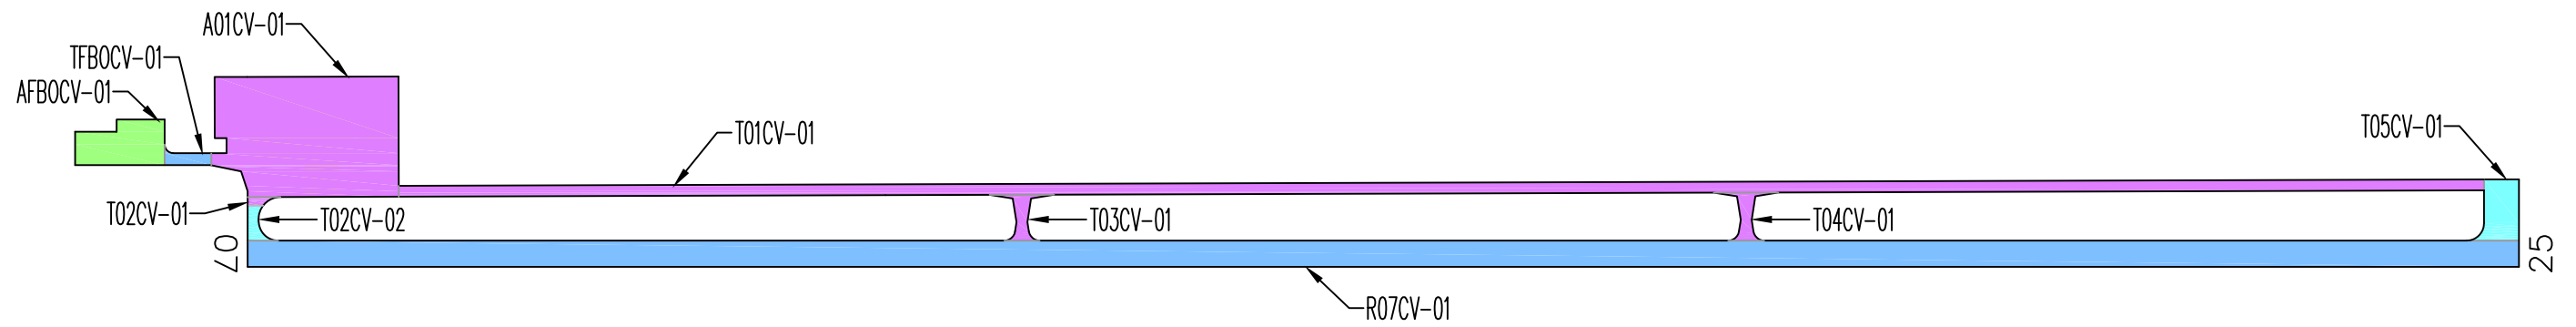
Figure CV-3. Pavement Condition in July 2016.  
Christmas Valley Airport

The Branch Condition Report in Appendix 1 summarizes current pavement condition by branch while the Section Condition Report in Appendix 2 lists pavement condition by section. The current Pavement Condition Rating (PCR) is shown graphically in Figure CV-3.

Section PCIs at Christmas Valley Airport range from a low of 43 (a PCR of “Poor”) to a high of 100 (a PCR of “Good”). The area-weighted average PCI for all airport pavements is 80, corresponding to an overall PCR of “Satisfactory”. Figure CV-4 shows how much pavement area is associated with each Pavement Condition Rating category and also shows pavement condition distribution from the inspections conducted in 2009 and 2013.

The primary distresses observed during the inspection were: longitudinal and transverse cracking, block cracking, raveling, and an isolated occurrence of depression.
