# COTTAGE GROVE STATE AIRPORT

This report describes how your Pavement Maintenance Management Program (PMMP) was developed. Your Program was developed as part of the Oregon Continuous Aviation System Plan sponsored in part by the Oregon Department of Aviation and the Federal Aviation Administration (FAA). The information and data contained in this report ensures you are in compliance with the requirements of FAA Grant Assurance Number 11 which states that any airport requesting federal funds for pavement improvement projects must have implemented a pavement maintenance management program.

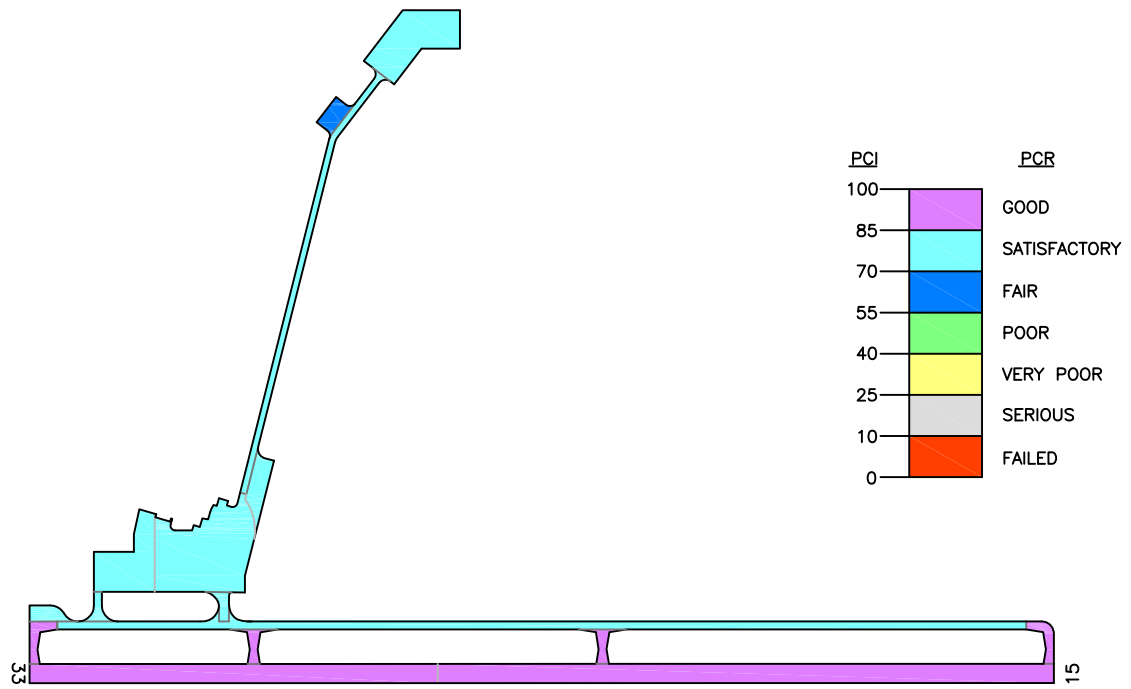
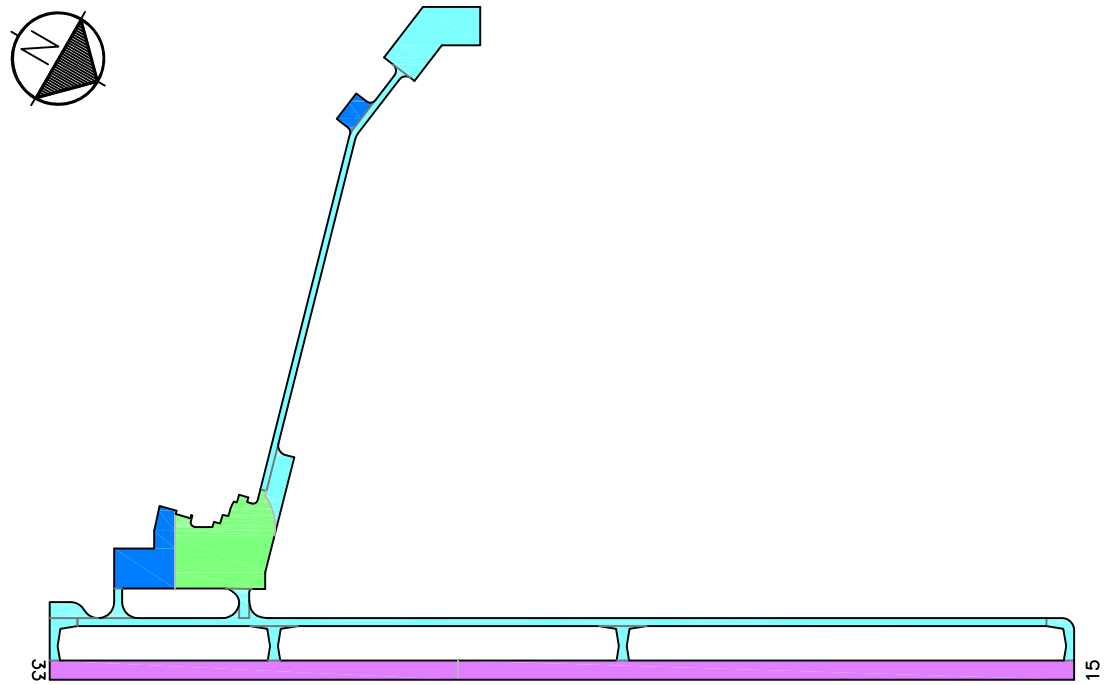
**Figure CG-5. Future Pavement Condition.**

A graphical representation of the projected PCIs listed in Table 1 is shown in Figure CG-5.
