CRATER LAKE – KLAMATH REGIONAL AIRPORT

Using the branch, section and sample unit divisions established, a visual condition survey was conducted at Crater Lake - Klamath Regional Airport in July 2016. During the inspection, pavement defects were identified and measured in accordance with the methodology outlined in ASTM D5430. This inspection ensures your airport complies with the “detailed inspection” requirement of FAA’s PMMP guidelines. After collection, the data were entered into the Micro PAVER software for analysis. These data are reproduced in the Re-Inspection Report attached as Appendix 4.

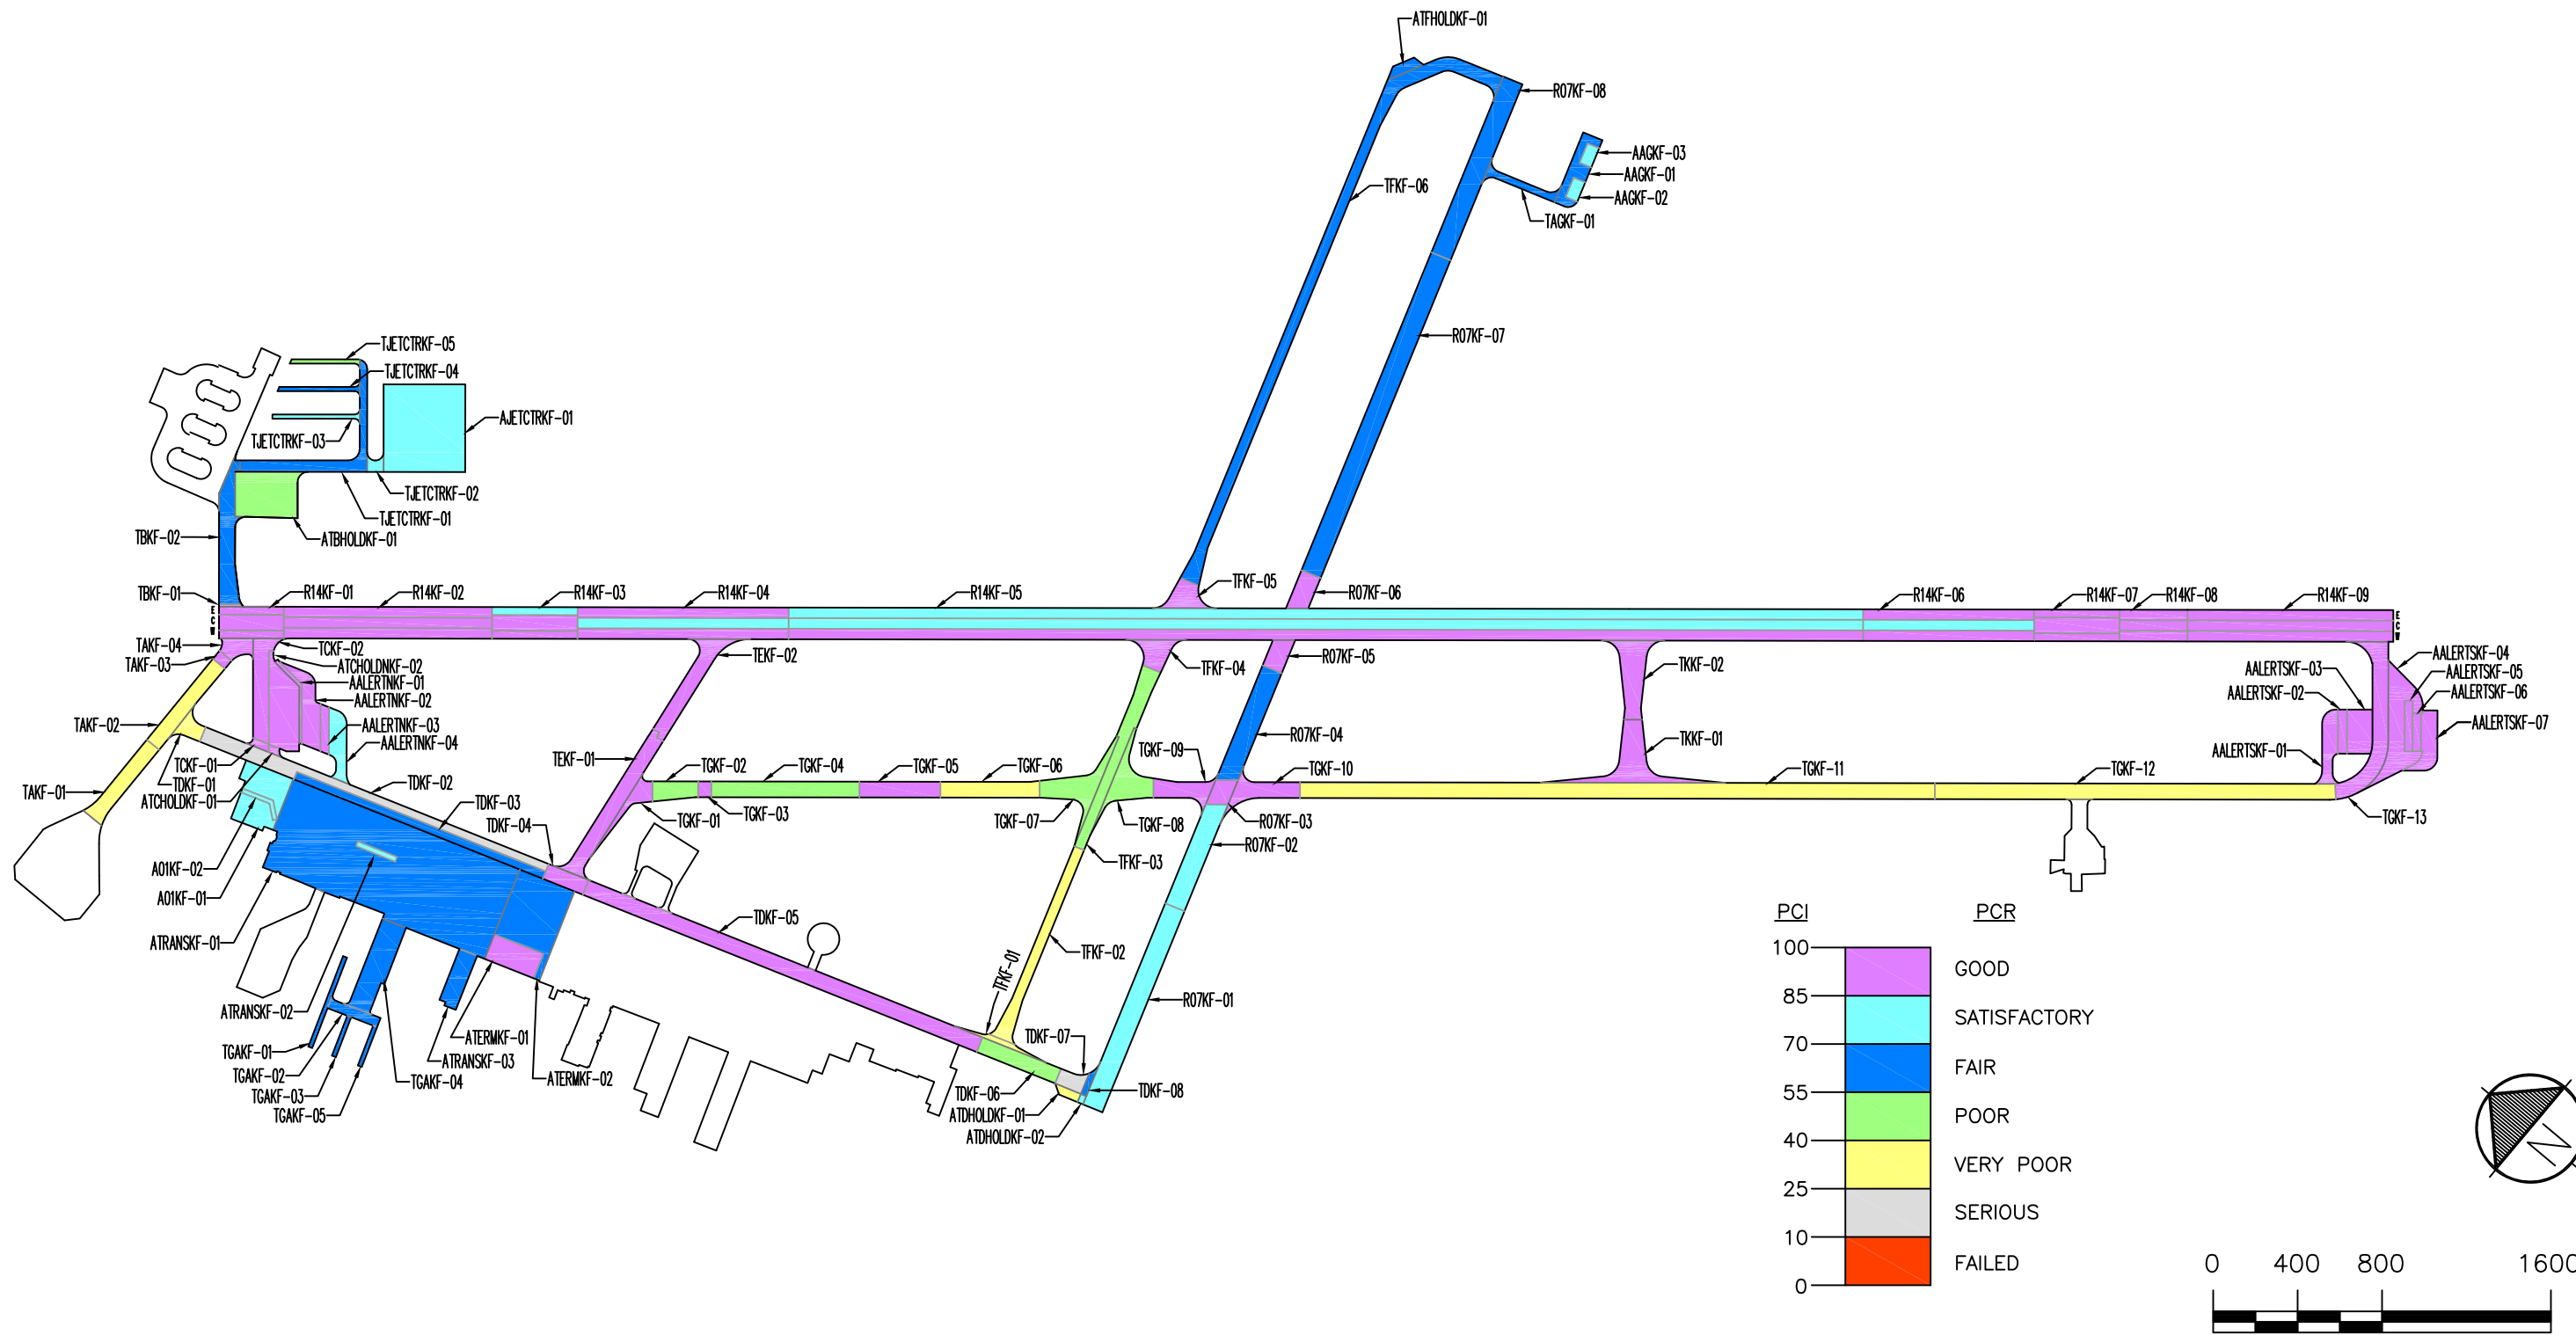
Figure KF-2. Pavement Condition in July 2016.
 Crater Lake – Klamath Regional Airport

The Branch Condition Report in Appendix 1 summarizes current pavement condition by branch while the Section Condition Report in Appendix 2 lists pavement condition by section. The current Pavement Condition Rating (PCR) is shown graphically in Figure KF-2.

Section PCIs at Crater Lake - Klamath Regional Airport range from a low of 22 (a PCR of “Serious”) to a high of 100 (a PCR of “Good”). The area-weighted average PCI for all airport pavements is 74, corresponding to an overall PCR of “Satisfactory”. Figure KF-3 shows how much pavement area is associated with each Pavement Condition Rating category.

The primary distresses observed in the asphalt pavements during the inspection were: longitudinal and transverse cracking, weathering, block cracking, patching, raveling, alligator cracking, rutting and oil spills with isolated occurrences of bleeding and depressions. The primary distresses observed in the portland cement concrete pavements were: shrinkage cracks, joint spalls, small patches, corner spalls, linear cracking, large patches, corner breaks, and scaling.

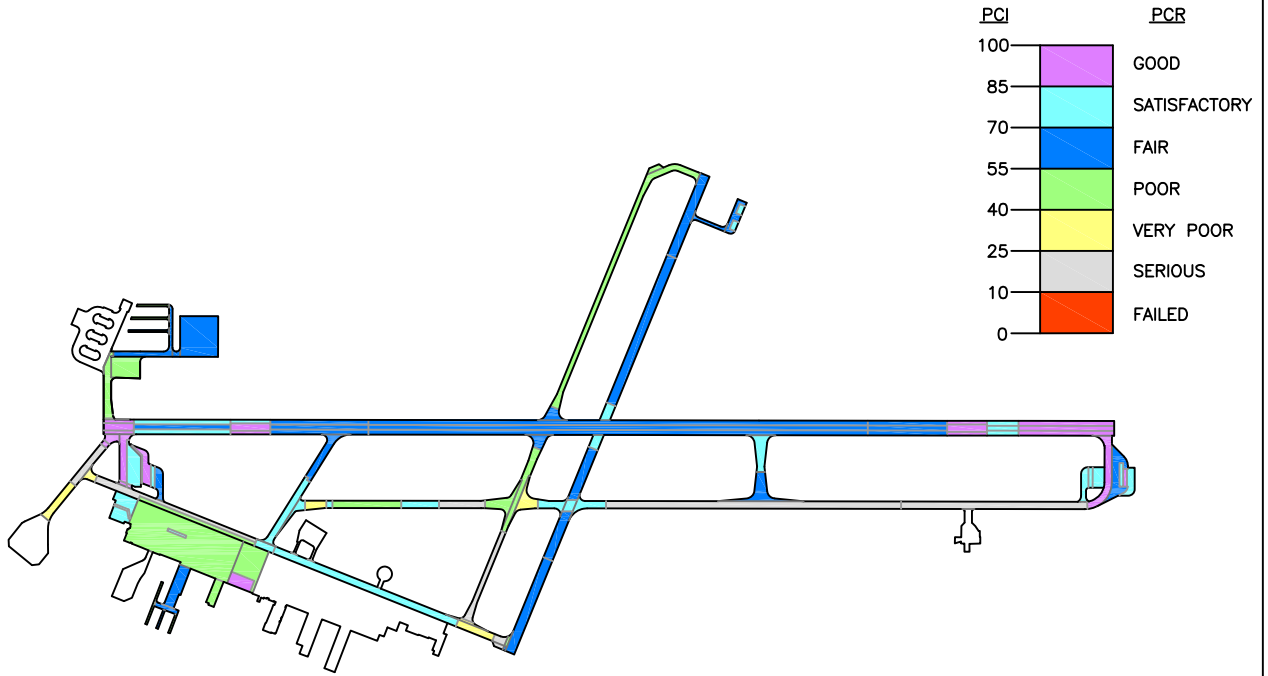
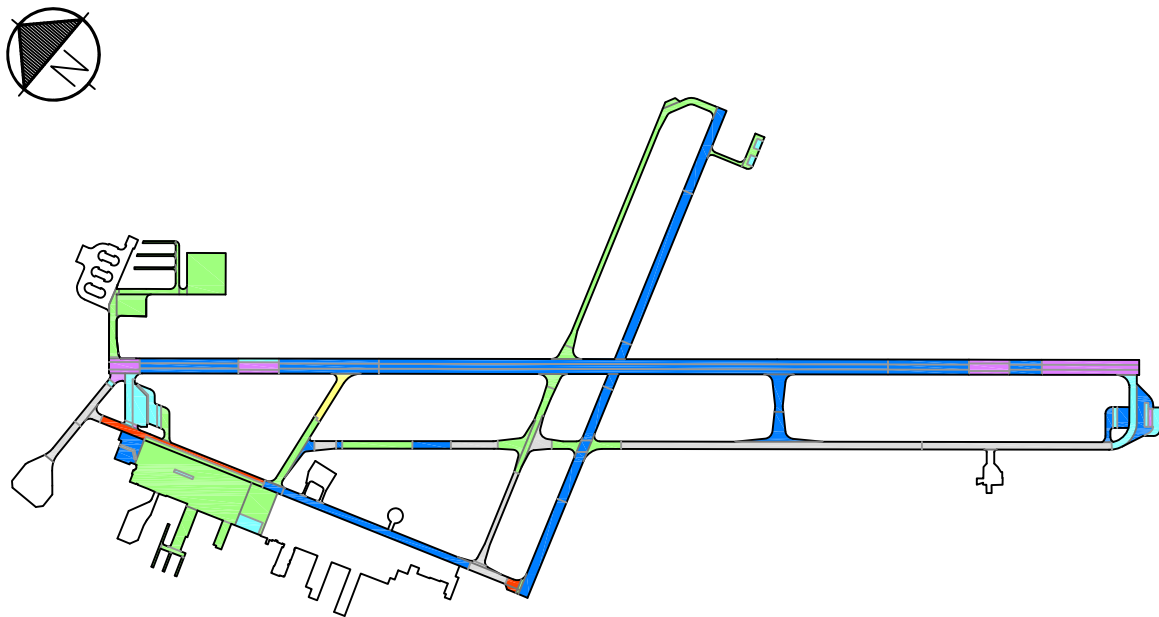
Figure KF-4. Future Pavement Condition.

A graphical representation of the projected PCIs listed in Table 1 is shown in Figure KF-4.
