# CRESWELL HOBBY FIELD

Figure CE-1. Airport Layout, Dimensions and Pavement Cross-Sections.  
Creswell Municipal Airport (Hobby Field)

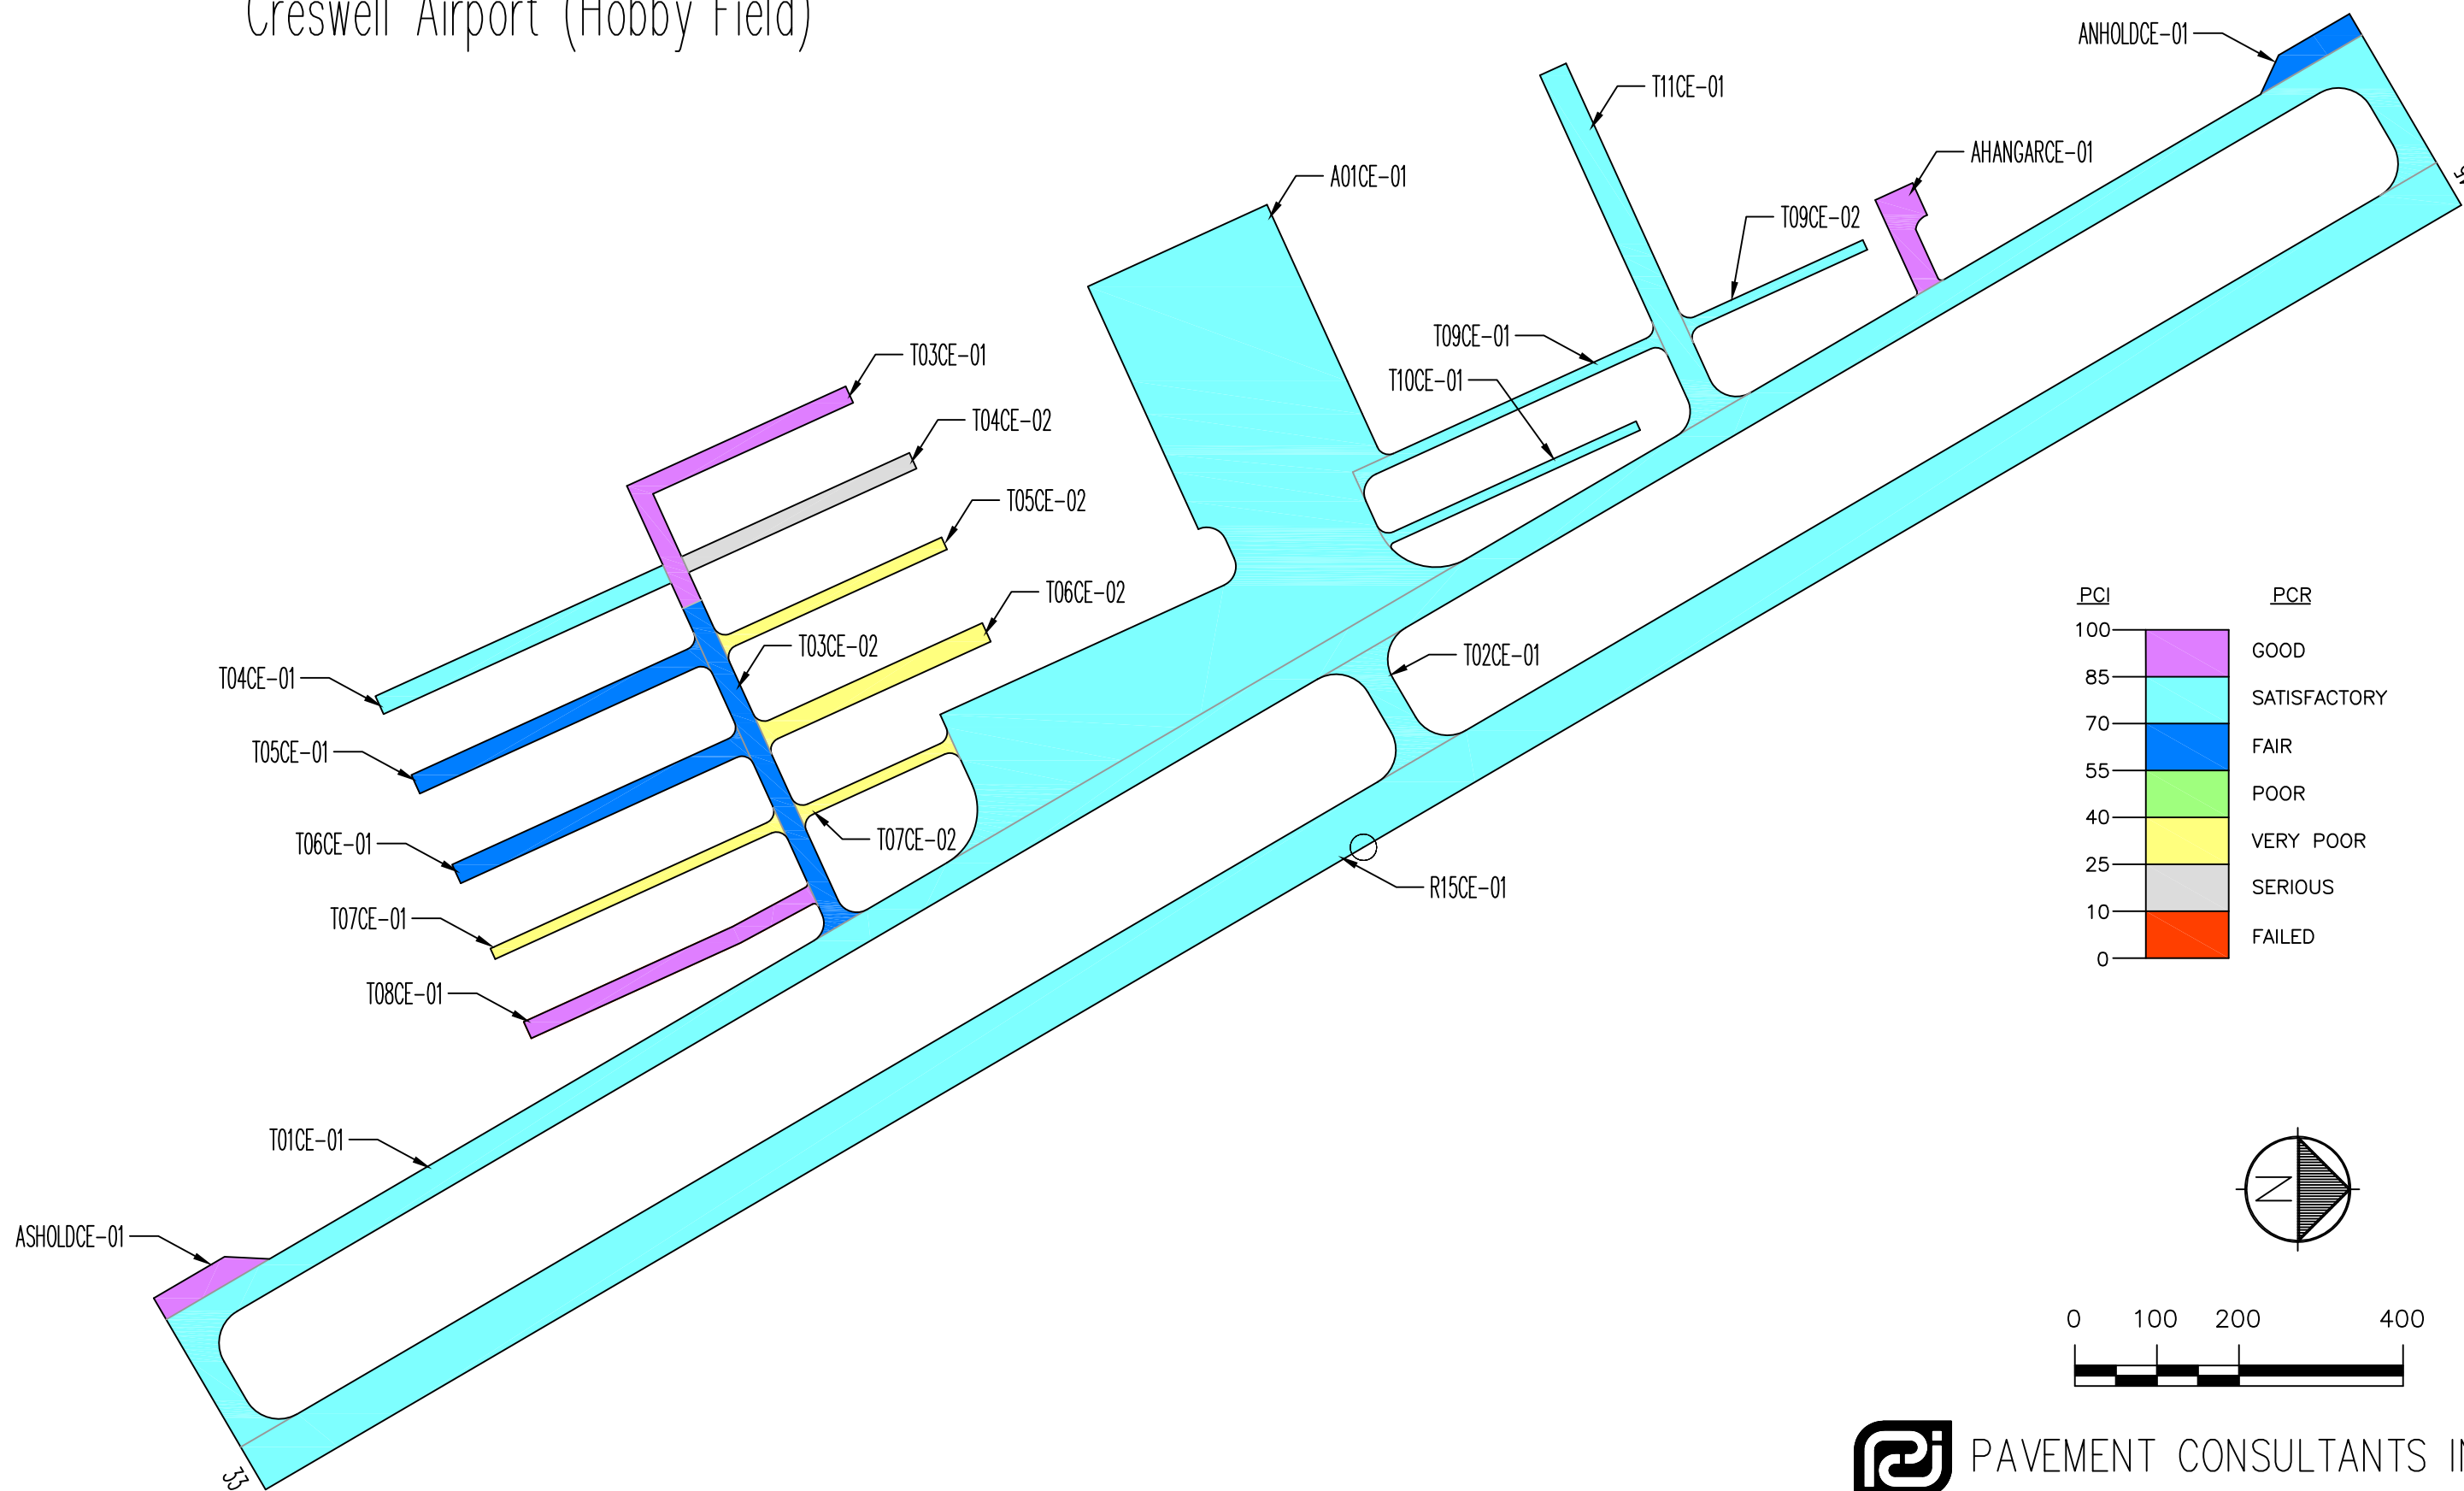
Figure CE-3. Pavement Condition in August 2016.  
Creswell Airport (Hobby Field)

Section PCIs at Creswell Hobby Field range from a low of 23 (a PCR of “Serious”) to a high of 100 (a PCR of “Good”). The area-weighted average PCI for all airport pavements is 75, corresponding to an overall PCR of “Satisfactory”. Figure CE-4 shows how much pavement area is associated with each Pavement Condition Rating category and also shows pavement condition distribution from the inspections conducted in 2009 and 2013.

The primary distresses observed during the inspection were: longitudinal and transverse cracking, patching, raveling, alligator cracking, and depressions.
