FLORENCE MUNICIPAL AIRPORT

Figure FL-1. Airport Layout, Dimensions and Pavement Cross-Sections.
 Florence Municipal Airport

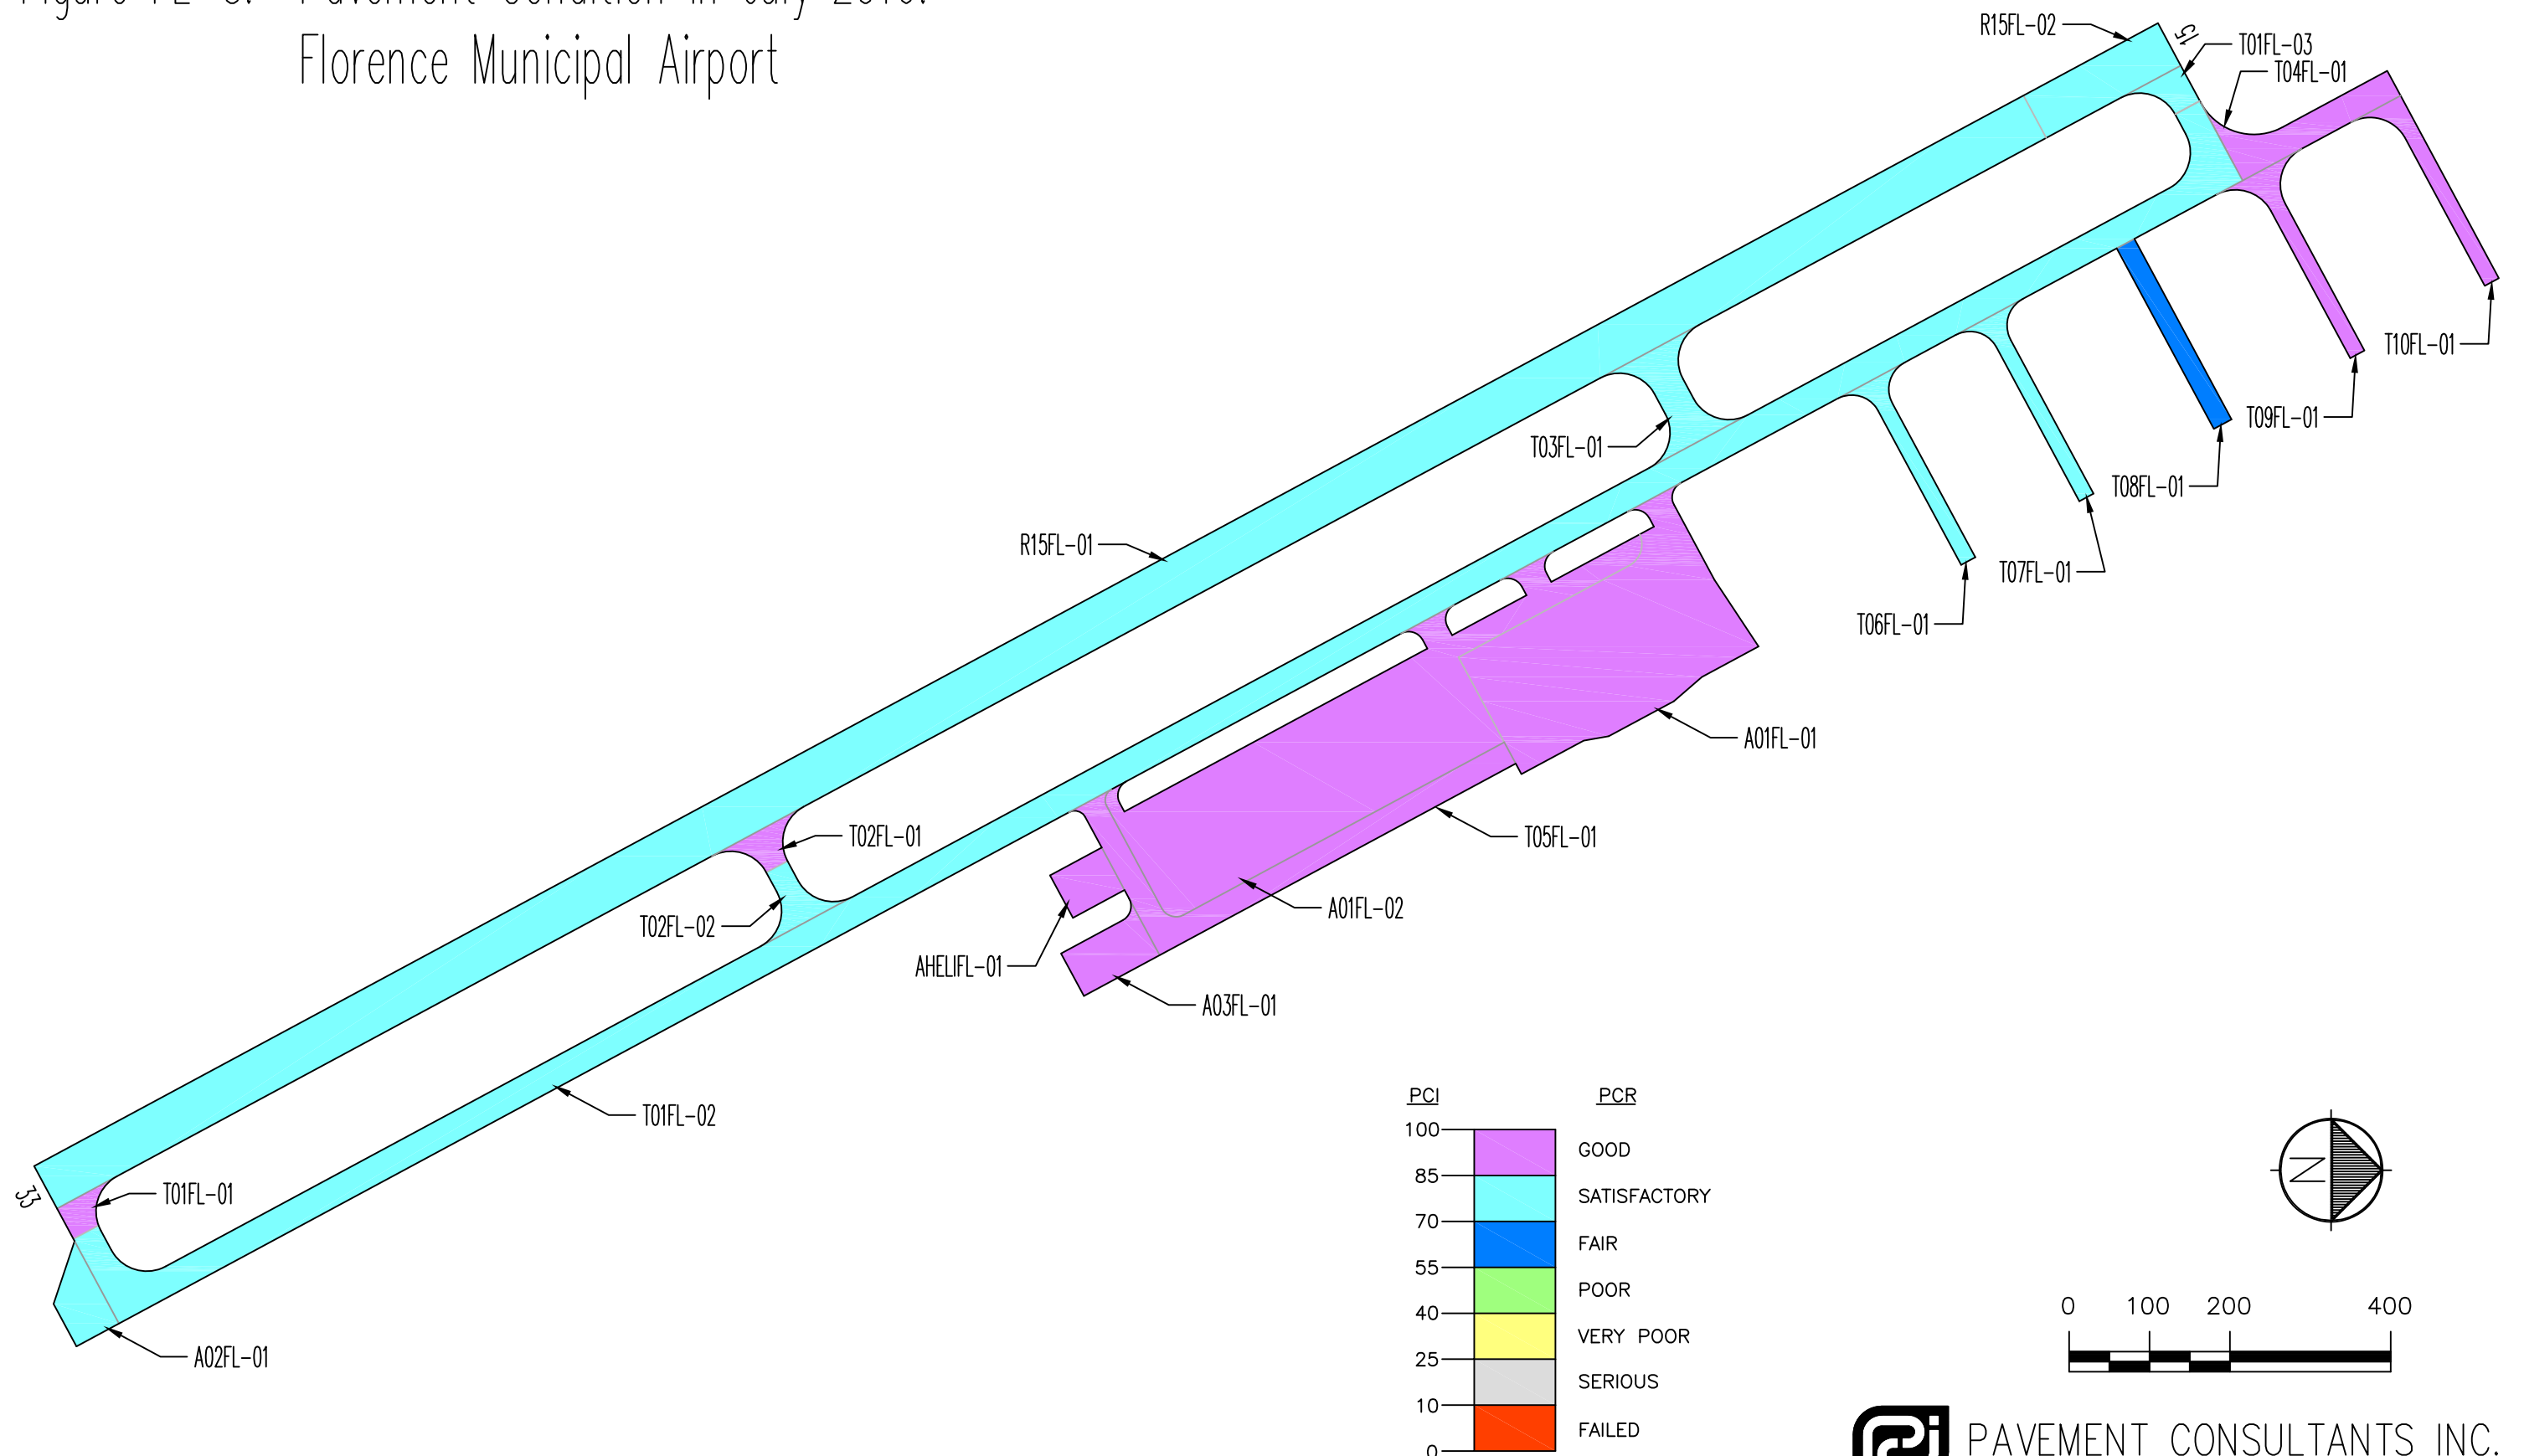
Figure FL-3. Pavement Condition in July 2016.
 Florence Municipal Airport

Section PCIs at Florence Municipal Airport range from a low of 66 (a PCR of “Fair”) to a high of 100 (a PCR of “Good”). The area-weighted average PCI for all airport pavements is 89, corresponding to an overall PCR of “Good”. Figure FL-4 shows how much pavement area is associated with each Pavement Condition Rating category and also shows pavement condition distribution from the inspections conducted in 2009 and 2013.

The primary distresses observed during the inspection were: longitudinal and transverse cracking, weathering, depressions, and isolated occurrences of alligator cracking and raveling.

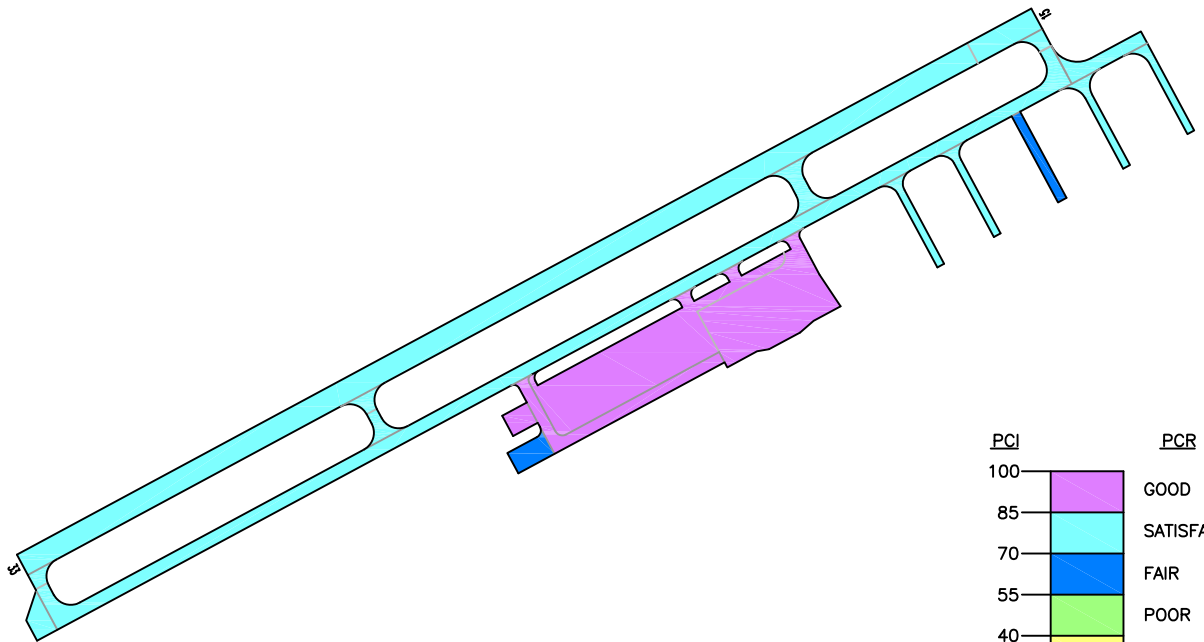
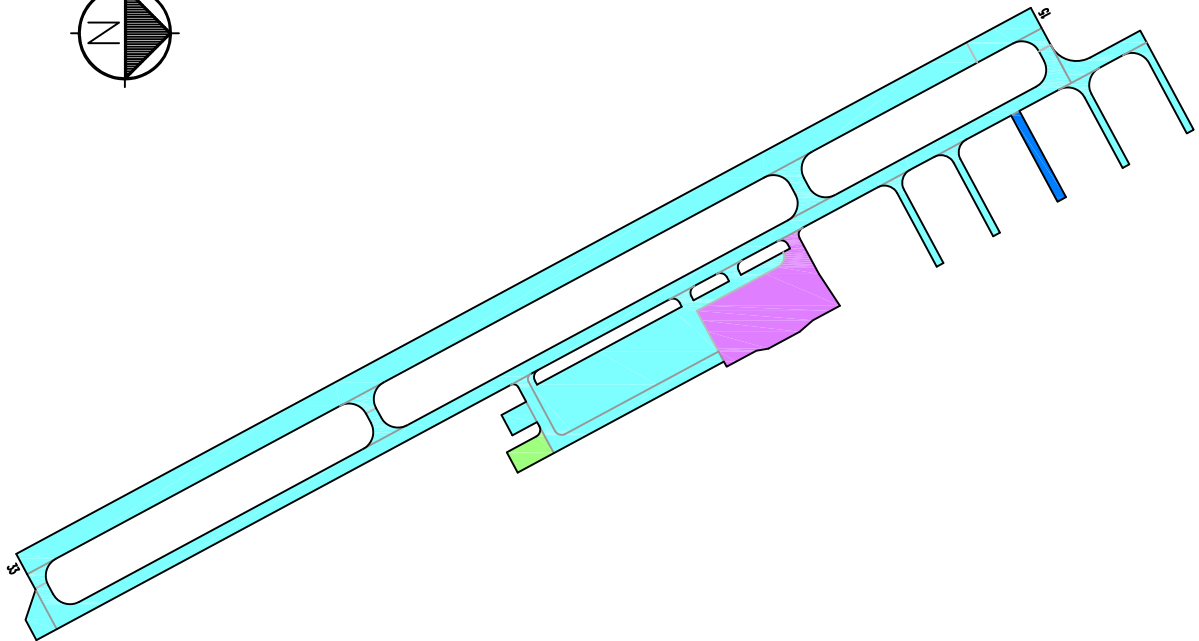
Figure FL-5. Future Pavement Condition.

A graphical representation of the projected PCIs listed in Table 1 is shown in Figure FL-5.
