GOLD BEACH MUNICIPAL AIRPORT

Figure GB-1. Airport Layout, Dimensions and Pavement Cross-Sections.
Gold Beach Municipal Airport

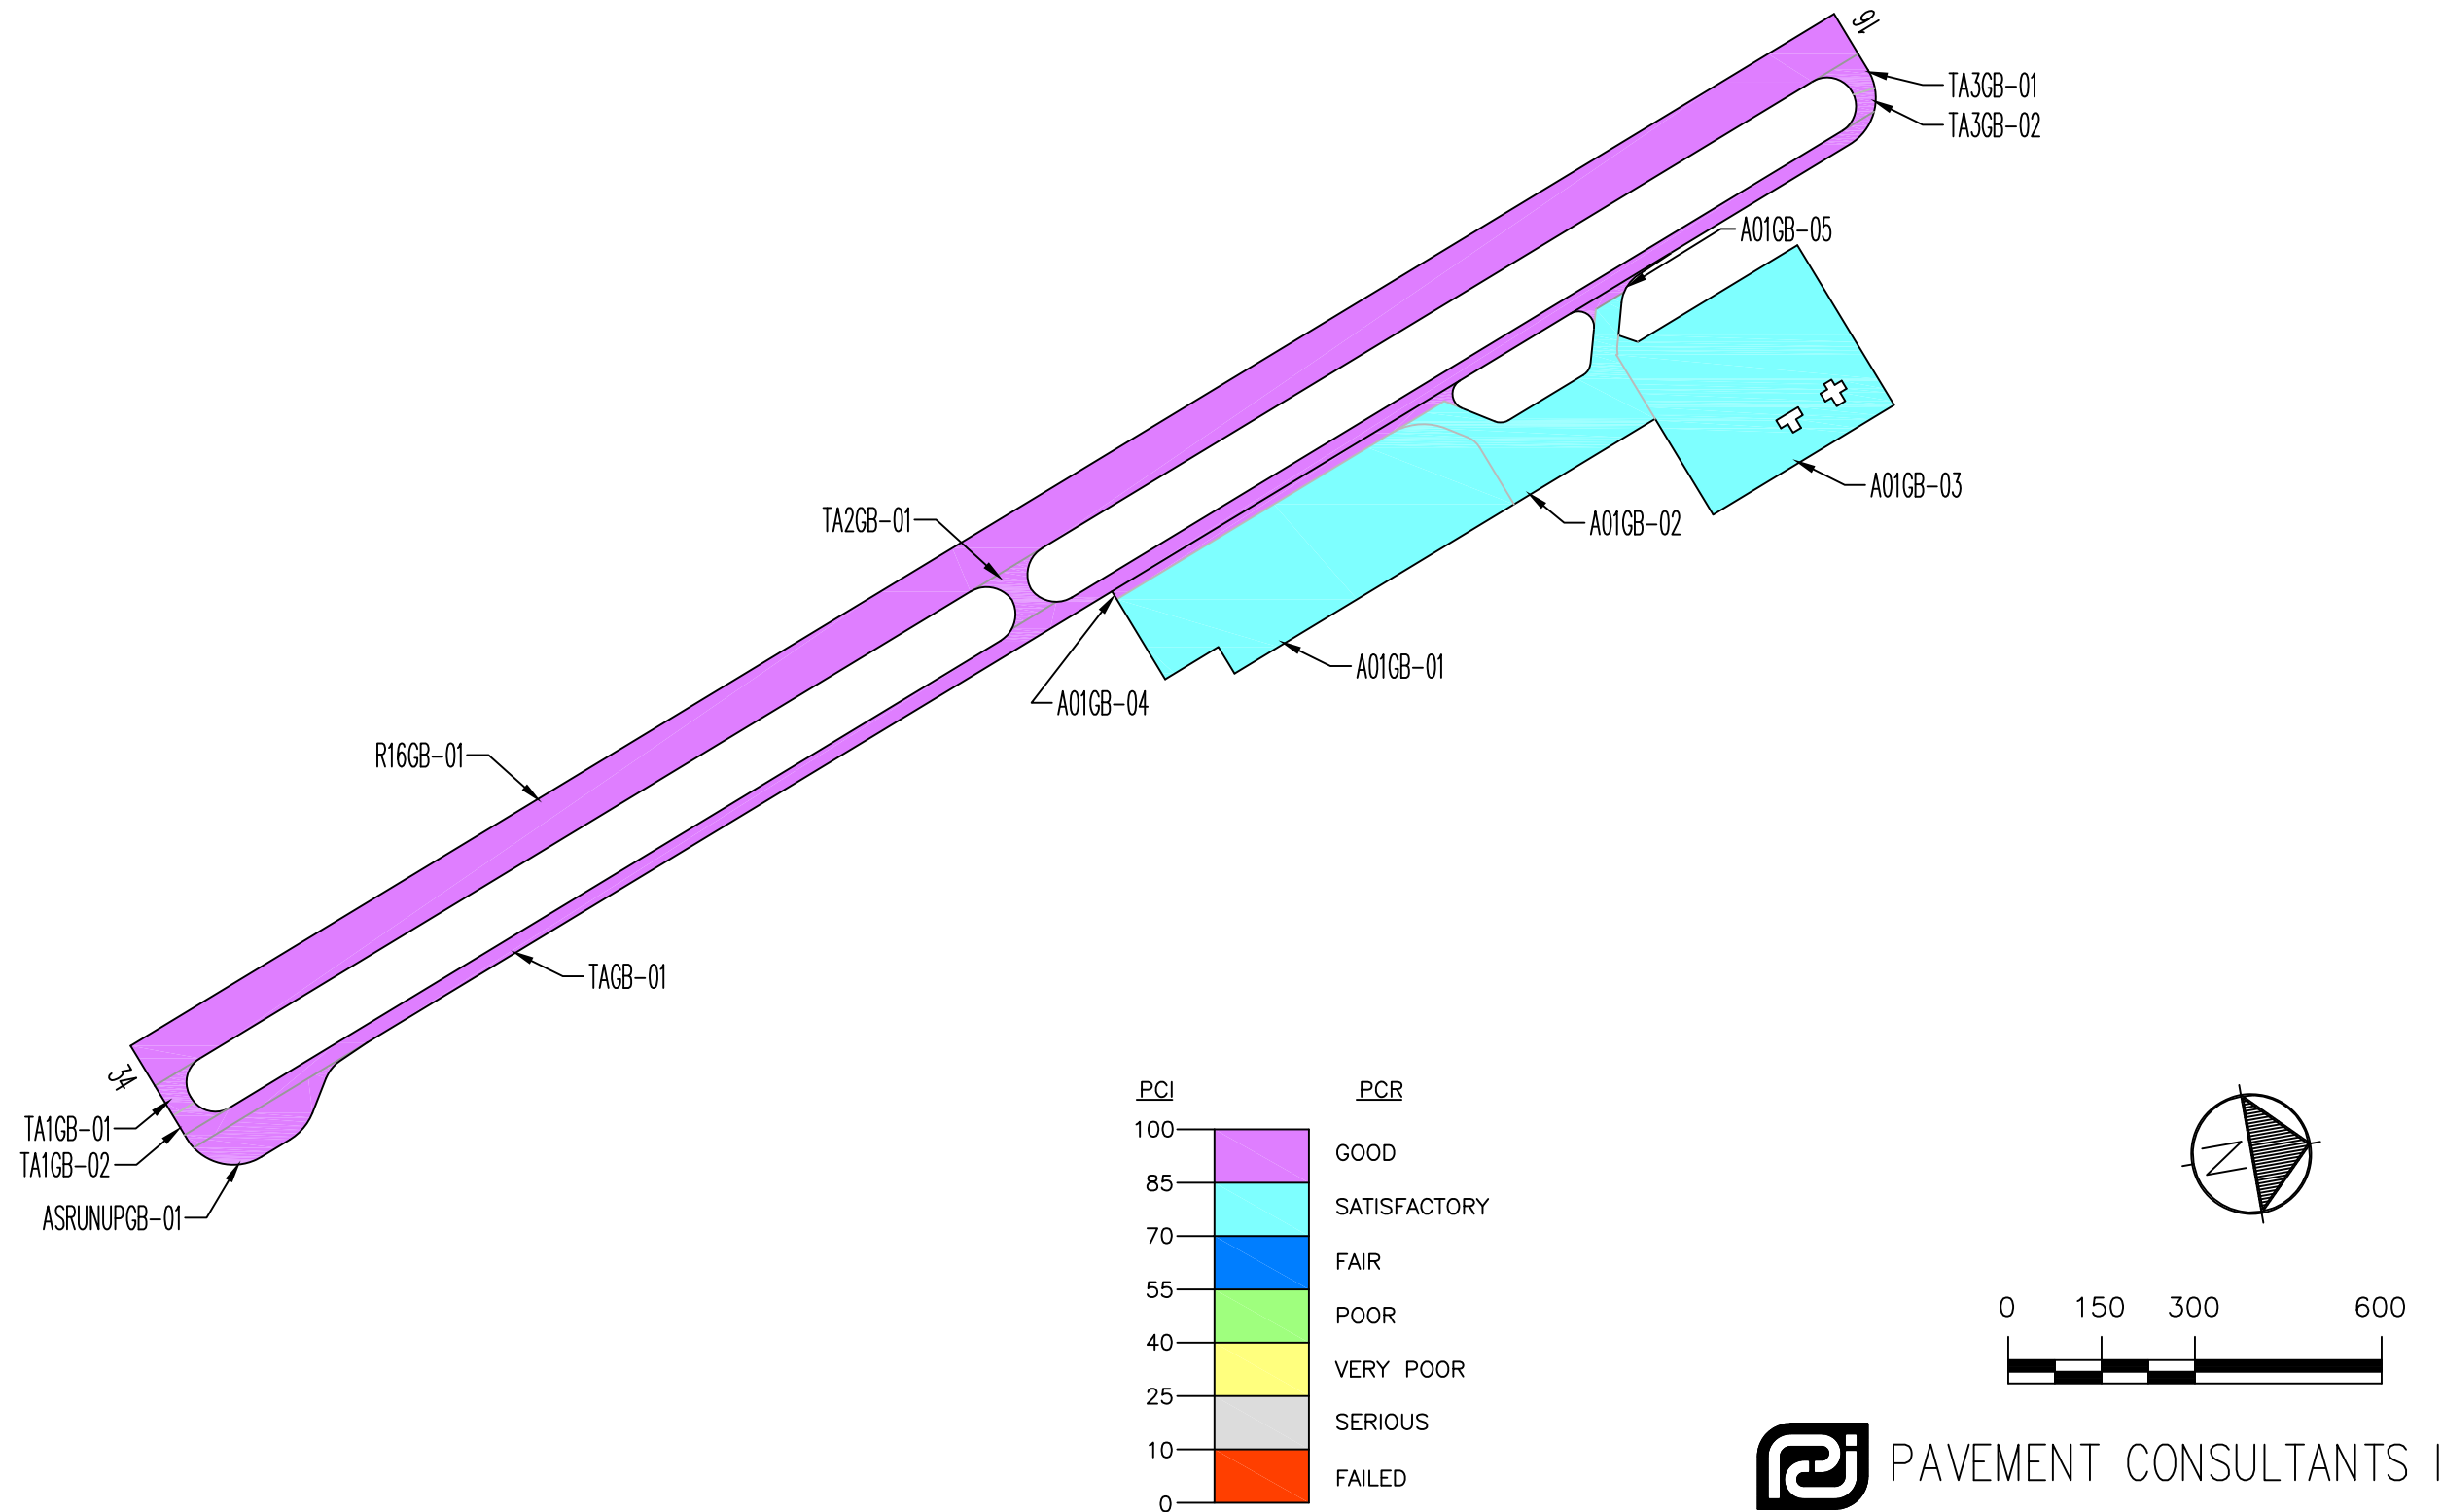
Figure GB-3. Pavement Condition in July 2016.
Gold Beach Municipal Airport

Section PCIs at Gold Beach Municipal Airport range from a low of 81 (a PCR of “Satisfactory”) to a high of 100 (a PCR of “Good”). The area-weighted average PCI for all airport pavements is 91, corresponding to an overall PCR of “Good”. Figure GB-4 shows how much pavement area is associated with each Pavement Condition Rating category and also shows pavement condition distribution from the inspections conducted in 2009 and 2013.

The primary distresses observed during the inspection were: longitudinal and transverse cracking, and depressions.

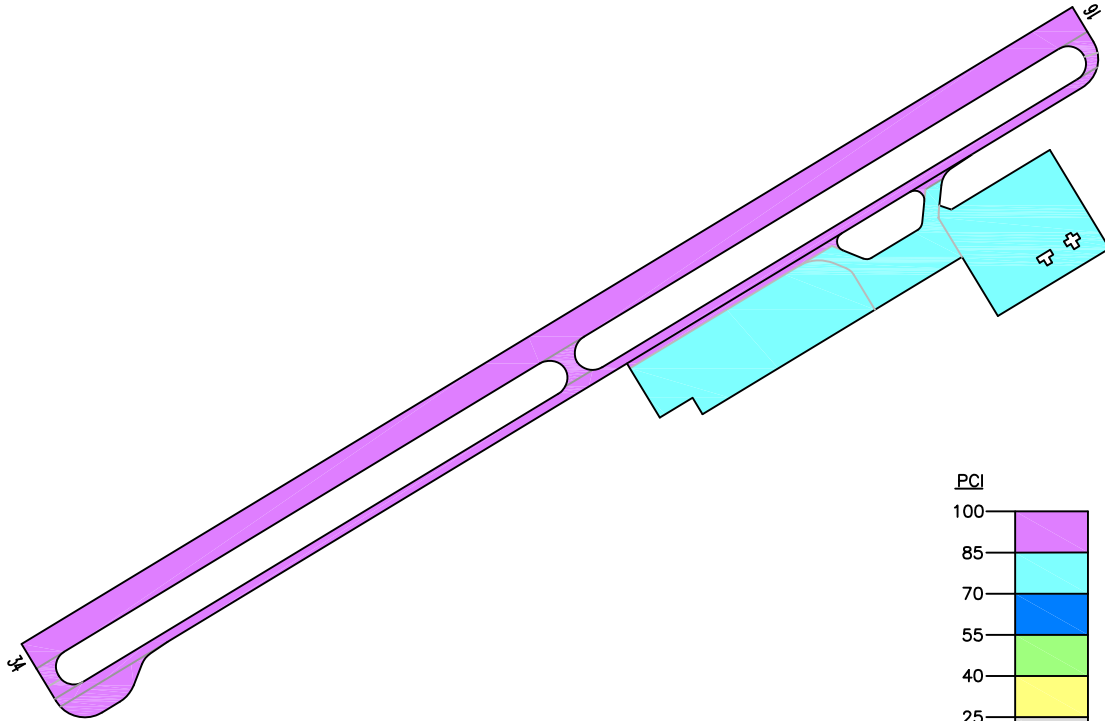
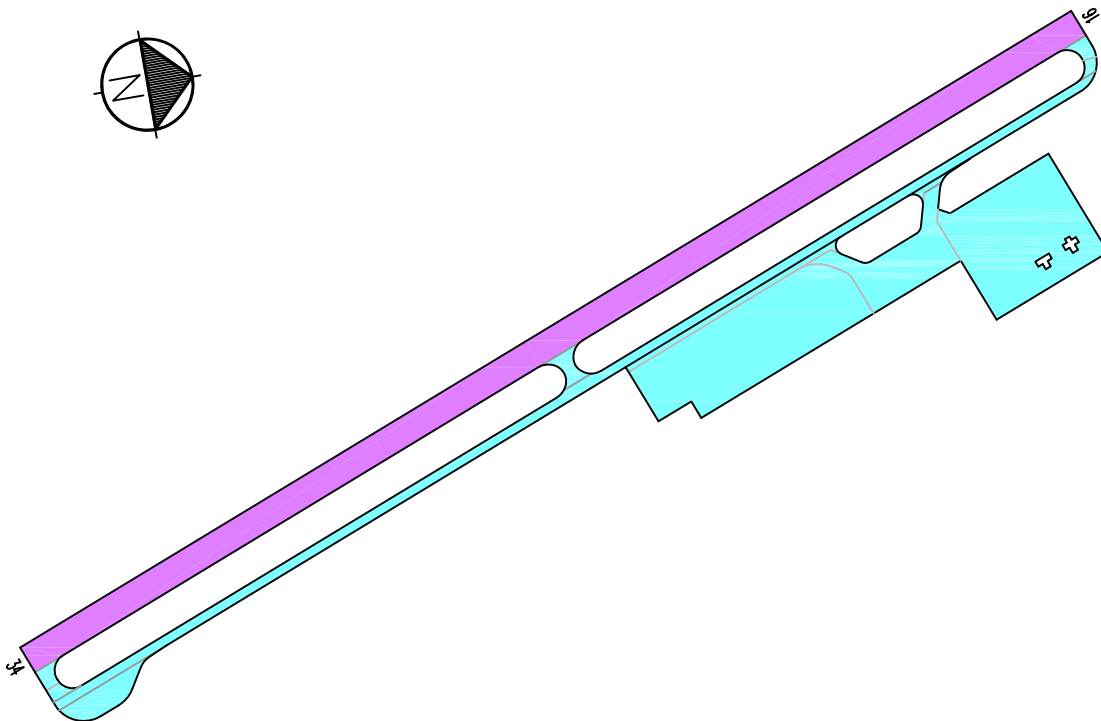
Figure GB-5. Future Pavement Condition.

A graphical representation of the projected PCIs listed in Table 1 is shown in Figure GB-5.
