GRANTS PASS AIRPORT

Figure GR-1A. Airport Layout, Dimensions and Pavement Cross-Sections.
Grants Pass Airport

Figure GR-2. Pavement Branch, Section and Sample Unit Layout.
Grants Pass Airport

Figure GR-3. Pavement Condition in July 2016.
Grants Pass Airport

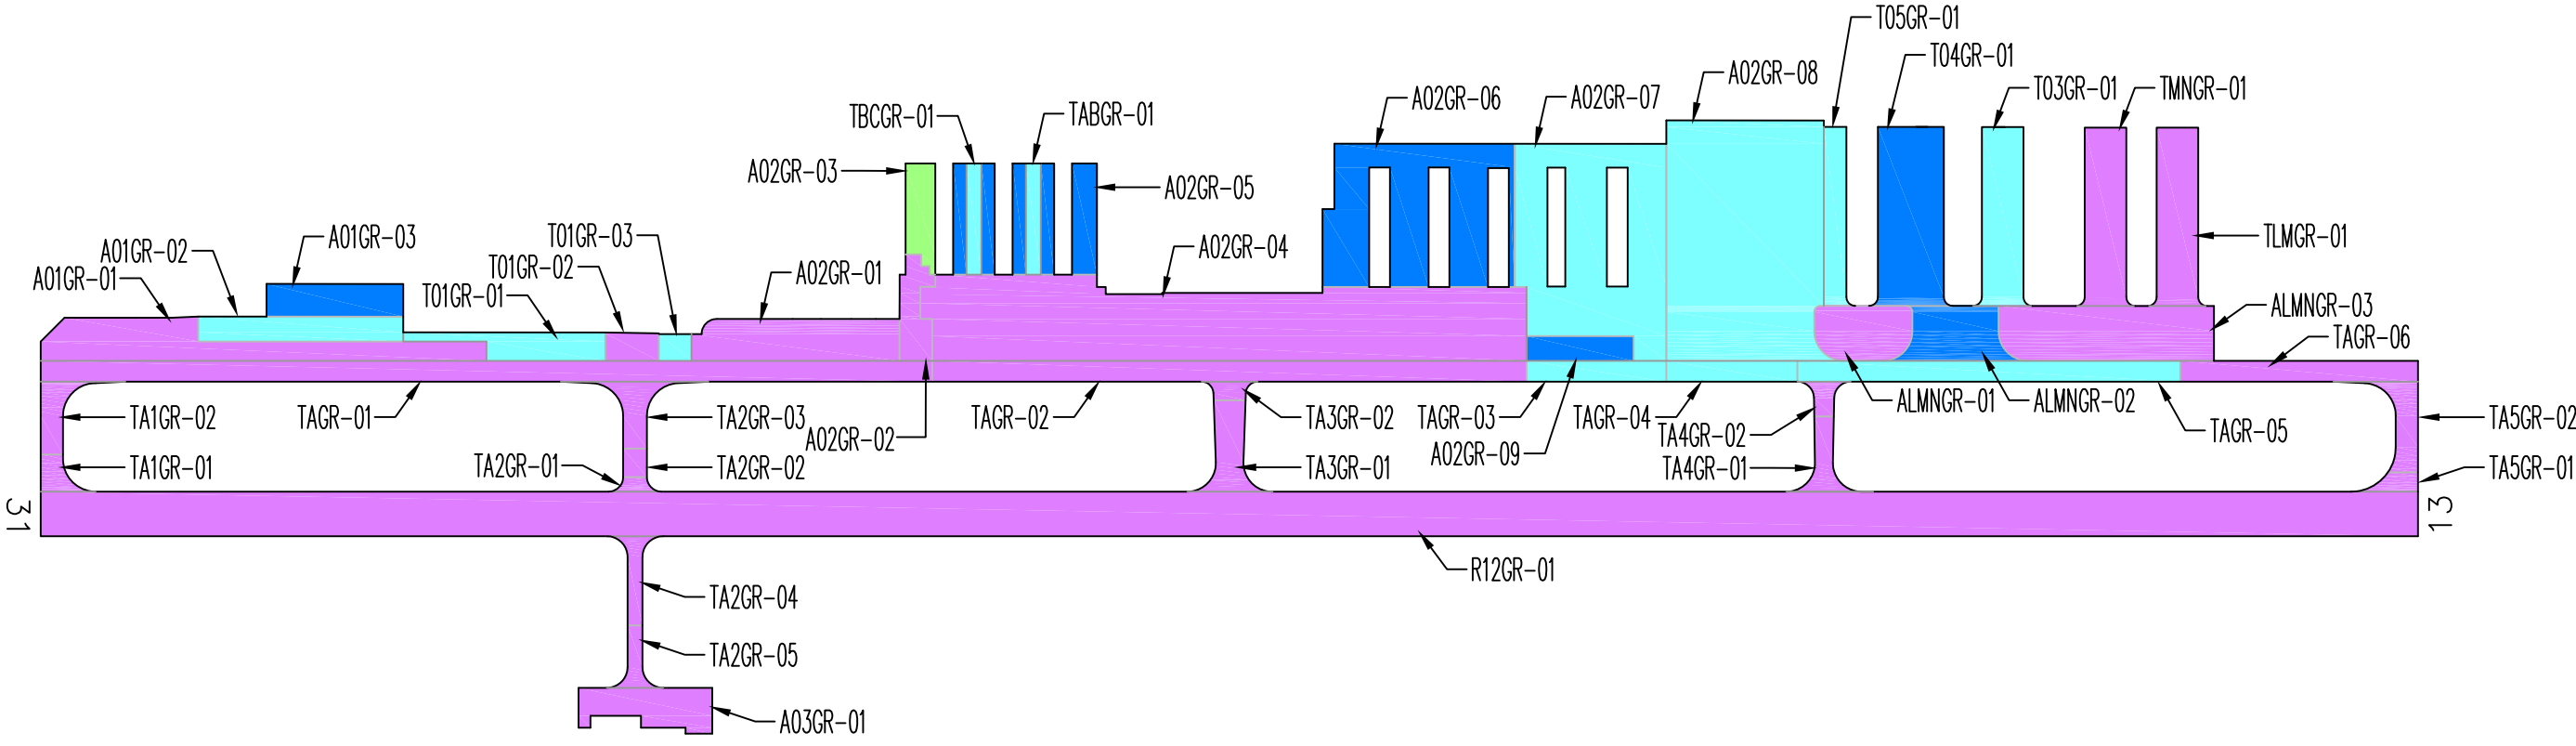
Section PCIs at Grants Pass Airport range from a low of 52 (a PCR of “Poor”) to a high of 100 (a PCR of “Good”). The area-weighted average PCI for all airport pavements is 86, corresponding to an overall PCR of “Good”. Figure GR-4 shows how much pavement area is associated with each Pavement Condition Rating category and also shows pavement condition distribution from the inspections conducted in 2009 and 2013.

The primary distresses observed during the inspection were: longitudinal and transverse cracking, patching, weathering, and block cracking, with an isolated occurrence of depression.
