ILLINOIS VALLEY AIRPORT

Figure IV-1. Airport Layout, Dimensions and Pavement Cross-Sections.
Illinois Valley Airport

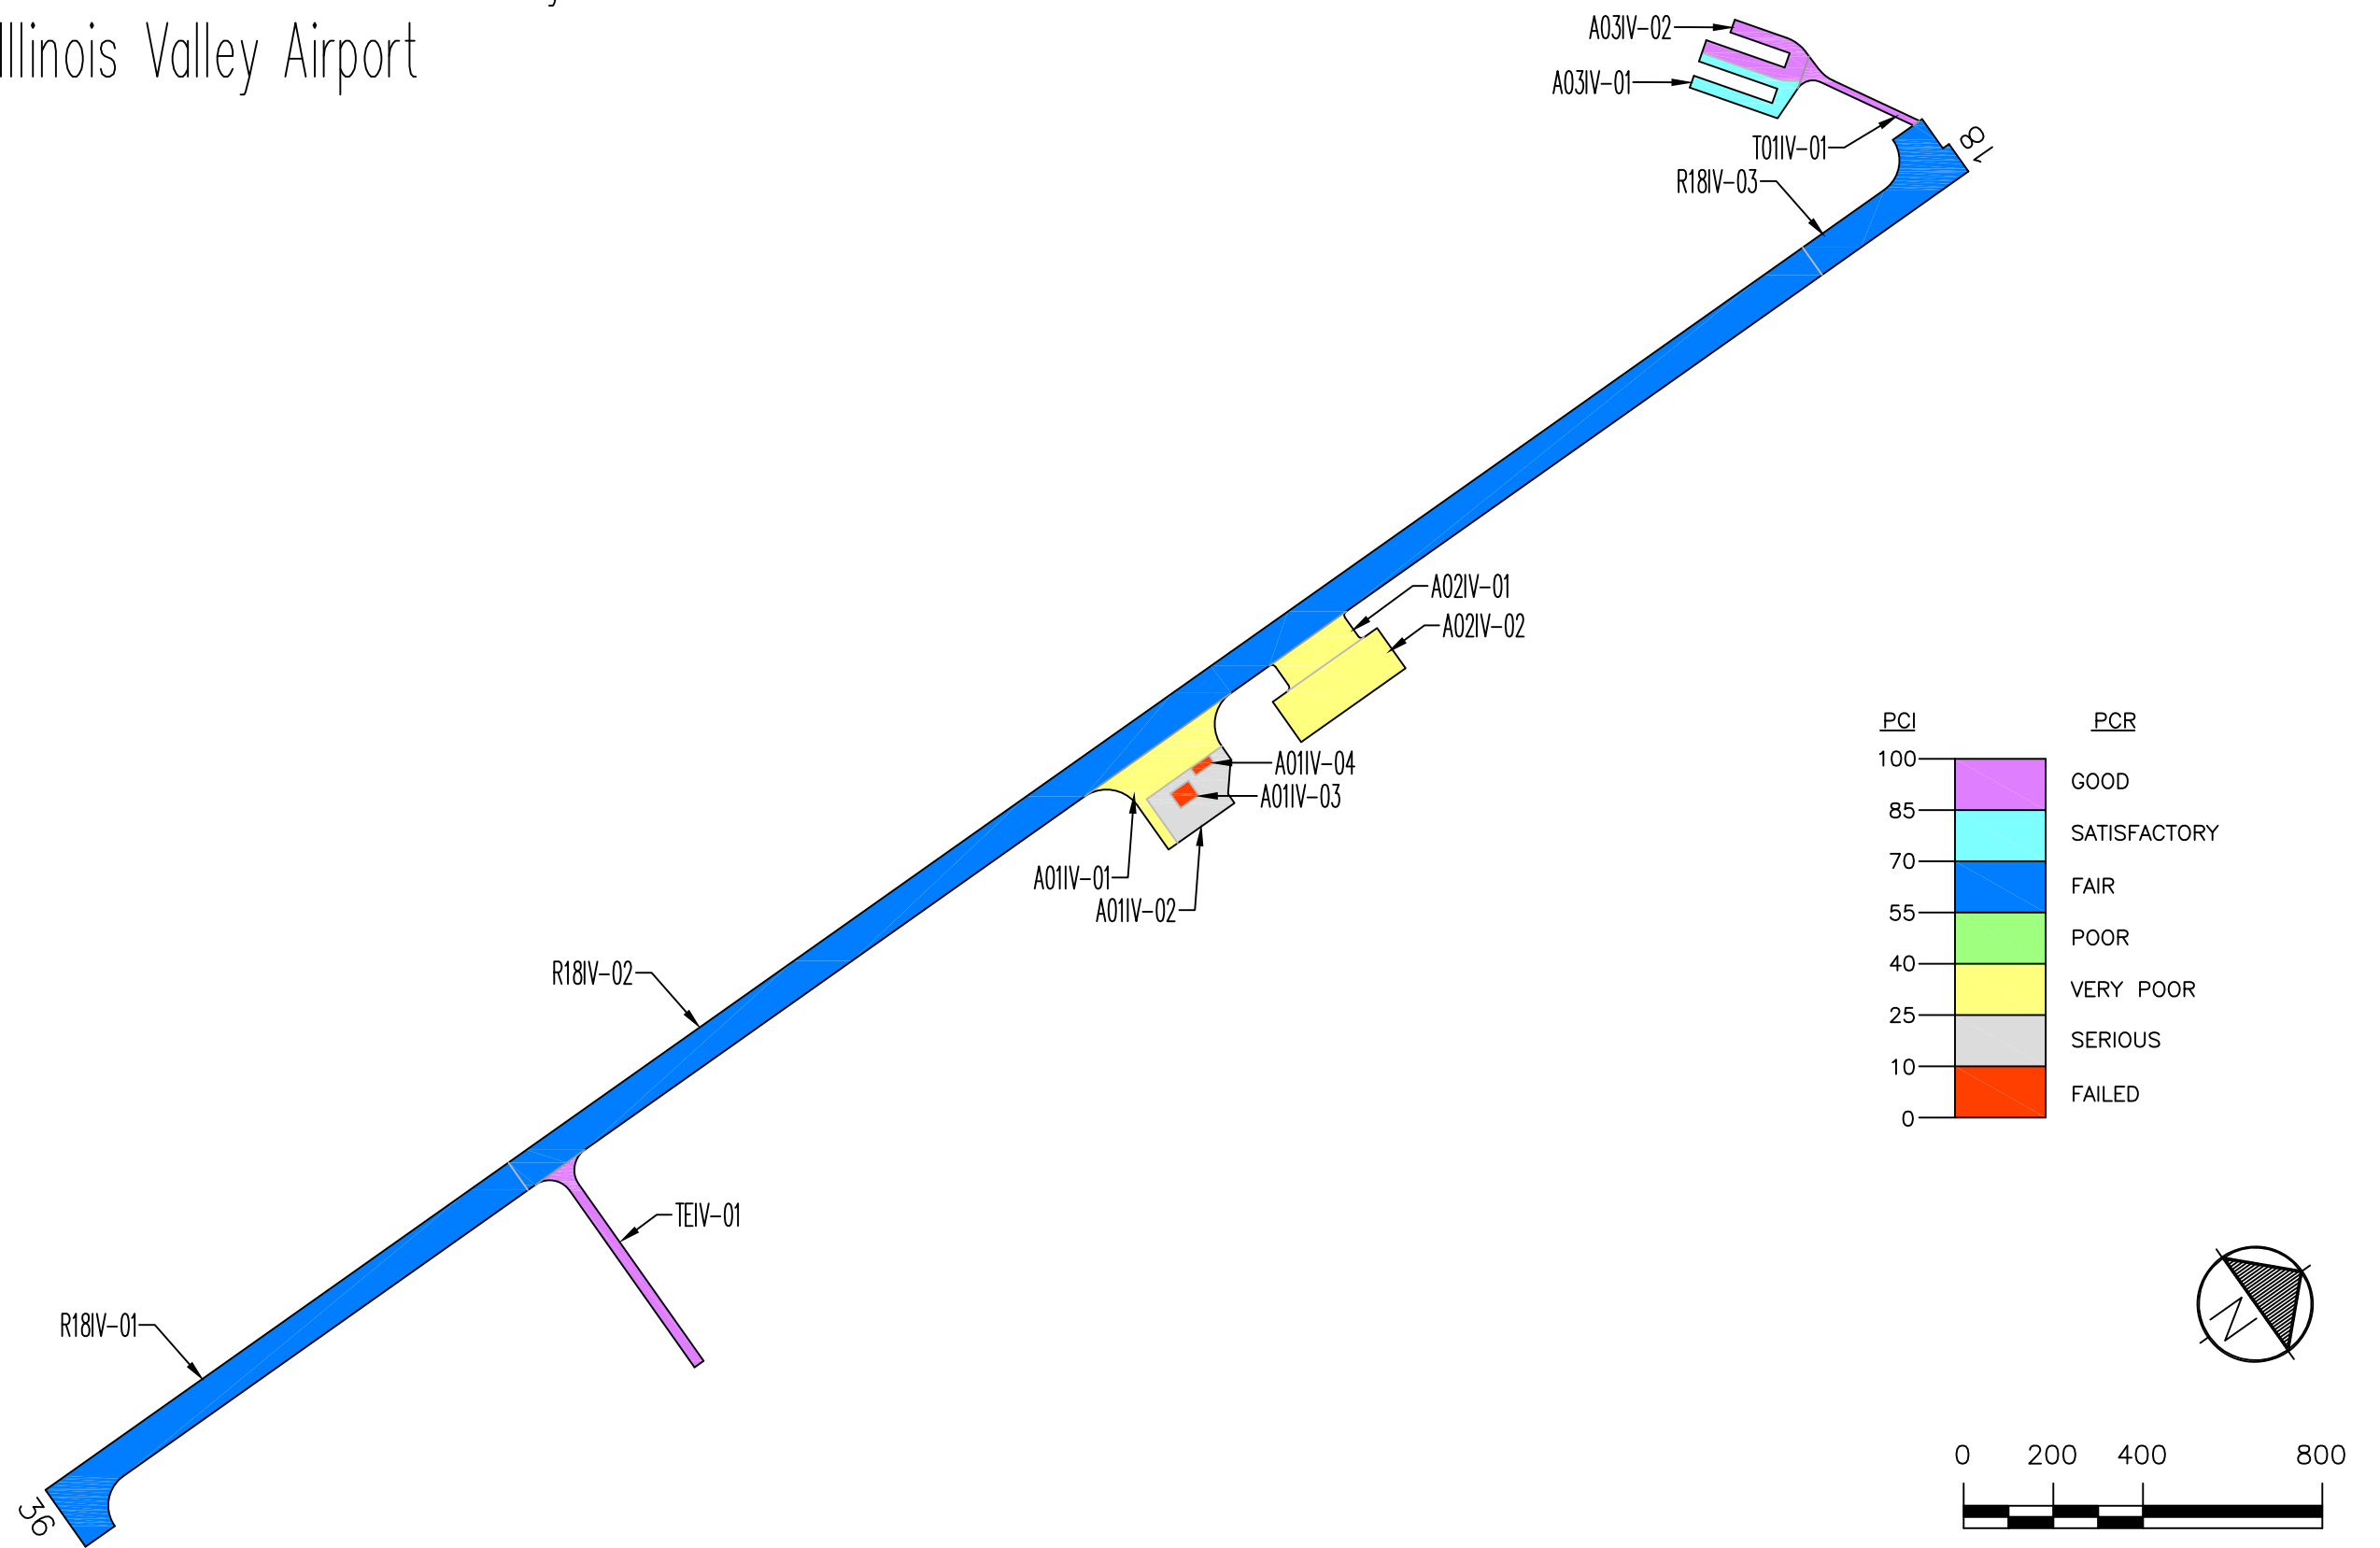
Figure IV-3. Pavement Condition in July 2016.
Illinois Valley Airport

The Branch Condition Report in Appendix 1 summarizes current pavement condition by branch while the Section Condition Report in Appendix 2 lists pavement condition by section. The current Pavement Condition Rating (PCR) is shown graphically in Figure IV-3.

Section PCIs at Illinois Valley Airport range from a low of 0 (a PCR of “Failed”) to a high of 100 (a PCR of “Good”). The area-weighted average PCI for all airport pavements is 62, corresponding to an overall PCR of “Fair”. Figure IV-4 shows how much pavement area is associated with each Pavement Condition Rating category and also shows pavement condition distribution from the inspections conducted in 2009 and 2013.

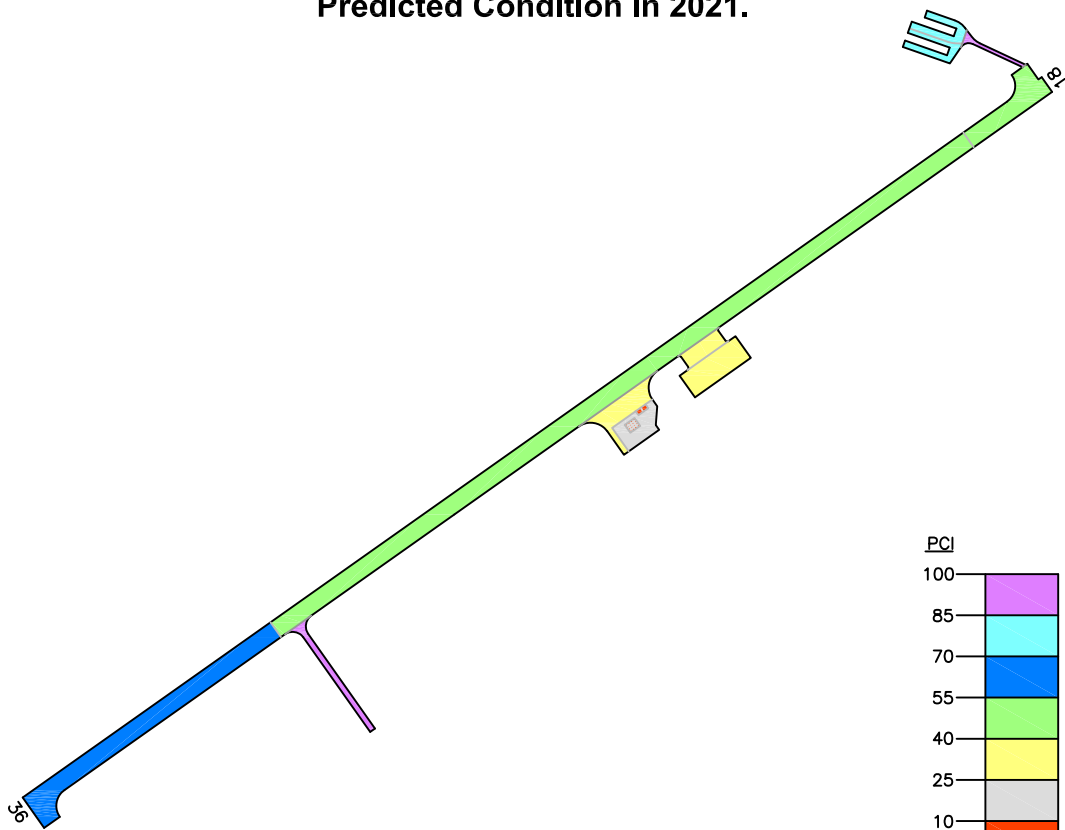
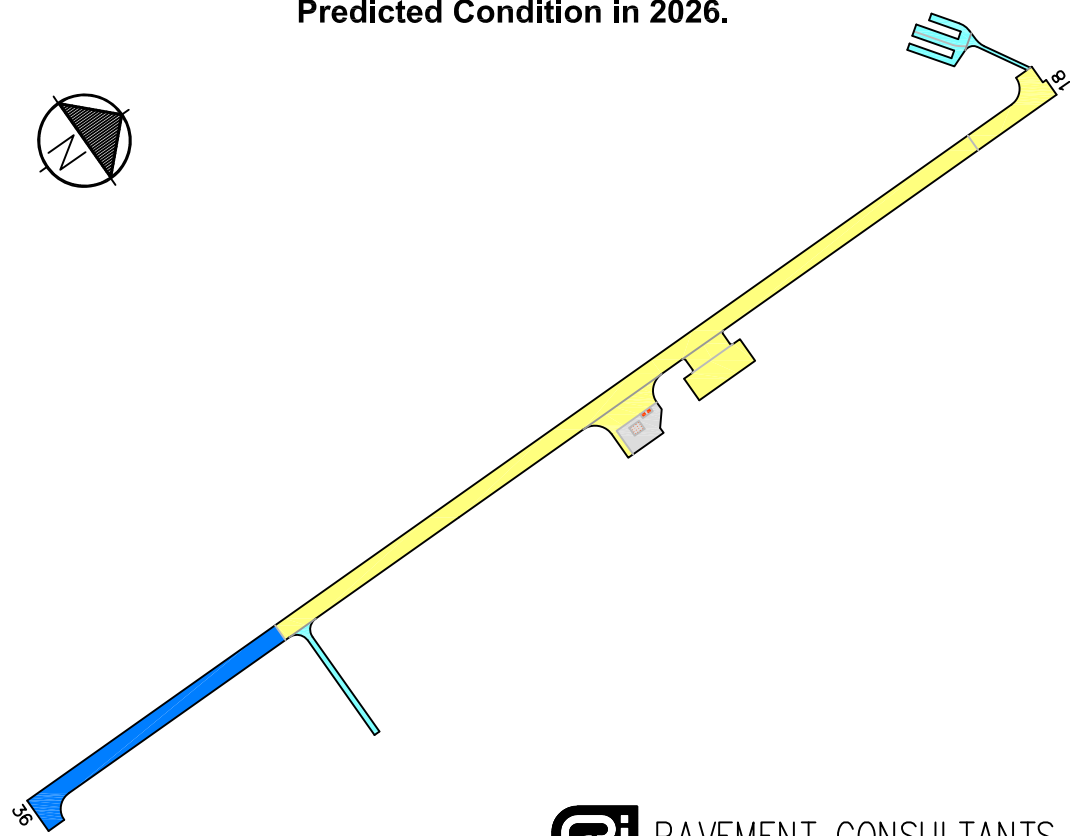
Figure IV-5. Future Pavement Condition.

A graphical representation of the projected PCIs listed in Table 1 is shown in Figure IV-5.
